**Town of Randolph
Stetson Hall**

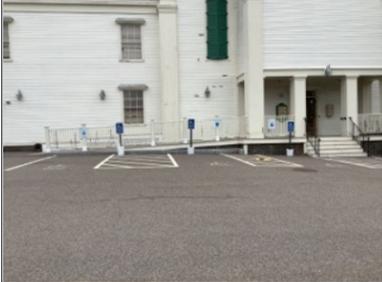
Total # of parking Total # of designated accessible parking spaces Total # of designated van accessible spaces Running or cross slope at access aisle > 1:50 (2.00%) Sign does not have the designation "Van Accessible" Sign bottom < 60" above finished grade	46 2 1 5.1% - 43"	Reduce running or cross slope to be no steeper than 1:50 (2.00%). Add the designation "Van Accessible" to the sign located at the van accessible space. Locate signs with the bottom of the signs 60" min. above the ground and the top of the signs 96" max. above the ground.	1	-	\$0
Entrance												
2	Secondary Entrance, Northwest Egress	Ext.		Entrance	Secondary Entrance

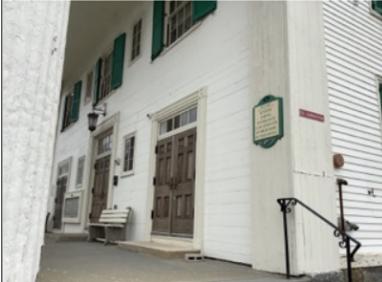
Directional sign to accessible entrance not provided Threshold > 3/4" high	- 5.5"	Provide a directional sign indicating the location of the nearest accessible entrance. Alter threshold to be 3/4" high max.	1	-	\$0

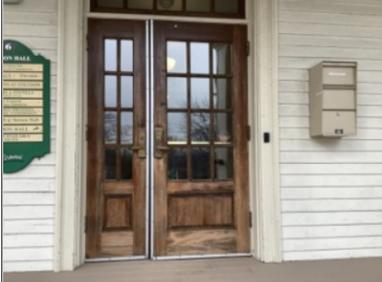
3	Main Entrance, Southeast Egress	Ext.		Entrance	Main Entrance

International Symbol of Accessibility not provided Door requires > 15 lbs. of force to open	- 17 lbs	Provide a sign with the International Symbol of Accessibility (ISA). Adjust closers so doors do not require more than 15 pounds of opening force.	1	-	\$0
Access to Goods and Services												
Means of Egress												
4	Southeast Egress, Main Entrance	1		Means of Egress	N/A

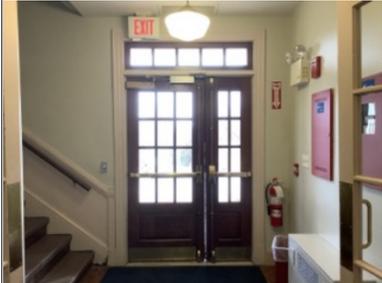
Tactile exit sign not provided Illuminated ISA symbol not provided (MAAB) Automatic door opener not operable	- -	Ensure tactile exit signs with raised characters and braille are provided at exit doors. Mount signs between 48"- 60" above the finished floor located on the latch side of the door. When the illuminated exit sign is repaired or replaced, provide an illuminated International Symbol of Accessibility (ISA). Repair the control for the door opener to ensure it is maintained in operable working condition.	1	3492	\$3492

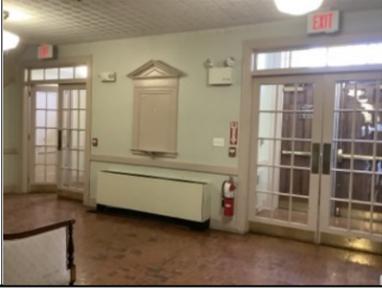
ID	Location	Floor	Room	Element	Type	Photo	Issues	Current Measure	Recommendations	Quantity	Price	Cost Estimation
5	Northwest Egress	1		Means of Egress	N/A

Tactile exit sign not provided Directional sign to accessible emergency exit not provided	- -	Ensure tactile exit signs with raised characters and braille are provided at exit doors. Mount signs between 48"- 60" above the finished floor located on the latch side of the door. Provide a directional sign indicating the location of the nearest accessible emergency exit.	2	232	\$464
Interior Access Route												
6	Great Hall to East Staircase by Main Entrance, East Egress	2		Interior Access Route	N/A

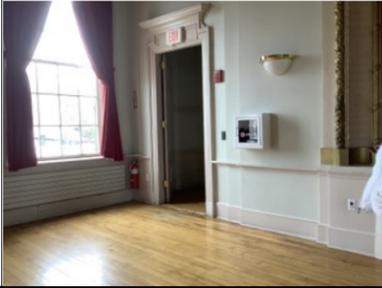
Obstructed by protruding objects	7"	Provide a cane-detectable barrier under the automatic external defibrillator (AED).	1	306	\$306
7	Balcony	3		Interior Access Route	N/A

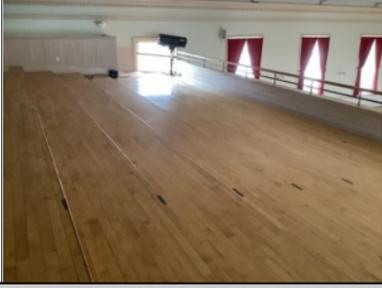
Accessible route not provided	-	Determination should be made as to whether it is technically feasible to provide an accessible route in compliance with the ADA Standards.	1	-	\$0

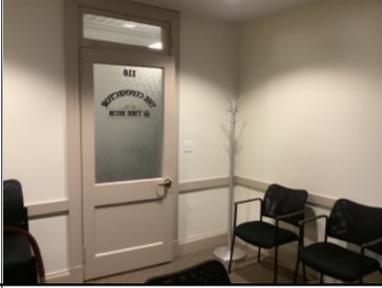
Doors, Doorways, & Gates												
8	The Connector	1	110	Doors, Doorways, & Gates	Office

Maneuvering clearance(s) not provided	11"	Relocate the chair to maintain the required 18" min. maneuvering clearance at the pull side of the door.	1	Labor	\$0
9	GAR Hall	1	112	Doors, Doorways, & Gates	Circulation

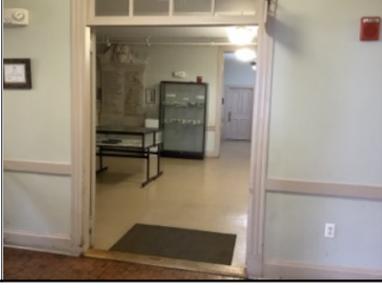
Threshold > 1/2" high	1.5"	Alter the threshold to be 1/2" high max. (Applies to all offices located on the first floor with thresholds that are higher than 1/2".)	10	150	\$1500

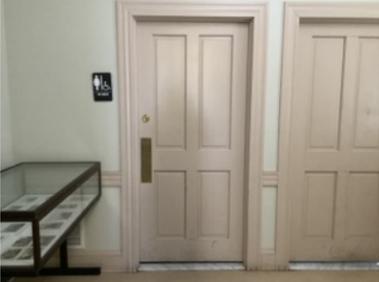
ID	Location	Floor	Room	Element	Type	Photo	Issues	Current Measure	Recommendations	Quantity	Price	Cost Estimation
10	Women's Multi-User Toilet Room	1		Doors, Doorways, & Gates	Toilet Room

Door requires > 5 lbs. of force to open	10 lbs	Adjust closers so doors do not require more than 5 pounds of force to open.	1	Labor	\$0
11	Men's Multi-User Toilet Room	1		Doors, Doorways, & Gates	Toilet Room

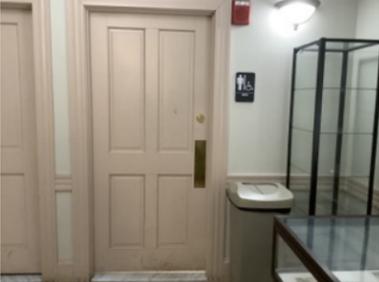
Door requires > 5 lbs. of force to open	10 lbs	Adjust closers so doors do not require more than 5 pounds of force to open.	1	Labor	\$0
12	Kitchen	2		Doors, Doorways, & Gates	Other

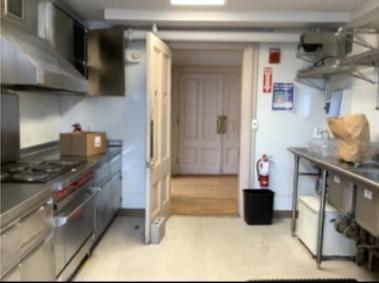
Maneuvering clearance(s) not provided	9"	Relocate the trash can and the fire extinguisher to provide 18" min. pull side maneuvering clearance.	1	Labor	\$0
13	Family Multi-User Toilet Room	2		Doors, Doorways, & Gates	Toilet Room

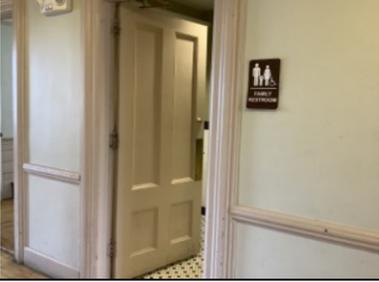
Door requires > 5 lbs. of force to open	11lbs	Adjust closers so doors do not require more than 5 pounds of force to open.	1	Labor	\$0

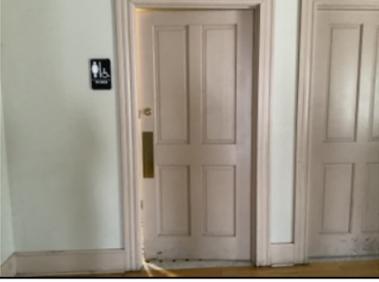
14	Women's Multi-User Toilet Room	2		Doors, Doorways, & Gates	Toilet Room

Door requires > 5 lbs. of force to open	15lbs	Adjust closers so doors do not require more than 5 pounds of force to open.	1	Labor	\$0

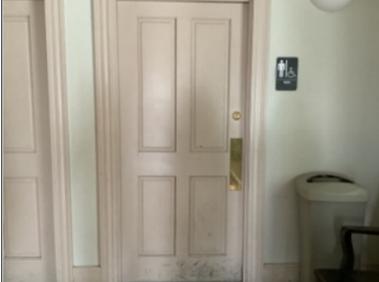
ID	Location	Floor	Room	Element	Type	Photo	Issues	Current Measure	Recommendations	Quantity	Price	Cost Estimation
15	Men's Multi-User Toilet Room	2		Doors, Doorways, & Gates	Toilet Room

Door requires > 5 lbs. of force to open	12 lbs	Adjust closers so doors do not require more than 5 pounds of force to open.	1	Labor	\$0
16	Stage	3		Doors, Doorways, & Gates	Other

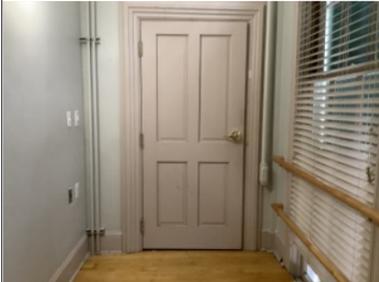
Maneuvering clearance(s) not provided	8.5"	Provide an automatic door opener or reverse the swing of the door if doing so provides 18" min, maneuvering clearance on the pull side of the door, (Price based on providing an automatic door opener.)	1	3060	\$3060
Stairways												
17	Northwest Staircase by West Egress	1		Stairways	Other

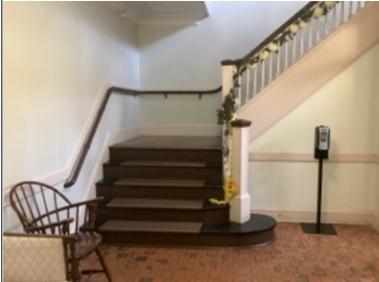
Handrail height < 34" or > 38" Handrails do not extend 12" from stairs Vertical clearance < 80" above finished floor	30" - 78"	Alter so the handrails are 34"- 38" high above the floor. Top: Ensure handrails extend horizontally above the landing for 12" min.. Bottom: Ensure handrails extend to one tread depth beyond the last riser. It may be technically infeasible to adjust the vertical clearance. Consider adding signage that says, "Low Headroom" or, "Low Ceiling".	1	-	\$0

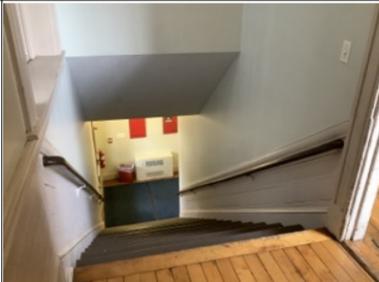
18	East Staircase by Main Entrance, East Egress	2		Stairways	Egress

Handrail height < 34" or > 38" Handrails do not extend 12" from stairs Not maintained in operable working condition	30" -	Alter so the handrails are 34"- 38" high above the floor. Top: Ensure handrails extend horizontally above the landing for 12" min. beginning above the first riser nosing. Bottom: Ensure handrails extend to one tread depth beyond the last riser. Repair stair treads to ensure stairs are maintained in operable working condition.	1	-	\$0
19	East Staircase by Main Entrance, East Egress	2		Stairways	Egress

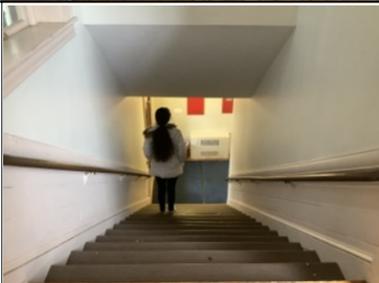
Vertical clearance < 80" above finished floor	-	It may be technically infeasible to adjust the vertical clearance. Consider adding signage that says, "Low Headroom" or, "Low Ceiling" or providing padding at stair entry.	1	-	\$0

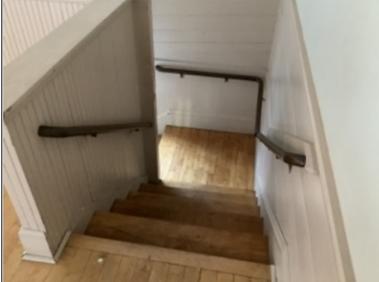
ID	Location	Floor	Room	Element	Type	Photo	Issues	Current Measure	Recommendations	Quantity	Price	Cost Estimation
20	Northwest Staircase to Balcony	3		Stairways	Other

Handrail height < 34" or > 38" Handrails do not extend 12" from stairs Handrails not continuous where required Not maintained in operable working condition	30" - - -	Alter so the handrails are 34"- 38" high above the floor. Top: Ensure handrails extend horizontally above the landing for 12" min. beginning above the first riser nosing. Bottom: Ensure handrails extend to one tread depth beyond the last riser. Provide continuous handrails.	1	-	\$0
21	Secondary Entrance, Northwest Egress	Ext.		Stairways	Other

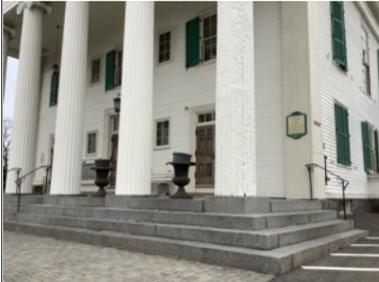
Handrail height < 34" or > 38" Handrail not provided on both sides Handrails do not extend 12" from stairs	32.5" - -	Alter so the handrails are 34"- 38" high above the floor. Provide handrail on one side. Top: Ensure handrails extend horizontally above the landing for 12" min. beginning above the first riser nosing. Bottom: Ensure handrails extend to one tread depth beyond the last riser.	1	-	\$0

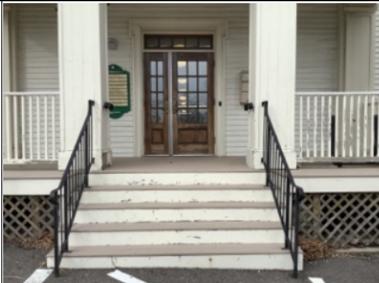
22	Main Entrance	Ext.		Stairways	Egress

Handrails not continuous where required Handrail height < 34" or > 38"	32.5" -	Alter so the handrails are 34"- 38" high above the floor. Provide continuous handrails.	1	-	\$0
Signage												
23	The Connector	1	110	Signage	Designation

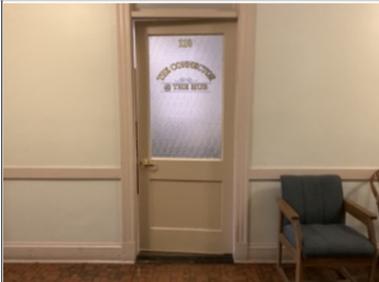
Raised characters not provided on sign Braille not provided on sign Sign not located on the latch side of the door	- - -	Provide text with raised characters duplicated in braille on sign. Locate the sign at permanent rooms alongside the door on the latch side.	1	232 Labor	\$232
24	GAR Hall	1	112	Signage	Designation

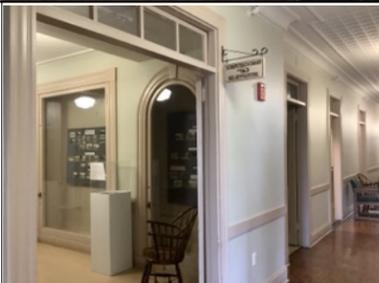
Raised characters not provided on sign Braille not provided on sign Sign not located on the latch side of the door	- - -	Provide text with raised characters duplicated in braille on sign. Locate the sign at permanent rooms alongside the door on the latch side.	1	232 Labor	\$232

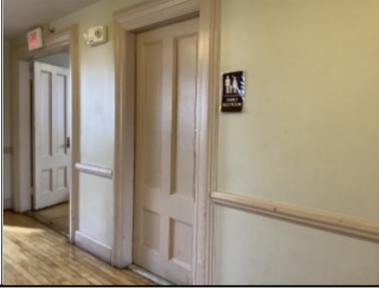
ID	Location	Floor	Room	Element	Type	Photo	Issues	Current Measure	Recommendations	Quantity	Price	Cost Estimation
25	Family Multi-User Toilet Room	2		Signage	Designation

Raised characters not provided on sign Braille not provided on sign Non-glare finish and contrast not provided on sign		Provide text with raised characters duplicated in braille on sign. Install a sign with a non-glare finish with characters that have a high contrast to the background.	1	232	\$232
Assembly Area												
26	Great Hall	2		Assembly Area	N/A

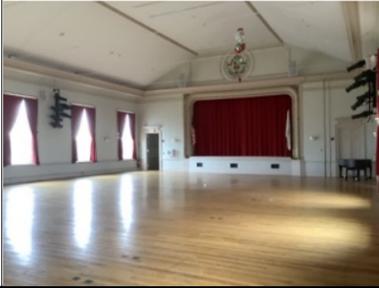
Assistive listening devices not provided	-	If audible communication is integral to the use of the space, provide an assistive listening system. (Cost based on an assistive listening system for 250 people.)	1	3941	\$3941
Kitchens and Kitchenettes												
27	Kitchen	2		Kitchens and Kitchenettes	Other

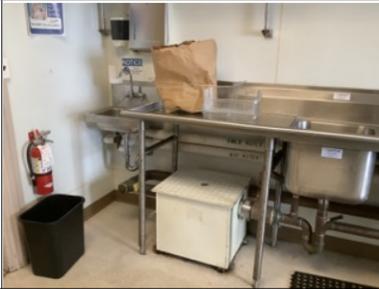
Knee/toe clearance not provided at sink Clear floor space not provided at all appliances	- -	Provide at least one sink in the kitchen with knee and toe clearance positioned for a forward approach, with a depth no greater than 8" and with faucet controls that can be used without tight grasping, pinching or twisting of the wrist.	1	3094	\$3094

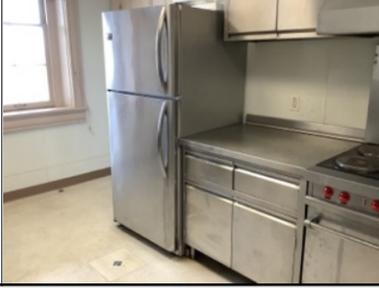
28	Kitchen	2		Kitchens and Kitchenettes	N/A

Knee/toe clearance not provided at cooktop Countertop > 34" high Wall oven type not provided Bottom of freezer > 44" height	- 36" - 58"	Provide a cooktop with knee and toe clearance positioned for a forward approach. Lower countertop to provide a work surface no higher than 34" with 15" width min. of countertop by the cooktop and sink that also has knee and toe clearance. Provide a wall type oven. Replace with a refrigerator that provides freezer space below 44". Note: See 521 CMR 32.8, kitchen figure 32b.	1	8680	\$8680
Toilet & Bathing Rooms

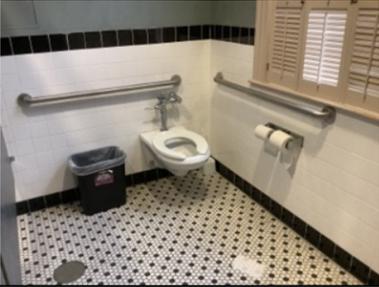
ID	Location	Floor	Room	Element	Type	Photo	Issues	Current Measure	Recommendations	Quantity	Price	Cost Estimation
Toilet Compartment												
29	Men's Multi-User Toilet Room	1		Toilet Compartment	Accessible Compartment

Inadequate maneuvering clearances		Relocate trash can to maintain the required 60" wide min. clear floor space at the toilet.	1	Labor	\$0
30	Women's Multi-User Toilet Room	1		Toilet Compartment	Accessible Compartment

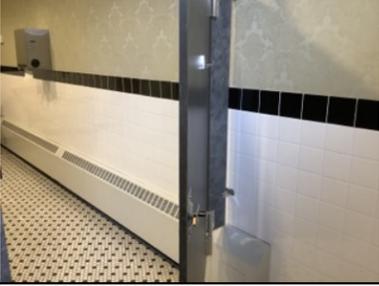
Door has malfunctioning self-closing hinge Door pull not provided	- -	Repair hinge. Provide a door pull on each side of the door between 34" to 48" above the finished floor that does not require tight grasping, pinching or twisting of the wrist.	1	Labor 70	\$70
31	Men's Multi-User Toilet Room	1		Toilet Compartment	Accessible Compartment

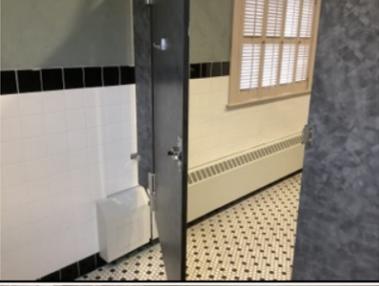
Door has malfunctioning self-closing hinge Door pull not provided	-	Repair hinge. Provide a door pull on each side of the door between 34" to 48" above the finished floor that does not require tight grasping, pinching or twisting of the wrist.	1	Labor 70	\$70

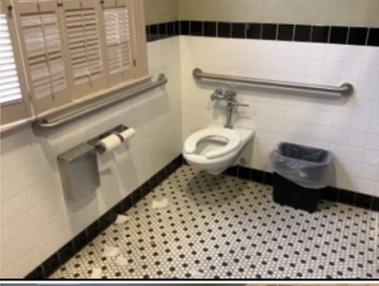
32	Women's Multi-User Toilet Room	2		Toilet Compartment	Accessible Compartment

Inadequate maneuvering clearances	-	Relocate trash can to maintain the required 60" wide min. clear floor space at the toilet.	1	Labor	\$0
33	Men's Multi-User Toilet Room	2		Toilet Compartment	Accessible Compartment

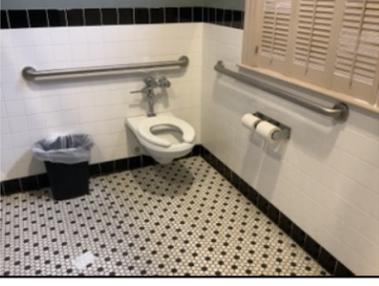
Inadequate maneuvering clearances		Relocate trash can to maintain the required 60" wide min. clear floor space at the toilet.	1	Labor	\$0

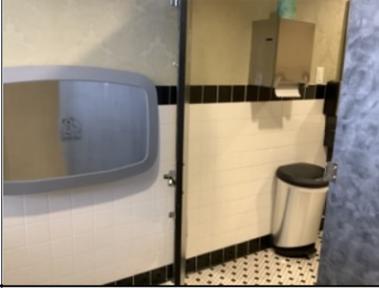
ID	Location	Floor	Room	Element	Type	Photo	Issues	Current Measure	Recommendations	Quantity	Price	Cost Estimation
34	Family Multi-User Toilet Room	2		Toilet Compartment	Accessible Compartment

Door has malfunctioning self-closing hinge Door pull not provided	- -	Repair hinge. Provide a door pull on each side of the door between 34" to 48" above the finished floor that does not require tight grasping, pinching or twisting of the wrist.	1	Labor 70	\$70
35	Women's Multi-User Toilet Room	2		Toilet Compartment	Accessible Compartment

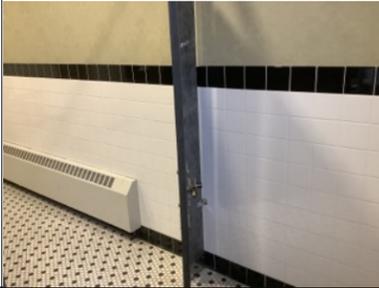
Door pull not provided	-	Provide a door pull on each side of the door between 34" to 48" above the finished floor that does not require tight grasping, pinching or twisting of the wrist.	1	70	\$70
36	Men's Multi-User Toilet Room	2		Toilet Compartment	Accessible Compartment

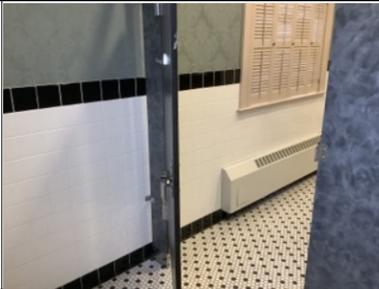
Door pull not provided	-	Provide a door pull on each side of the door between 34" to 48" above the finished floor that does not require tight grasping, pinching or twisting of the wrist.	1	70	\$70

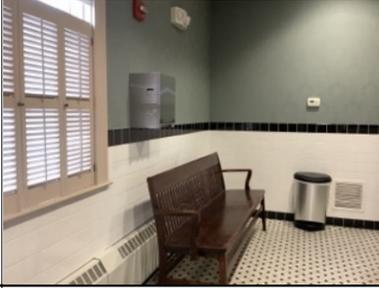
Dispensers												
37	Men's Multi-User Toilet Room	1		Dispensers	Paper Towel Dispenser

Clear floor space not provided at accessory Dispenser acts as a protruding object	- 9.5"	Relocate the bench to provide a 30" min. by 48" min. clear floor space at the paper towel dispenser. Relocate dispenser out of the circulation path or provide a cane-detectible barrier under the dispenser 27" max. above the finished floor.	1	306	\$306
38	Women's Multi-User Toilet Room	1		Dispensers	Paper Towel Dispenser

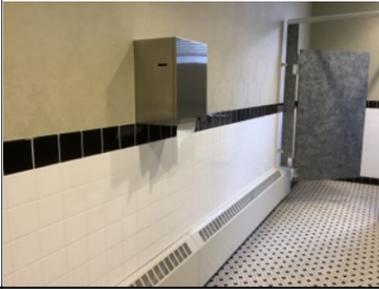
Dispenser acts as a protruding object	9.5"	Relocate dispenser out of the circulation path or provide a cane-detectible barrier under the dispenser 27" max. above the finished floor.	1	306	\$306

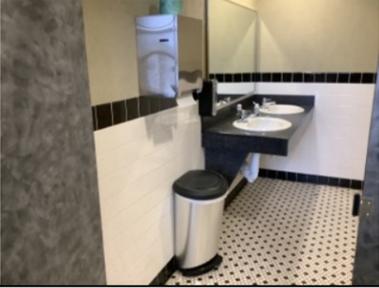
ID	Location	Floor	Room	Element	Type	Photo	Issues	Current Measure	Recommendations	Quantity	Price	Cost Estimation
39	Family Multi-User Toilet Room	2		Dispensers	Paper Towel Dispenser

Clear floor space not provided at accessory Dispenser acts as a protruding object	- 9.5"	Provide a 30" min. by 48" min. clear floor space or relocate dispenser. Relocate dispenser out of the circulation path or provide a cane-detectible barrier under the dispenser 27" max. above the finished floor.	1	306	\$306
40	Women's Multi-User Toilet Room	2		Dispensers	Paper Towel Dispenser

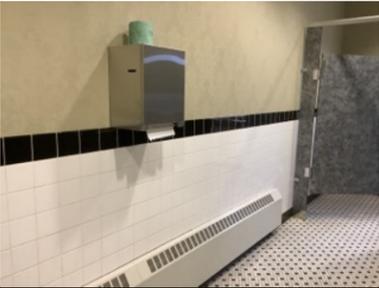
Dispenser acts as a protruding object	9.5"	Relocate dispenser out of the circulation path or provide a cane-detectible barrier under the dispenser 27" max. above the finished floor.	1	306	\$306
41	Men's Multi-User Toilet Room	2		Dispensers	Paper Towel Dispenser

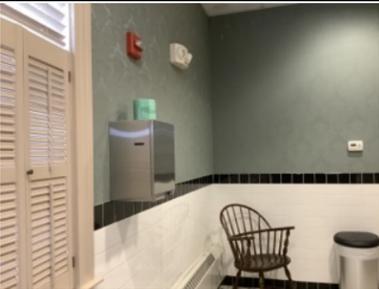
Dispenser acts as a protruding object	9.5"	Relocate dispenser out of the circulation path or provide a cane-detectible barrier under the dispenser 27" max. above the finished floor.	1	306	\$306

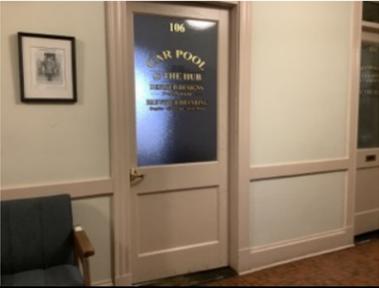
Best Practice												
Signage												
42	GAR Pool at The Hub	1	106	Signage	Designation

-	Recommend providing compliant designation signage with raised characters and braille mounted on the latch side of the door at all permanent rooms that lack designation signage.	1	-	\$0
43	Stair to Stage	2		Signage	Directional

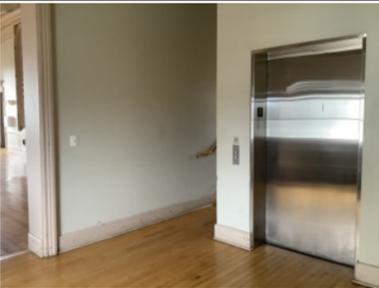
-	Recommend providing a directional sign, indicating where the stage is located.	1	-	\$0
