Town of Randolph, Massachusetts
Water Quality Limited Waterbodies Requirements
*MS4 Permit Year 5
August 2023*

BMP RETROFIT SITE INVESTIGATIONS

Prepared by: BETA GROUP, INC.
Prepared for: Town of Randolph

August 2023

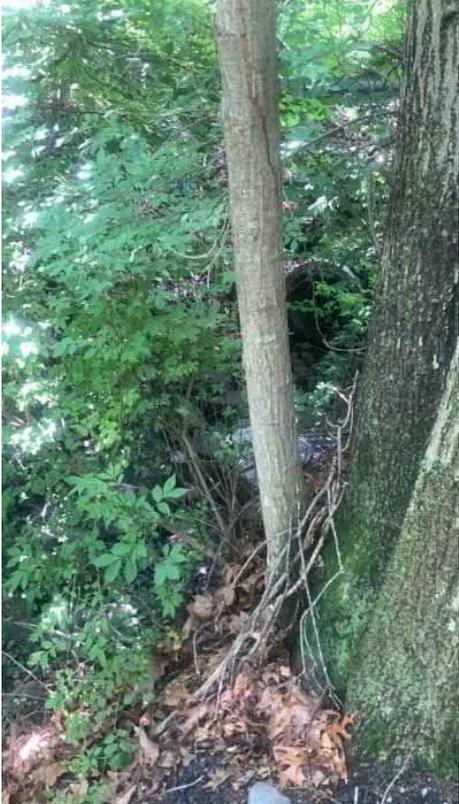
<p>Outfall off Clark Street discharges to drainage ditch. This ditch area could be retrofitted into a formalized infiltration basin with an outlet control structure.</p>

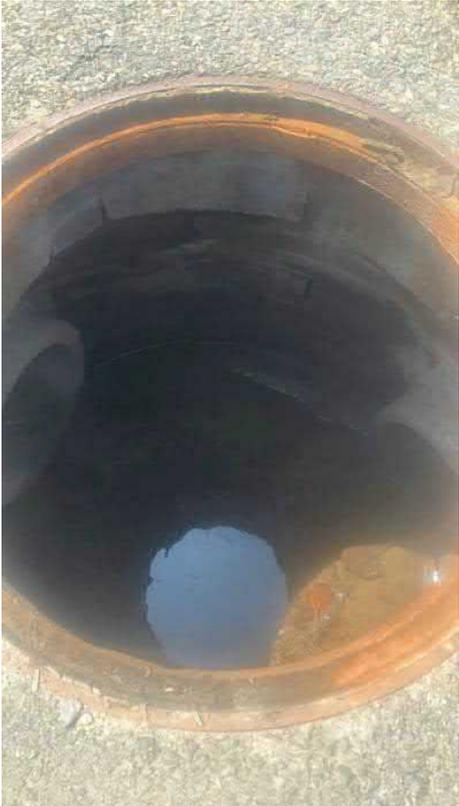
<p>Shallow 4ft deep manhole on Beverly Circle. Opportunity to take the 8" RCP outlet pipe and daylight to open space located east of the road where a surface infiltration basin could be installed. See next photo.</p>

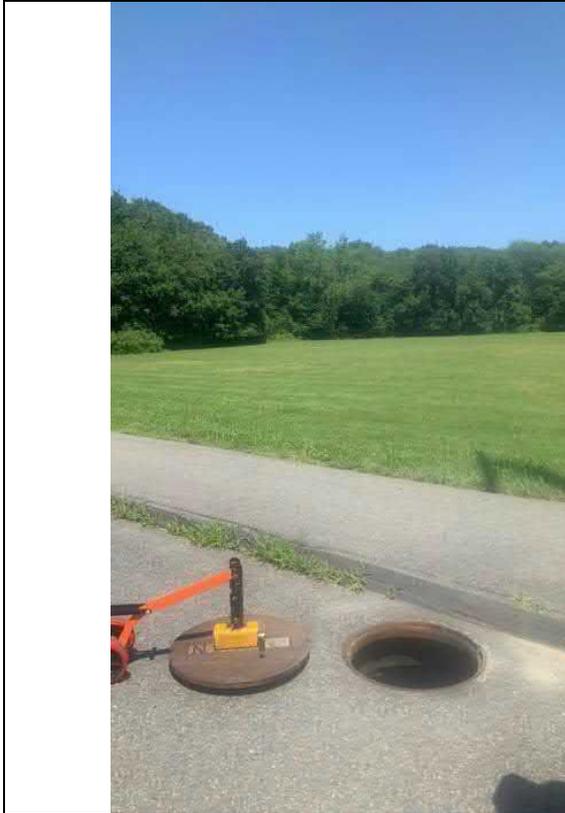
Open space off Beverly Circle is an ideal location for a BMP infiltration practice.

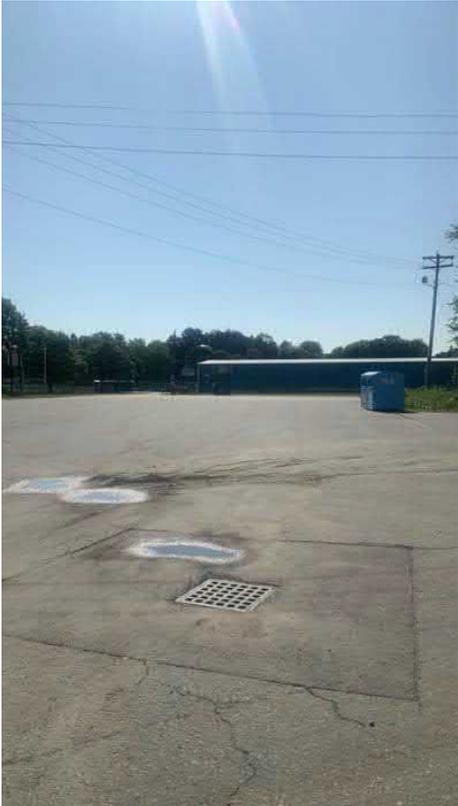
<p>Large impervious area where a subsurface infiltration system could be installed to treat all upstream runoff.</p>

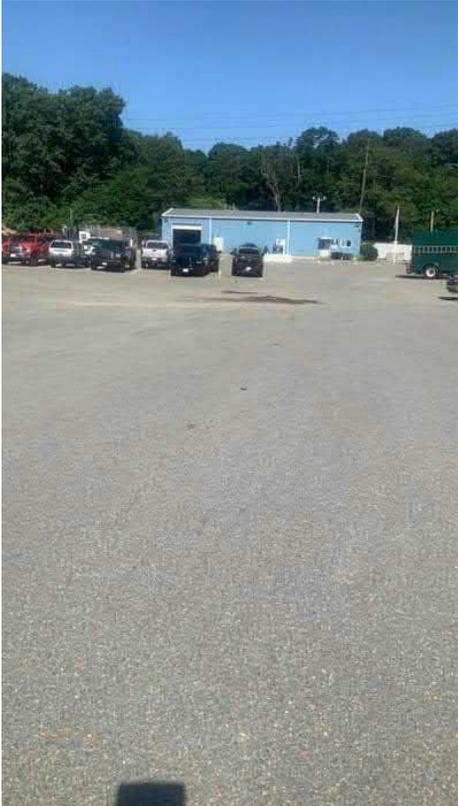
<p>View of open area looking at upstream catch basin.</p>

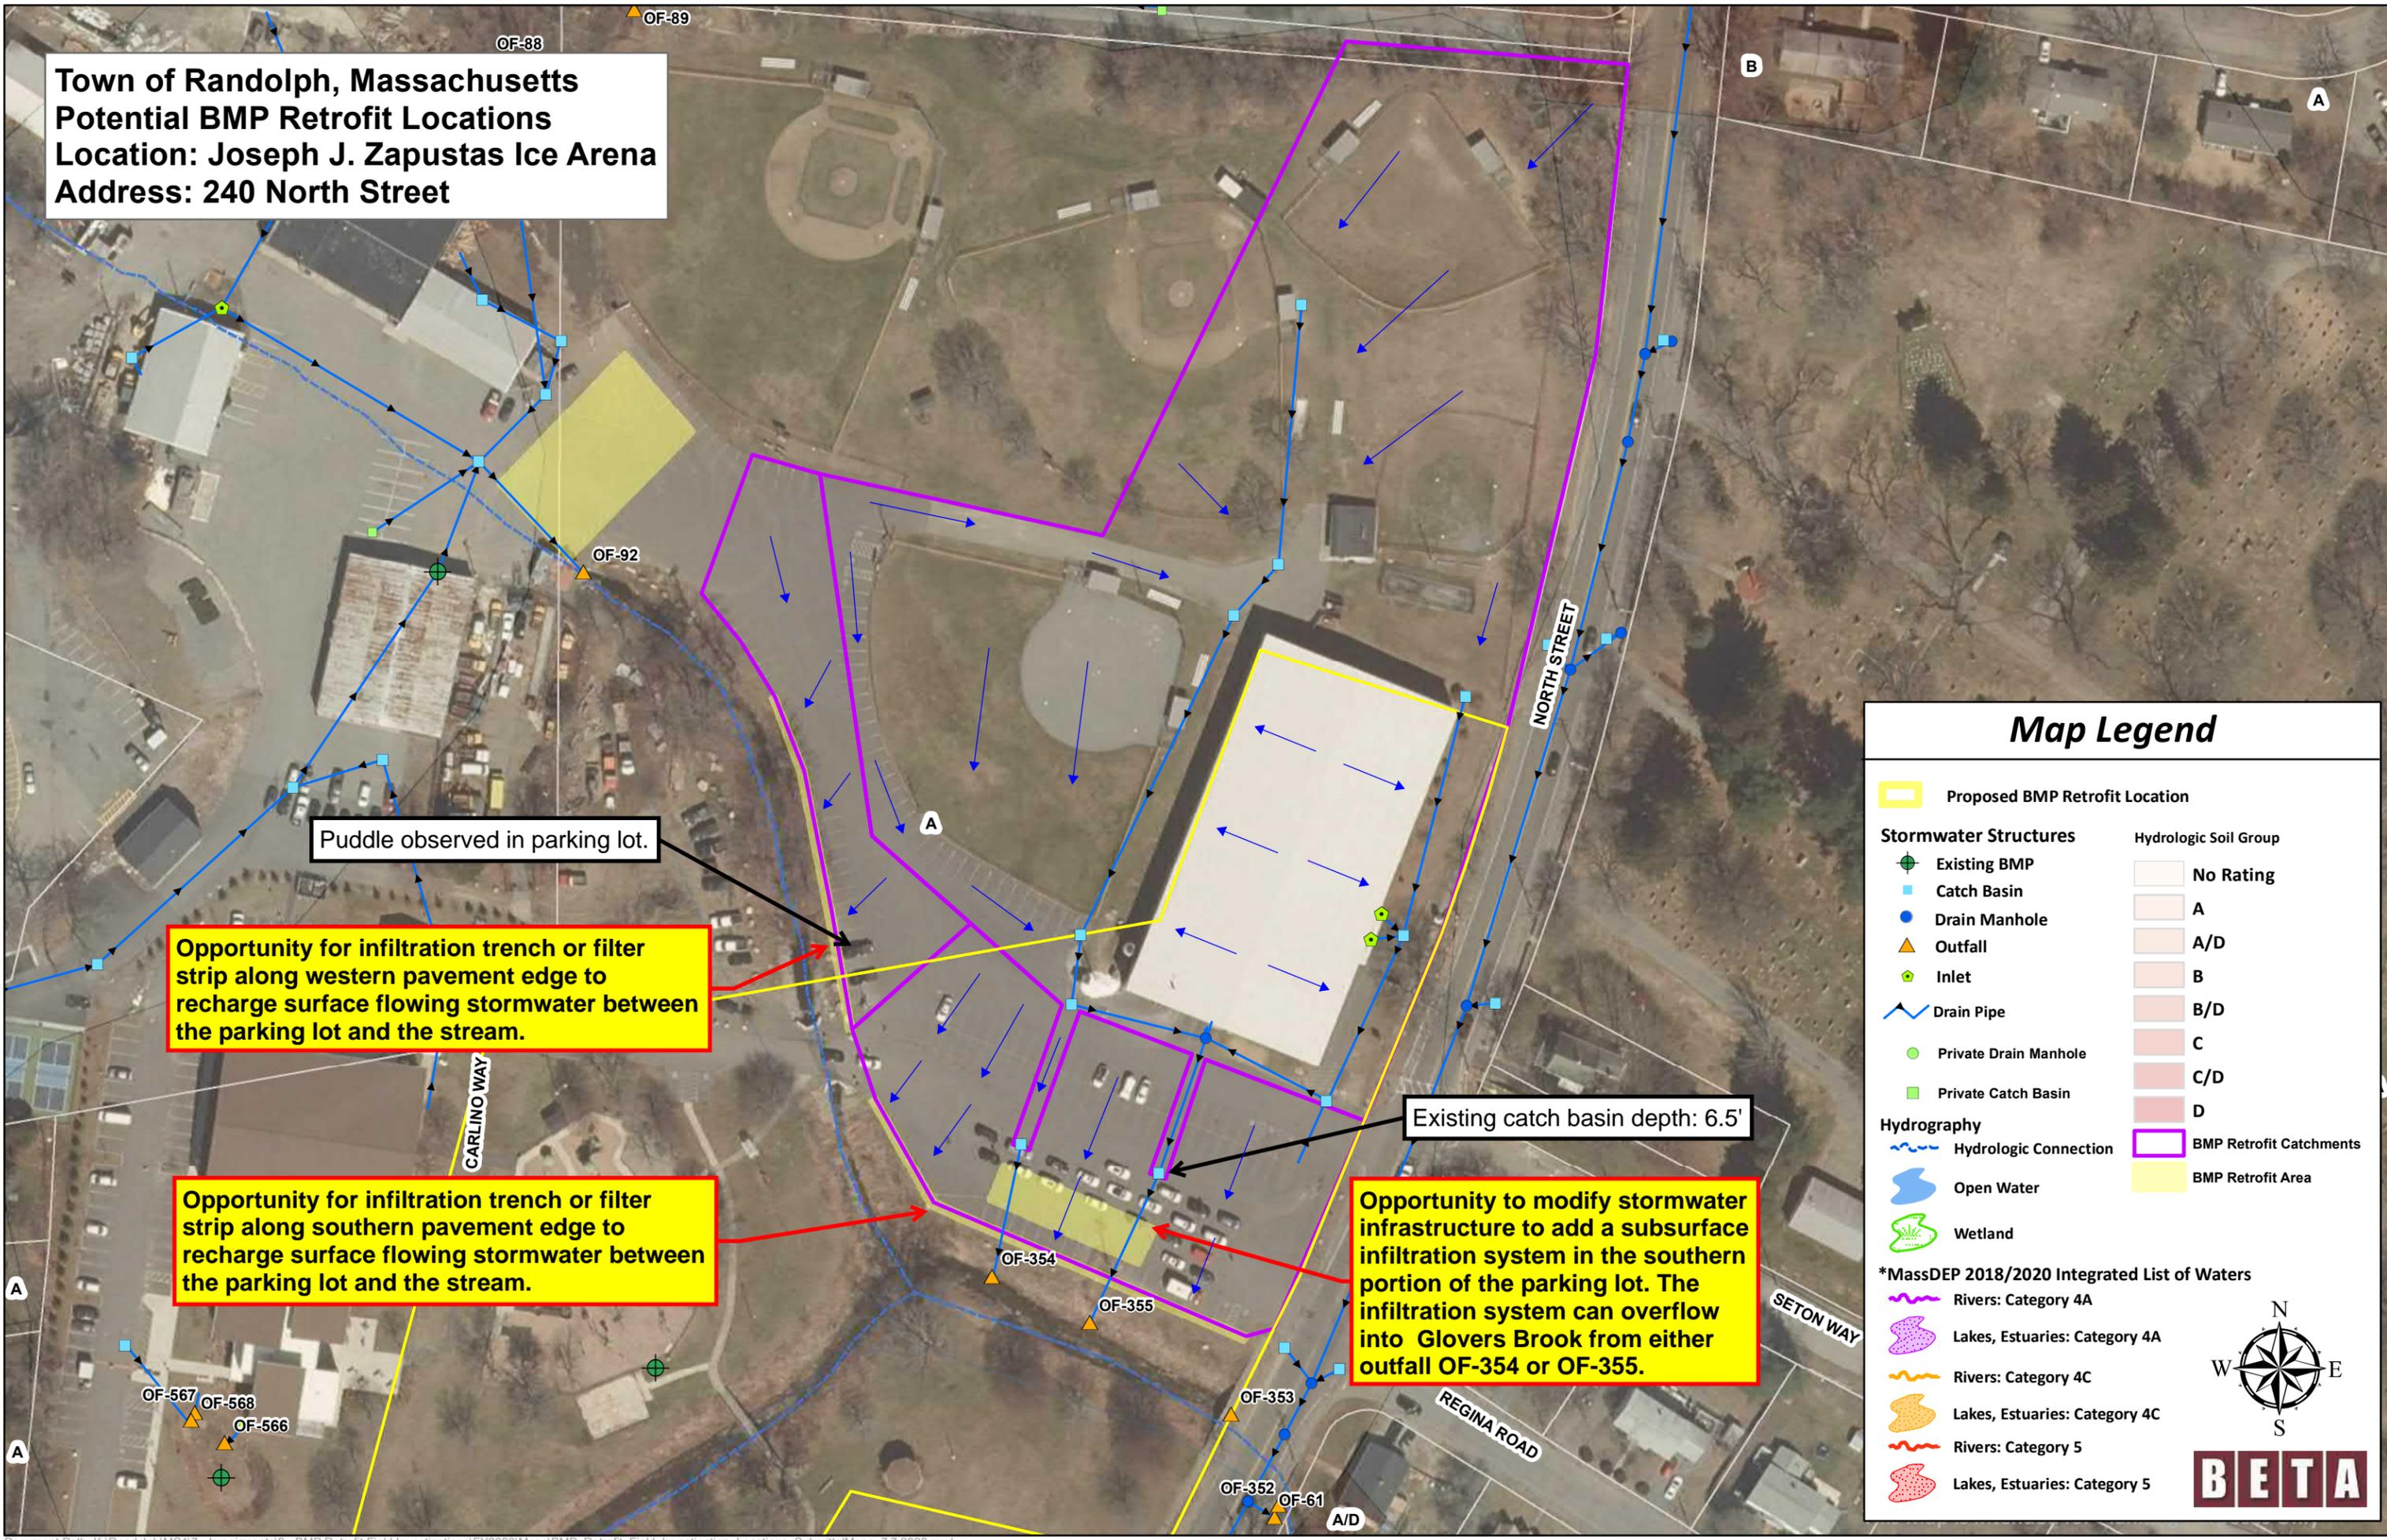
2.3.1 JOSEPH J. ZAPUSTAS SITE MAP

Puddle observed in parking lot.

Opportunity for infiltration trench or filter strip along western pavement edge to recharge surface flowing stormwater between the parking lot and the stream.

Opportunity for infiltration trench or filter strip along southern pavement edge to recharge surface flowing stormwater between the parking lot and the stream.

Opportunity to modify stormwater infrastructure to add a subsurface infiltration system in the southern portion of the parking lot. The infiltration system can overflow into Glovers Brook from either outfall OF-354 or OF-355.

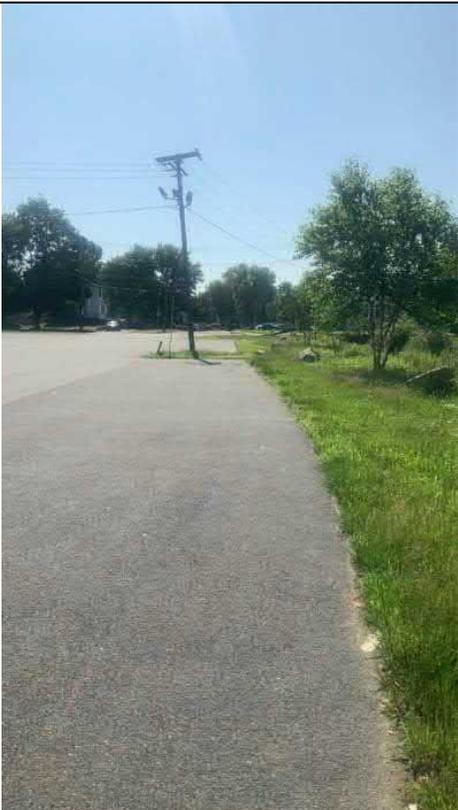
<p>Opportunity for infiltration trench along parking lot edge. View towards North Street.</p>

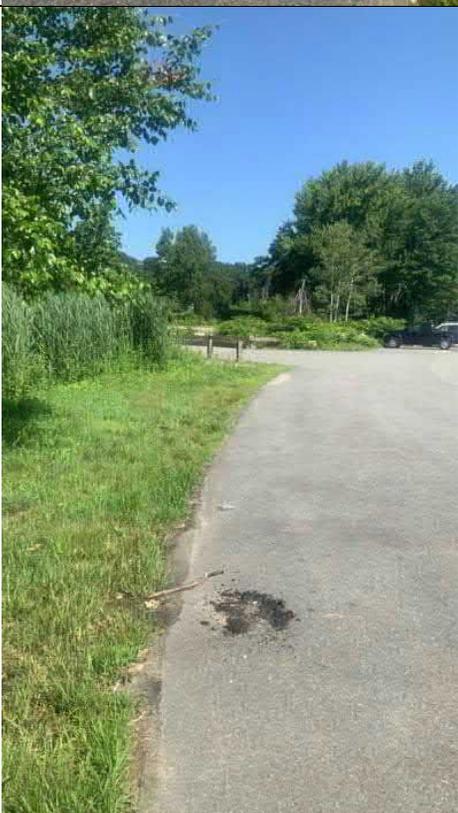
<p>View of parking lot edge towards the Highway Department and Community Center.</p>

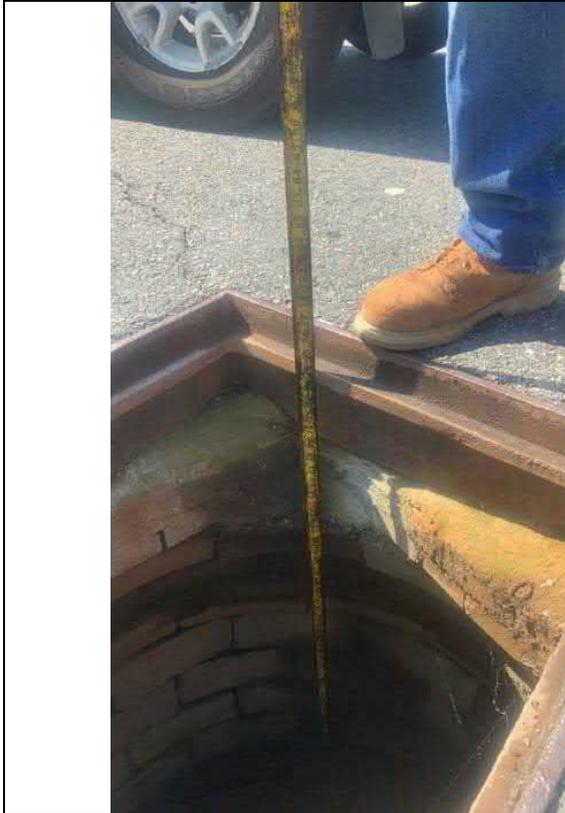
Depth of upstream infrastructure is roughly 6.5 ft. Catch basin does not have any sump. Retrofitting system with a subsurface leaching would be difficult to achieve.

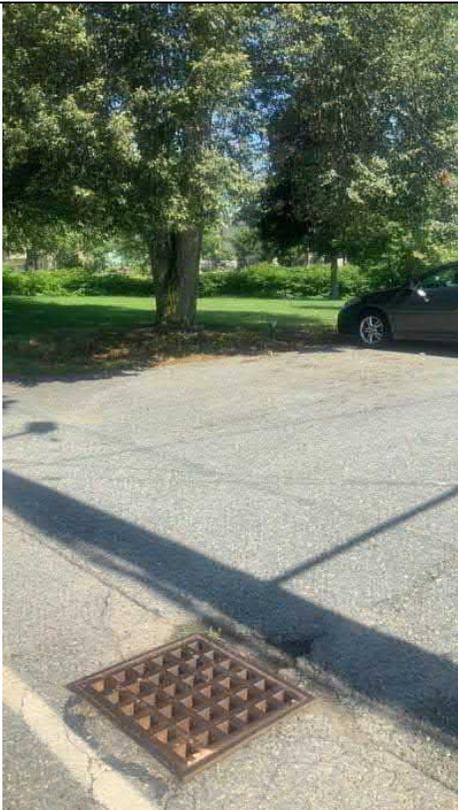
<p>Catch basin on Pleasant Street could be retrofitted downstream to discharge to a formalized infiltration basin in the open space of the park. Invert is shallow at roughly 3ft below surface. See next photo.</p>

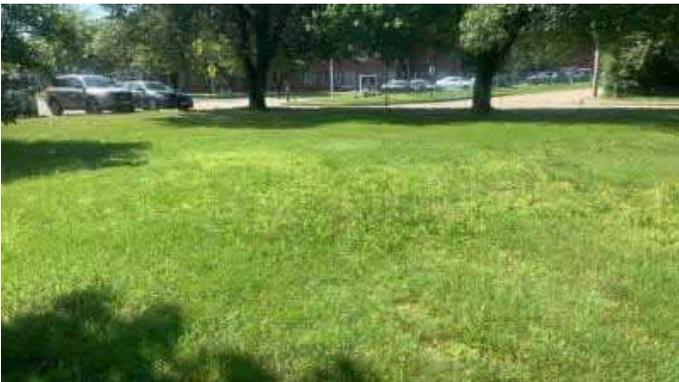
<p>Large open space in park is an ideal location for a formalized infiltration basin. Test pits would be required to confirm depth to water.</p>

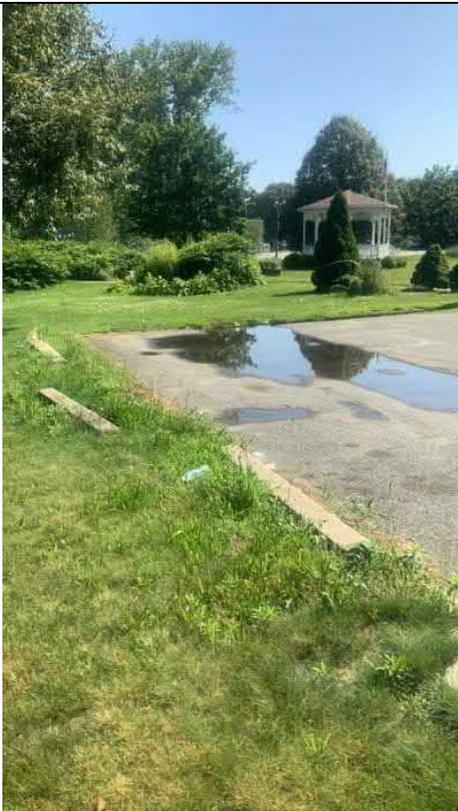
<p>Standing water in parking lot from recent rainfall. Town could regrade parking lot and install a formalized infiltration trench along northwestern corner of parking area.</p>

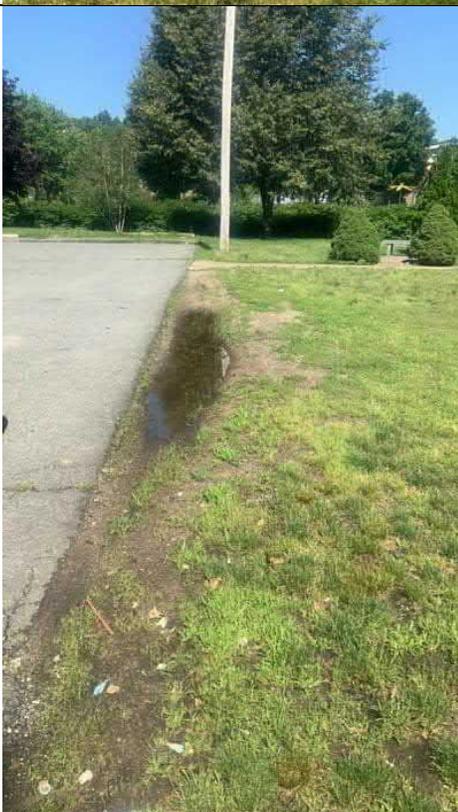
<p>Opportunity for infiltration trench along northern edge of pavement to treat a quarter of parking lot area.</p>

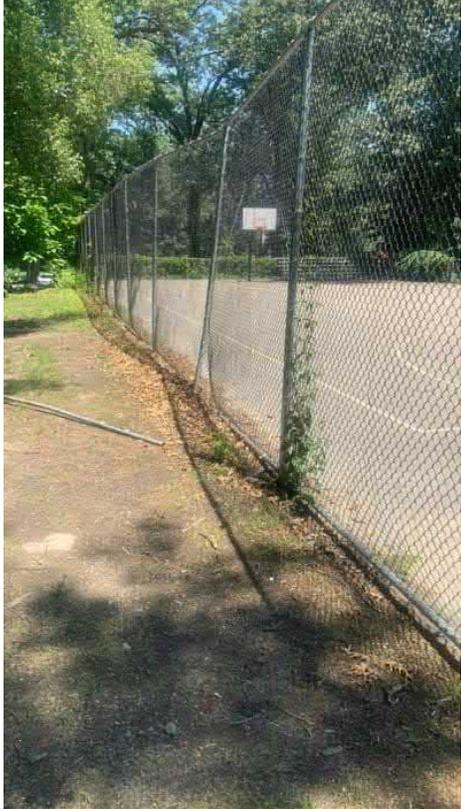
<p>Opportunity to install infiltration trench along the northwestern and western edges of basketball court pavement.</p>

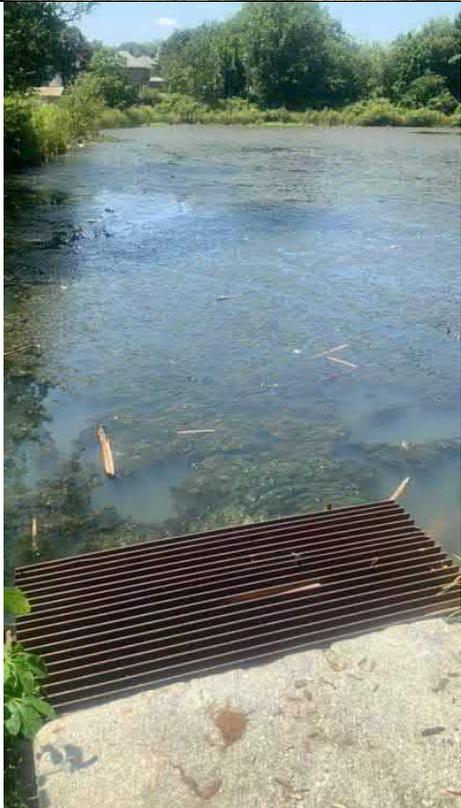
<p>Outlet control structure of existing pond on site. High turbidity and algae growth within pond area.</p>

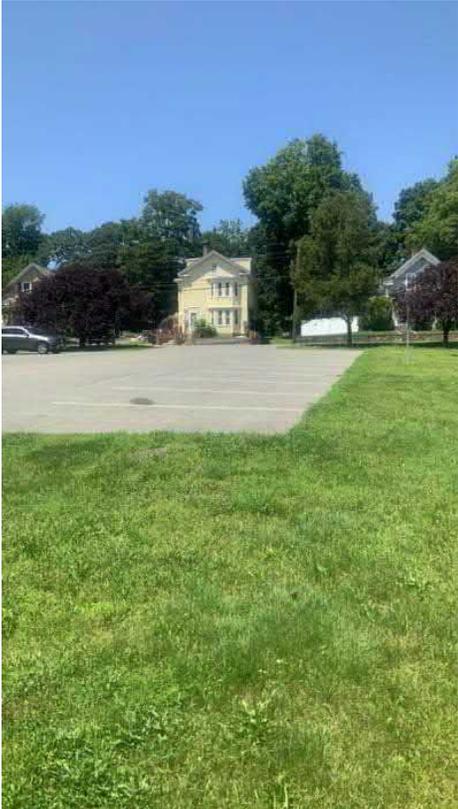
<p>Large impervious parking lot that grades towards the southeastern edge of pavement. Depending on depth to water and soils this may be a future BMP retrofit location. Either an infiltration trench or surface infiltration basin could be installed to treat stormwater runoff from existing parking lot and stormwater infrastructure in place on Allen Street.</p>

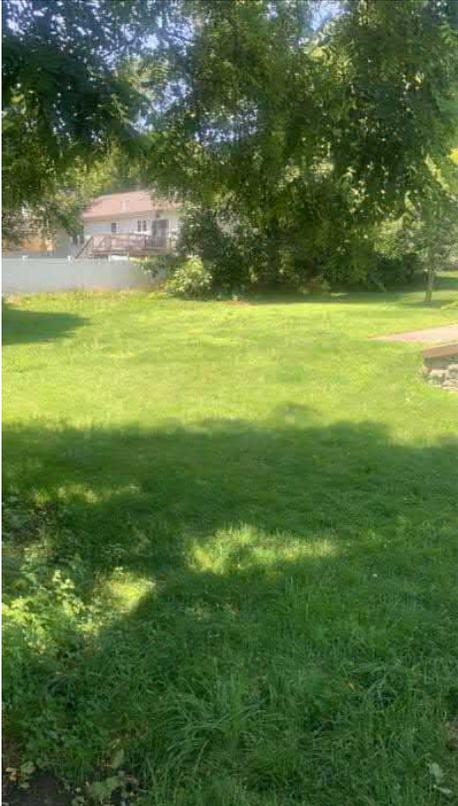
<p>Opportunity for infiltration trench along southwestern edge of parking lot. Option to connect with pipe to proposed trench and basin on the southeast side of parking lot located off Allen Street.</p>

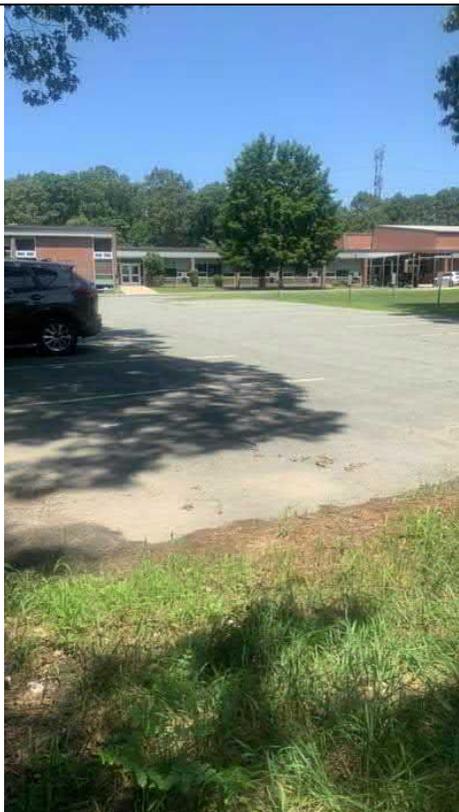
<p>Parking lot sheet flow discharges directly to open space/grass area. Opportunity to install an infiltration trench along the southeastern paved edge of lot.</p>

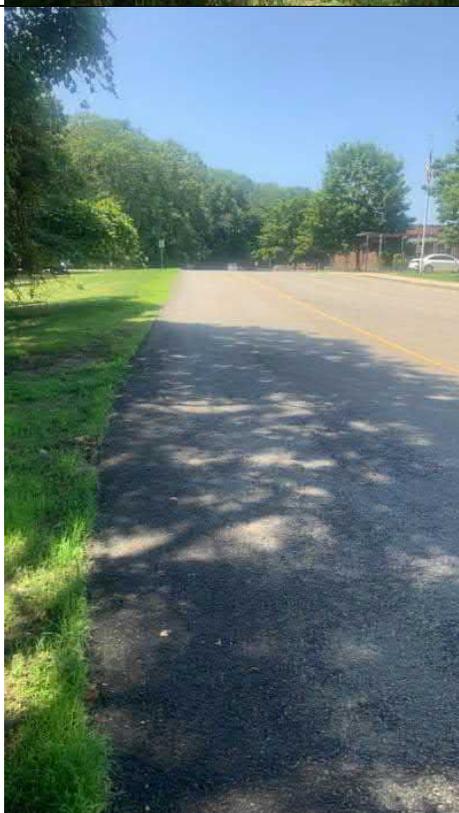
<p>Rear parking lot is graded towards southeast corner of paved edge. Opportunity for either a roadway infiltration trench or formalized surface infiltration basin. Town to confirm soil types and depth to water. See next photo for catchment area.</p>

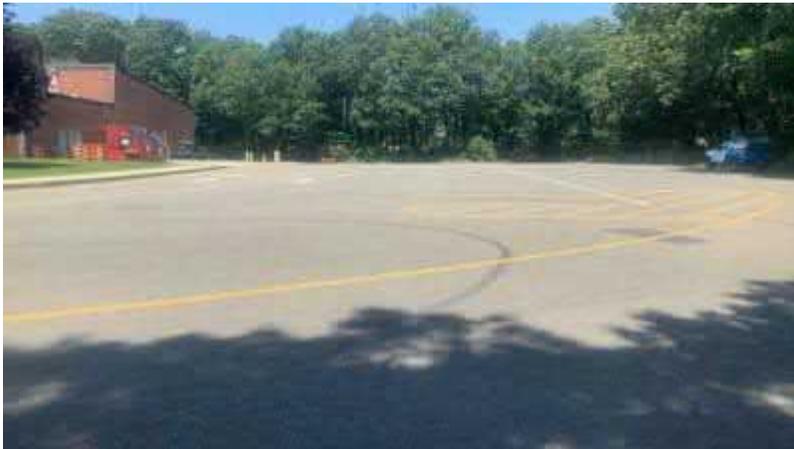
Observed catchment area for rear parking lot BMP infiltration practice.

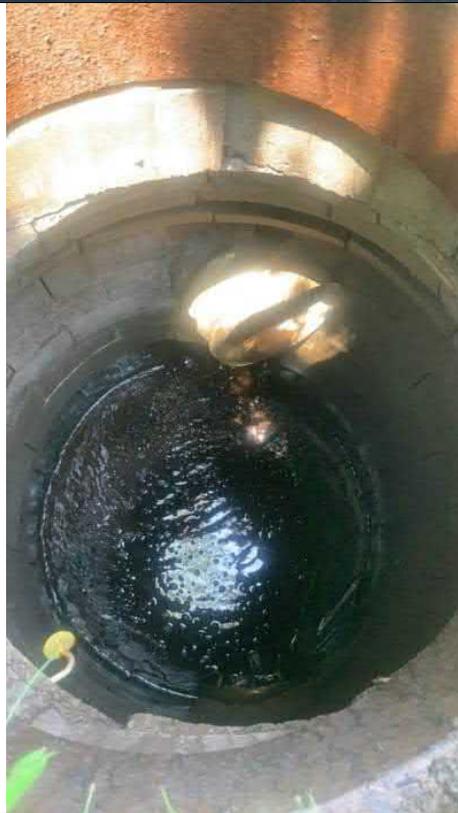
Upstream manhole to OF-102 has an invert of 7.25ft to surface. This is not a good candidate for BMP retrofits.

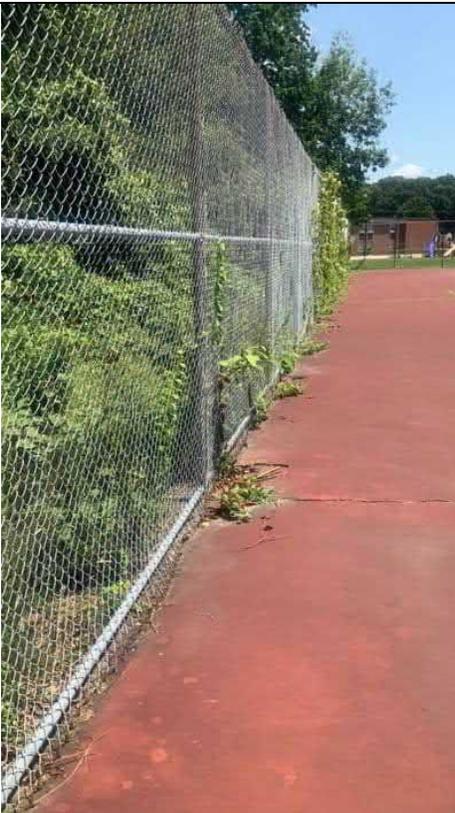
<p>Installation of infiltration trench along the northern edge of tennis court would be a good opportunity for Town as it appears the tennis court already requires resurfacing in the near future. The Town could consider retrofitting the space with a BMP at the same time as the tennis courts are refinished.</p>
--	---

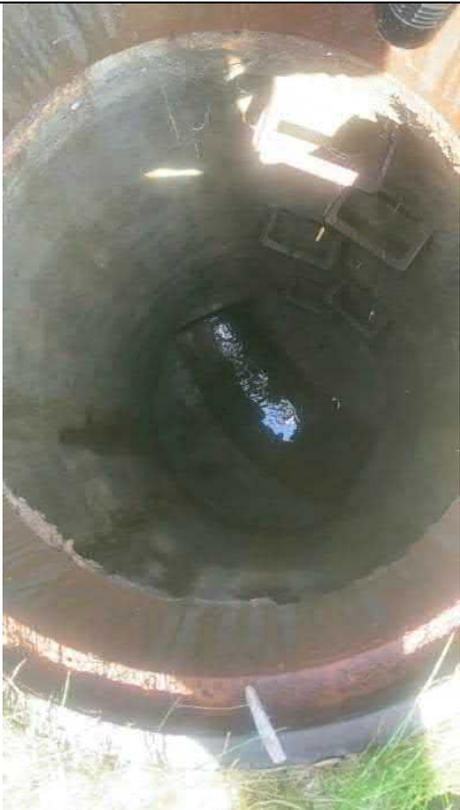
<p>Upstream manhole by playground is 10.5ft to invert, making BMP retrofits difficult to install in this area. See next photo for next manhole that is just upstream of OF-94.</p>

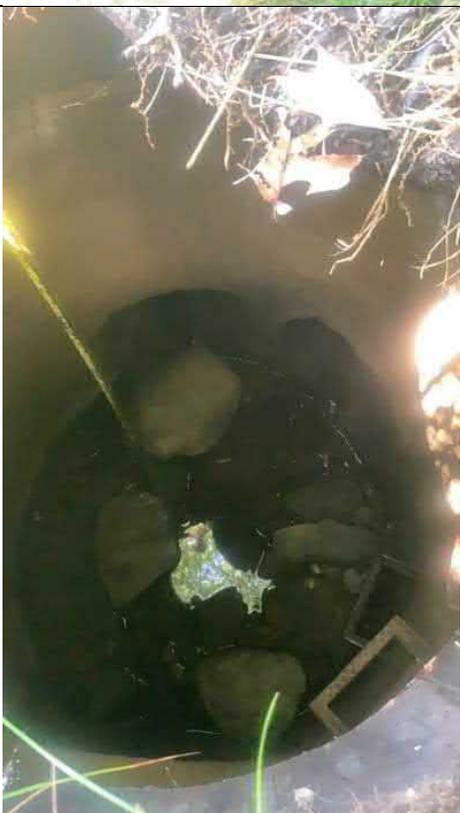
<p>Upstream manhole from OF-94 is roughly 6ft deep to invert. Installation of BMP in open field is likely not feasible due to depth of inverts.</p>

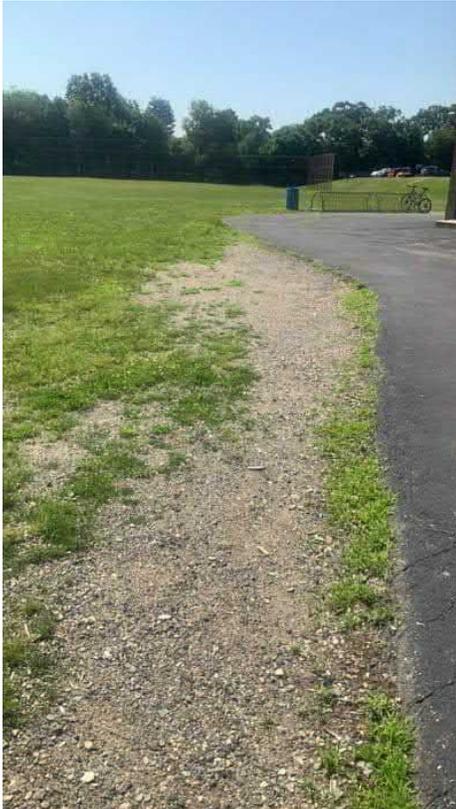
<p>Opportunity for infiltration trench by school playground area. Photo shows erosion likely from stormwater runoff. View is looking southeast towards baseball field and parking lot.</p>

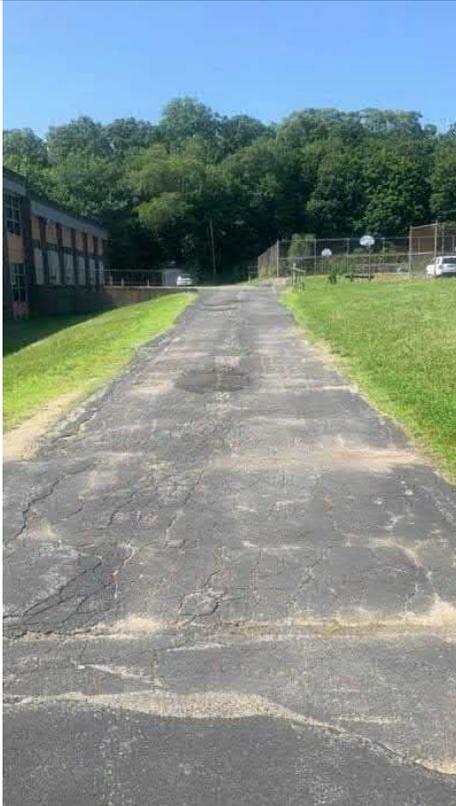
<p>Open spaces adjacent to edges of pavement could be regraded and installed with infiltration trenches to treat runoff from impervious roadway. See next photo.</p>

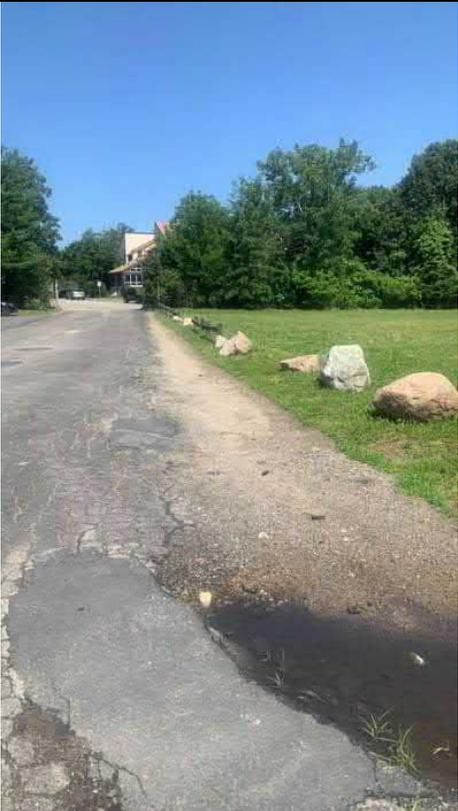
<p>Option to install formal infiltration trench along pavement edge adjacent to baseball field. This could connect to trenches recommended in previous photo.</p>

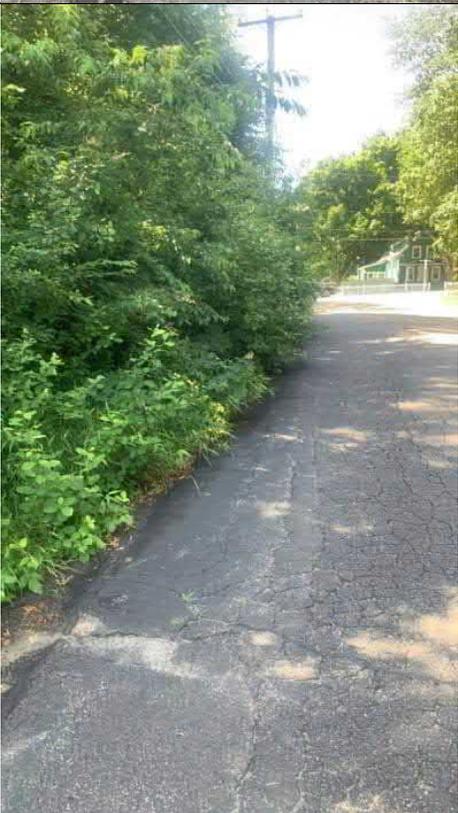
<p>Opportunity to install infiltration trench along both paved edges of Hurley Drive school main entrance. See next photo.</p>

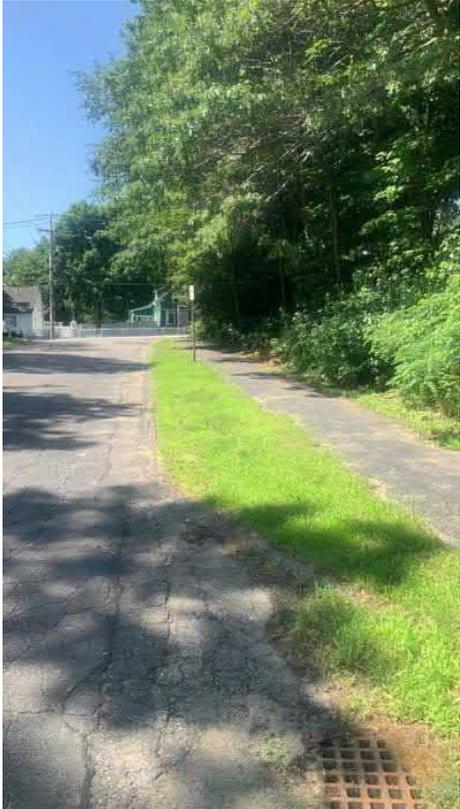
<p>Town would need to remove berm and cover the existing catch basins to capture sheet runoff for half the roadway on Hurley Drive. Soil testing would be required to confirm infiltration feasibility.</p>

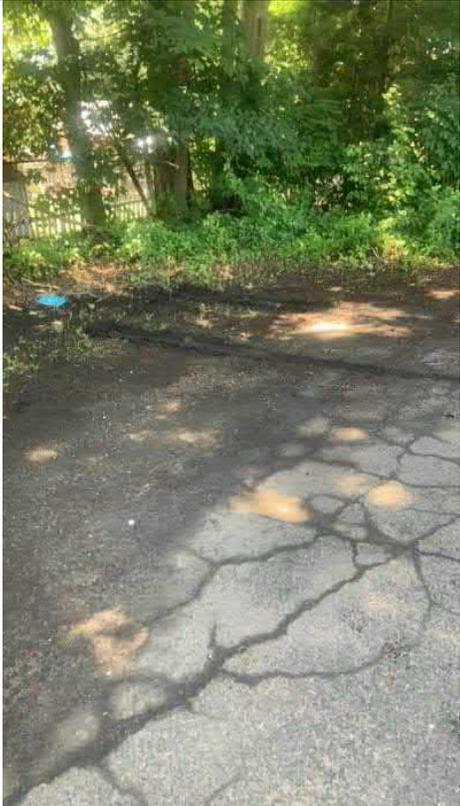
<p>Town GIS data indicates that a catch basin is located at the low point by southeast corner property. BETA personnel were not able to locate the basin as the area is full of sediment and debris. Town could remove sediment and modify catch basin into a leaching basin to treat and reduce impervious runoff to outfall.</p>

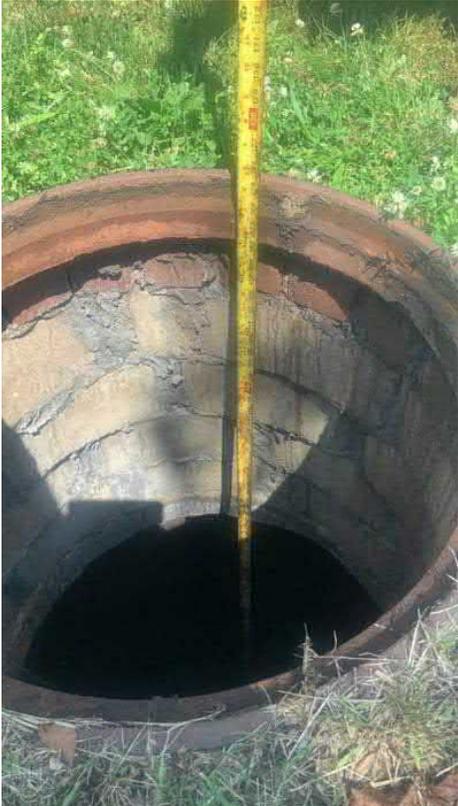
<p>Manhole that receives water from Pacella Park Drive is roughly 10.5 ft to invert. Modifying this manhole is not ideal for BMP retrofits.</p>

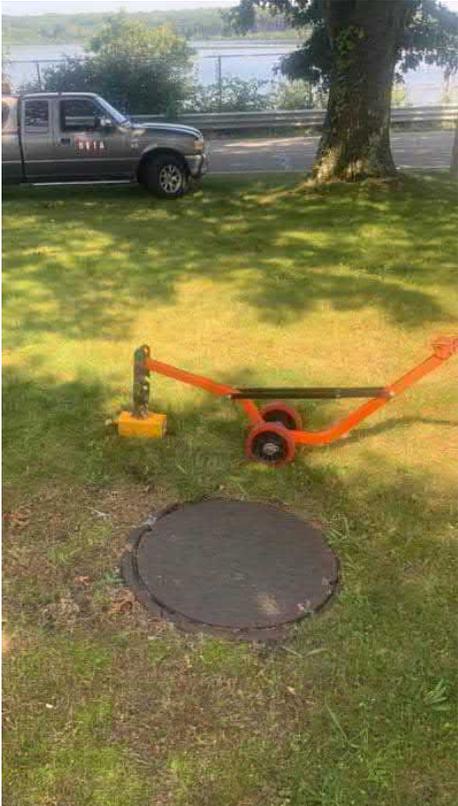
<p>Manhole receives stormwater from portion of Pacella Park Drive and parking lot from 55 Pacella Park Drive (Emerson Swan Warehouse). Opportunity for Town to convert manhole into a leaching basin or subsurface infiltration system. Depending on catchment area, multiple subsurface basins may be necessary.</p>

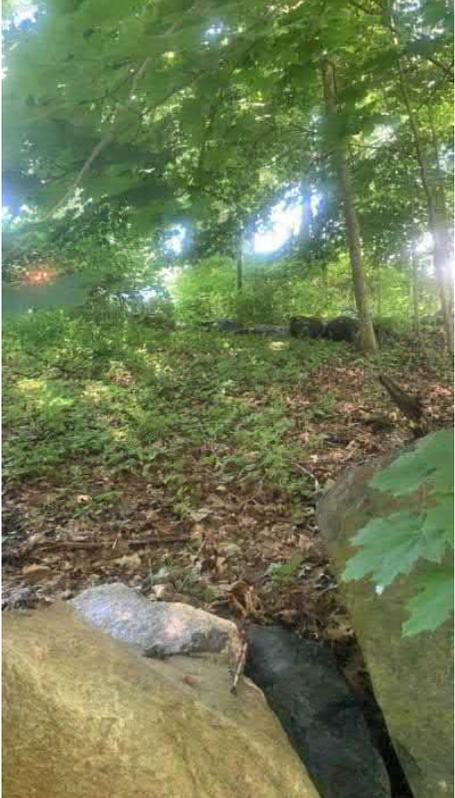
<p>Wooded space at dead end of S. Windermere Avenue. Downstream outfall significantly drops off past the rocks shown in the photo. The wooded area is slightly graded, but should not impact the installation of an infiltration basin.</p>

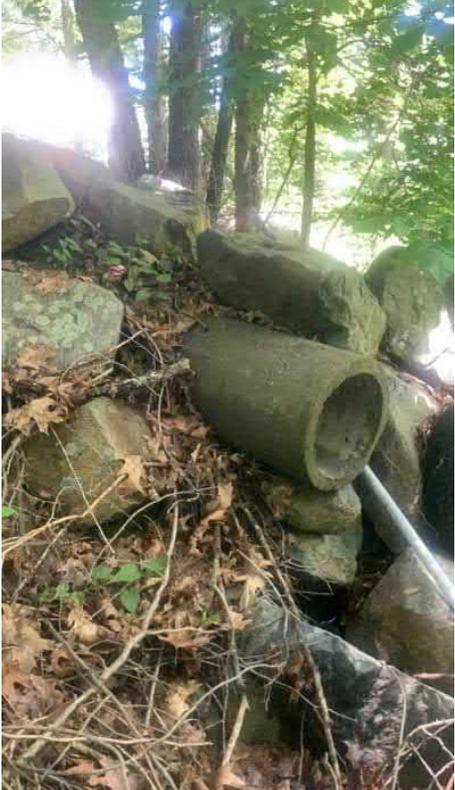
<p>Outfall drops off roughly 7 ft from proposed BMP retrofit space to wetland.</p>
