Attachment #2 - Detail of Cornice/Soffit Trim Construction:

Attachment #3 – Reflected Ceiling View showing damaged area:

Attachment #4 - Photographs of Items described in Scope of Work:

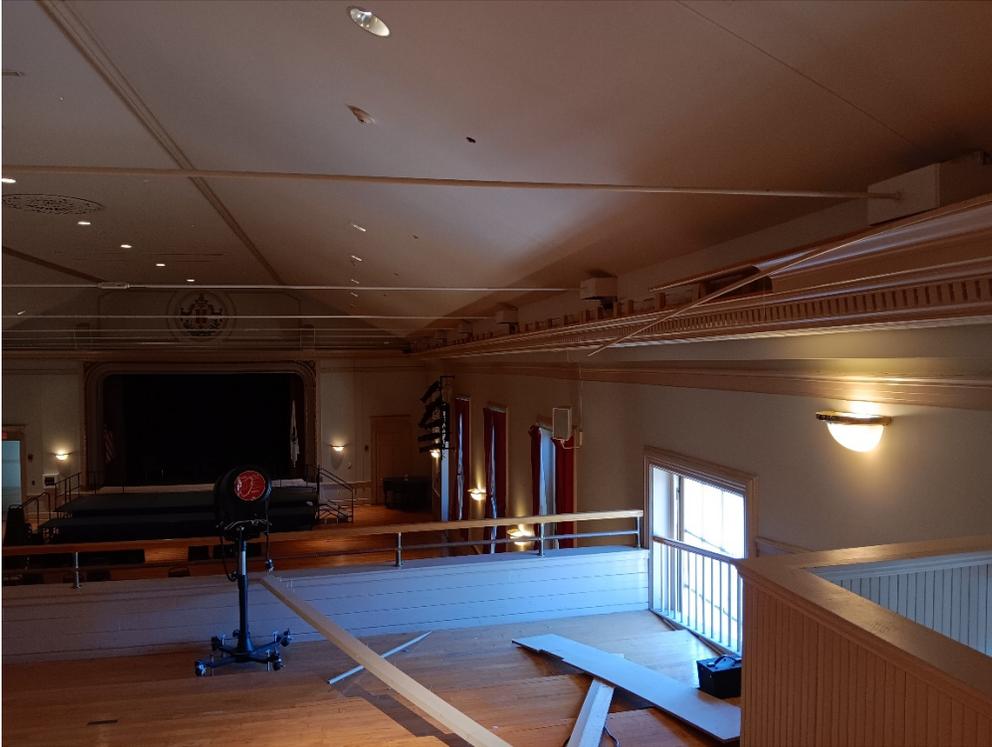
1. Cornice Trim on South Wall of Great Hall – note break in trim where it parted on 1-2-24

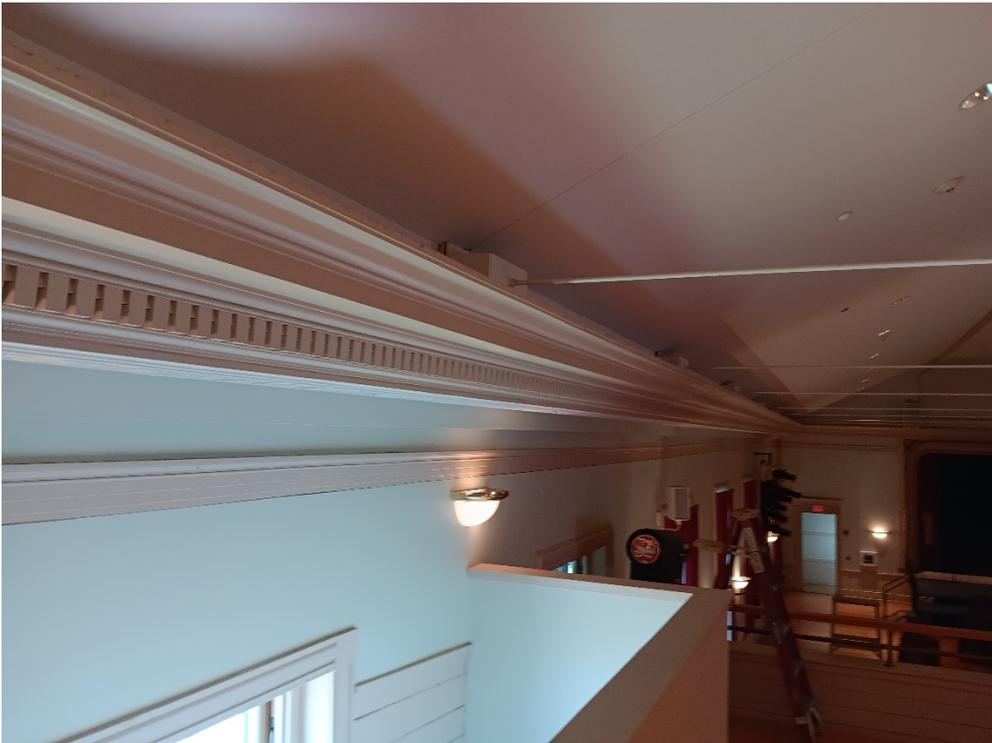
2. Cornice Trim on North Wall of Great Hall – trim tilts outward from wall

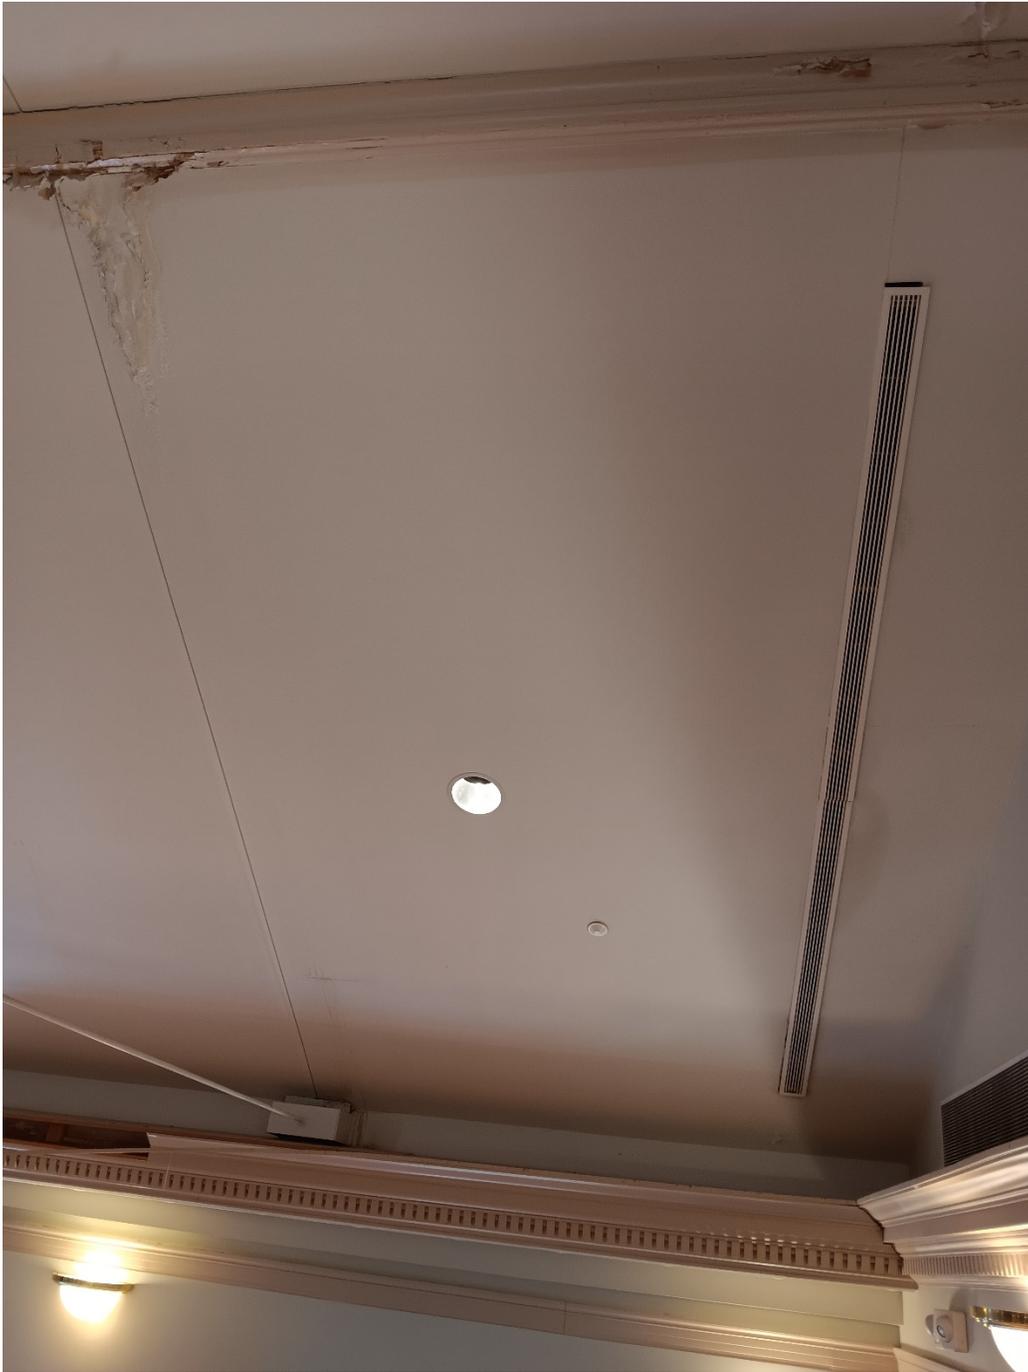
3. Great Hall Balcony Ceiling Damage

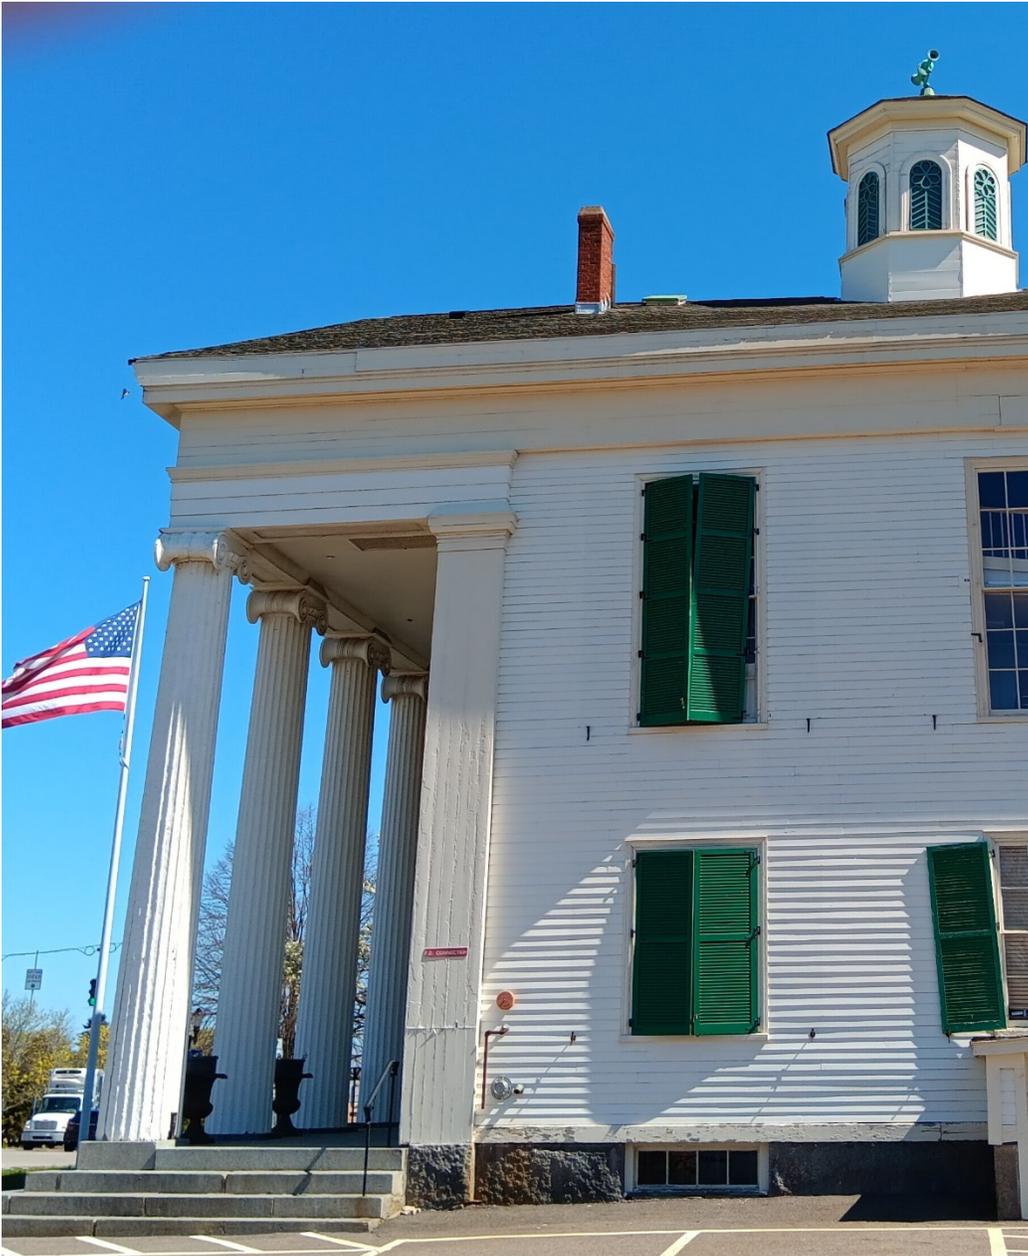
4. South Chimney and Roof Hatch (to right of chimney) which need flashing repairs.
