Route 28 Priority Corridor Study

Randolph, MA

Corridor Safety Analysis

TECHNICAL REPORT

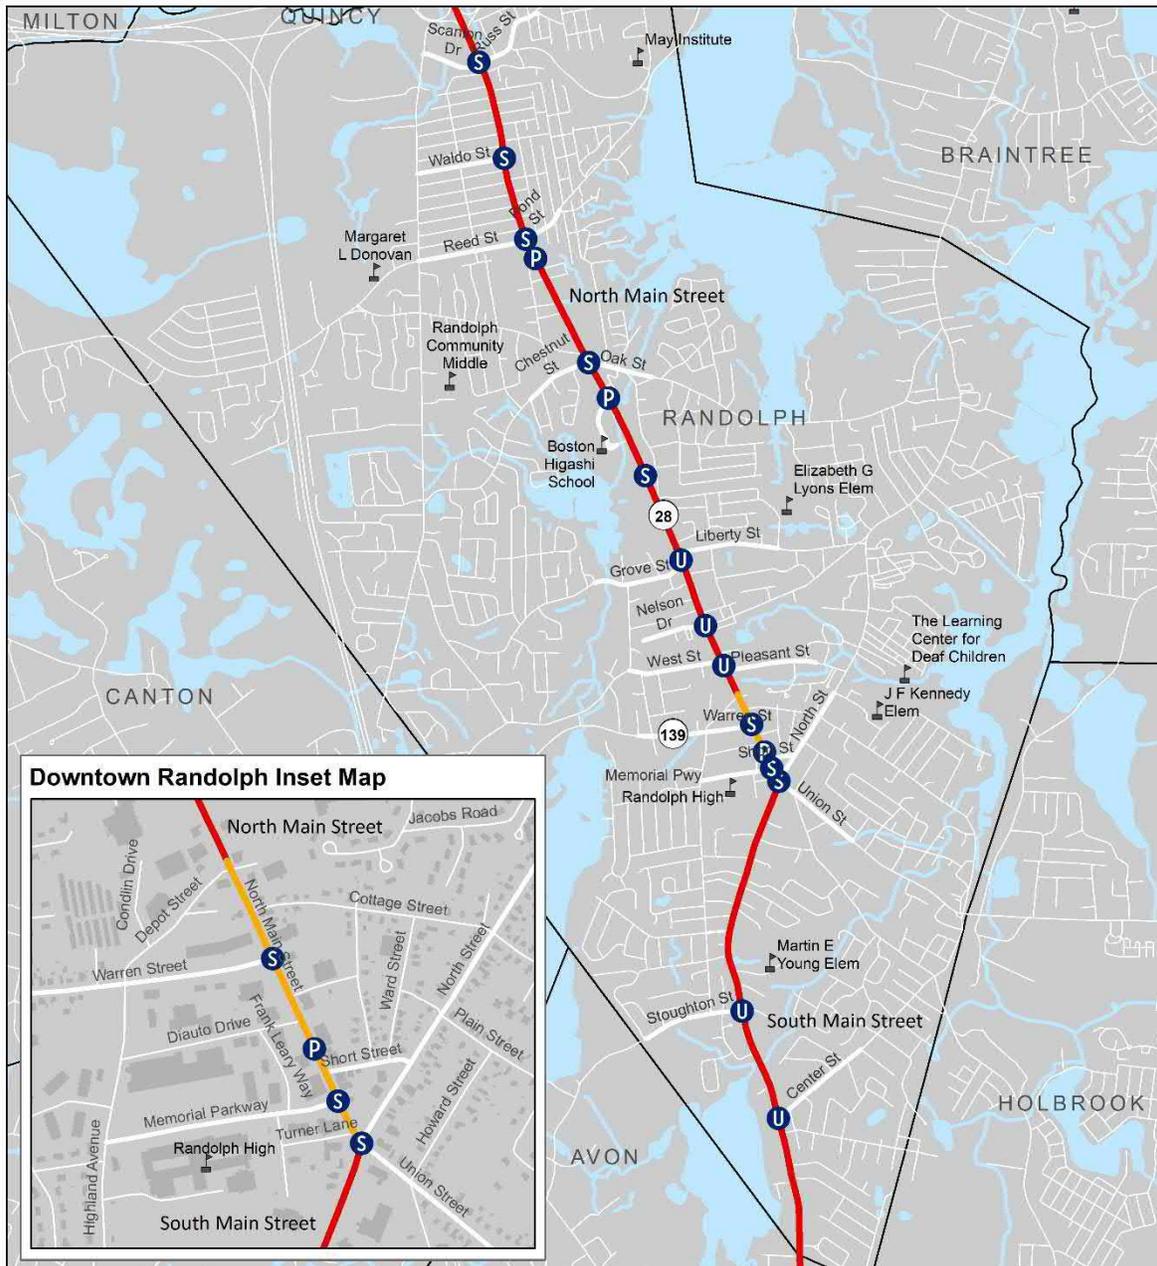
Figure 1 – Route 28 Corridor Study Intersections and Roadway Jurisdiction

Figure 1 on the following page shows the Route 28 study area and study intersections.

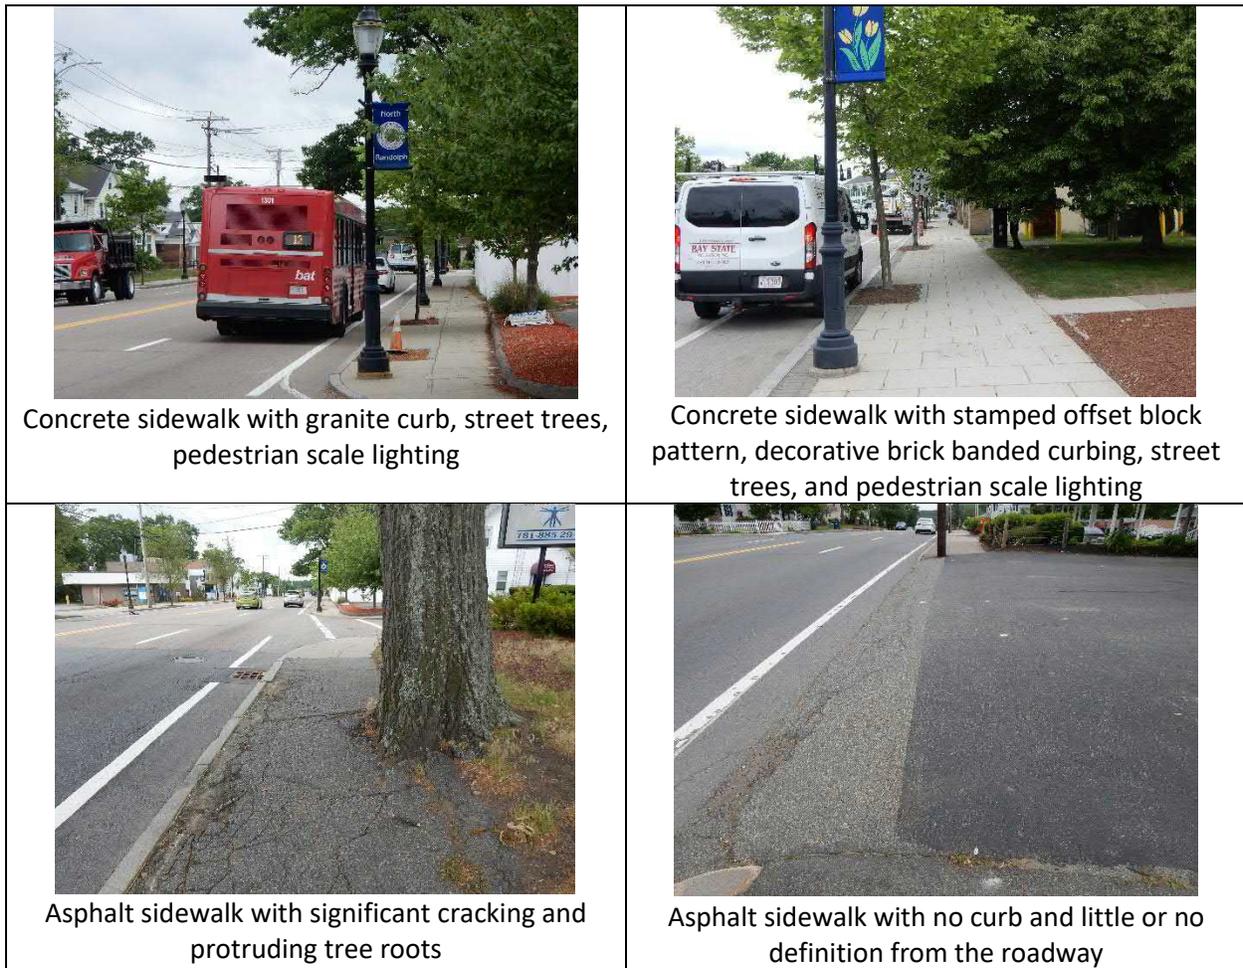
Figure 2- Existing Sidewalk Typologies

There are concrete sidewalks with granite curbing on both sides of South Main Street throughout the study corridor. They are largely in good condition and typically do not feature a landscaped buffer between the sidewalk and the curb. Occasional obstructions are present and include utility poles and mailboxes. Figure 2 includes a variety of typical sidewalk typologies found along the Route 28 study area corridor.

There are both concrete sidewalks with granite curbing and asphalt sidewalks on both sides of North Main Street throughout the study corridor. They are largely in good condition and although they do not feature a landscaped buffer between the sidewalk and the curb, there are significant portions that feature decorative brick banded edging. There is no sidewalk on the west side of North Main Street between #682 North Main Street on the south and the Boston Higashi School north driveway (approximately 1,400 feet). Occasional obstructions are present and include utility poles, however the sidewalk is generally wider on North Main Street than on South Main Street.

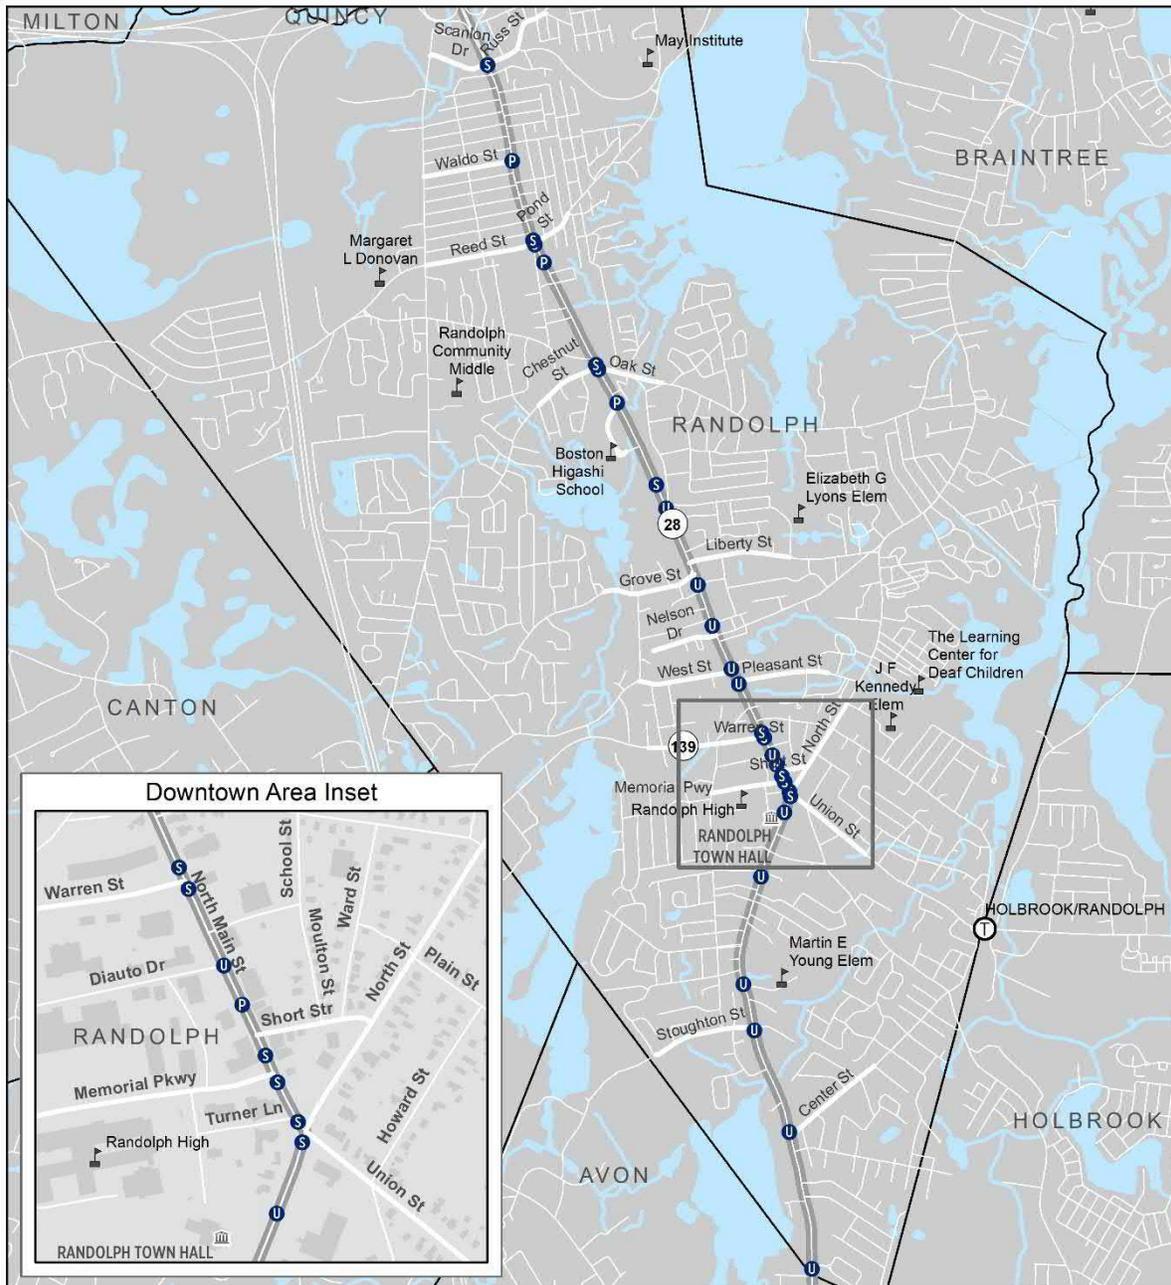
Figure 3 – Route 28 Pedestrian Crosswalk Locations

The location and condition of sidewalks, crosswalks, and curb ramps are discussed in this section. There is a total of 28 crosswalks (unsignalized and signalized) that cross Route 28 in the study corridor. On average there is one crosswalk every 1,100 feet (1/5th of a mile).

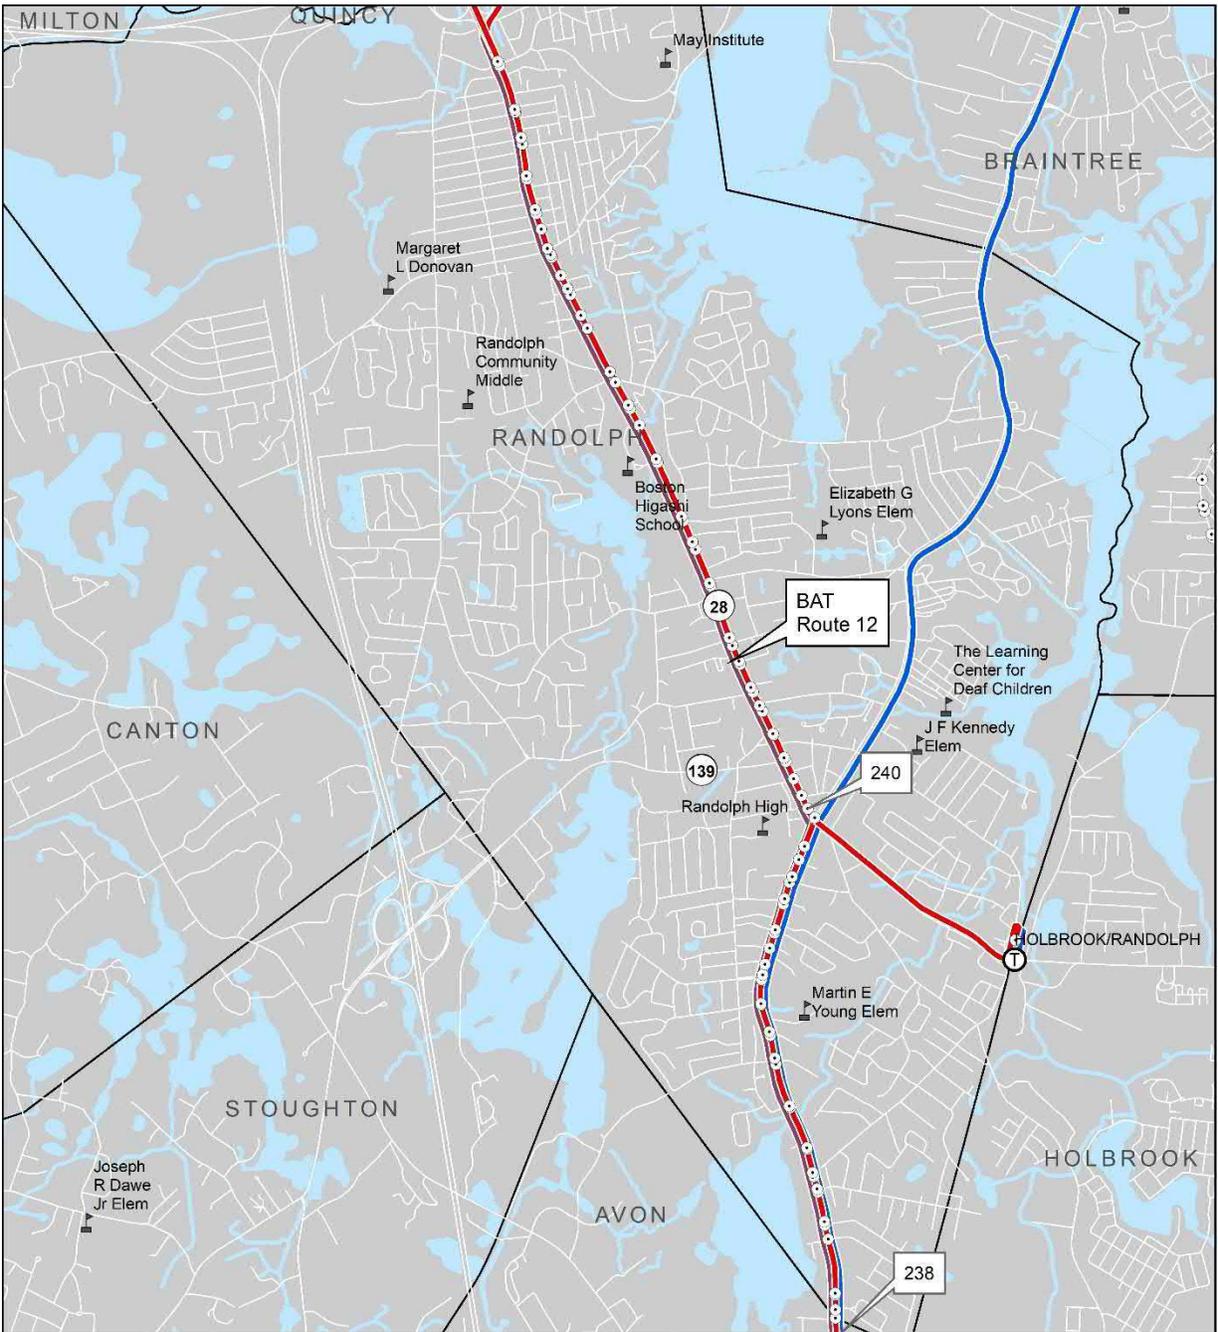
Figure 4 – MBTA and BAT Bus Routes

Figure 4 shows the MBTA bus stops along the Route 28 study area. There are approximately 92 bus stops along the study corridor. The bus stops can be broken into three categories:

All bus shelters are 10 feet long and 5 feet wide. There are no formal bus pull outs along the corridor, but rather curbside or shoulder-area pick up that may temporarily block motor vehicle traffic. Depending on lane width and configuration, motorists may have the ability to pull around a bus picking up or discharging passengers at a bus stop.

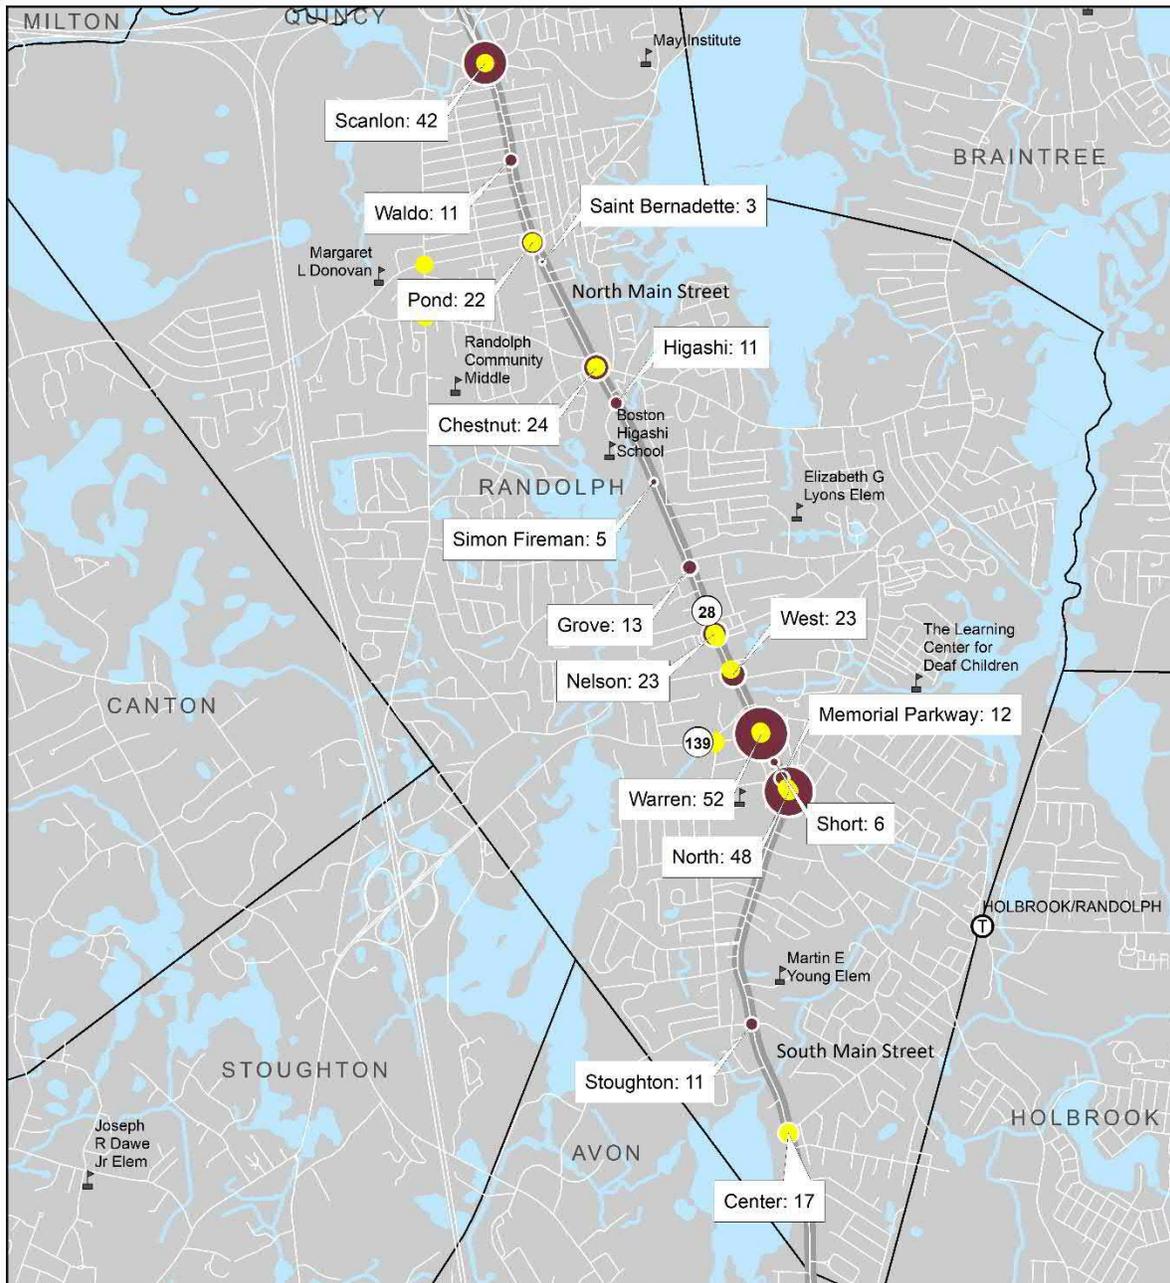
Figure 7 – Total Crashes 2016-2018

The MassDOT Highway Safety Improvement Program (HSIP) was evaluated to determine if the study area falls within a known high crash cluster. As shown in Figure 7 on the following page, there are 8 high crash clusters along the study corridor. An equation is utilized during the HSIP crash cluster analysis performed by MassDOT to assign each location an Equivalent Property Damage Only rating (EPDO). The equation factors in serious injuries and fatalities as well as non-serious injuries to determine the final rating. The HSIP high crash cluster intersections (and their EPDO scores) include:

- Fewest Crashes (3)
- Most Crashes (52)
- HSIP Crash Cluster (2015-2017)

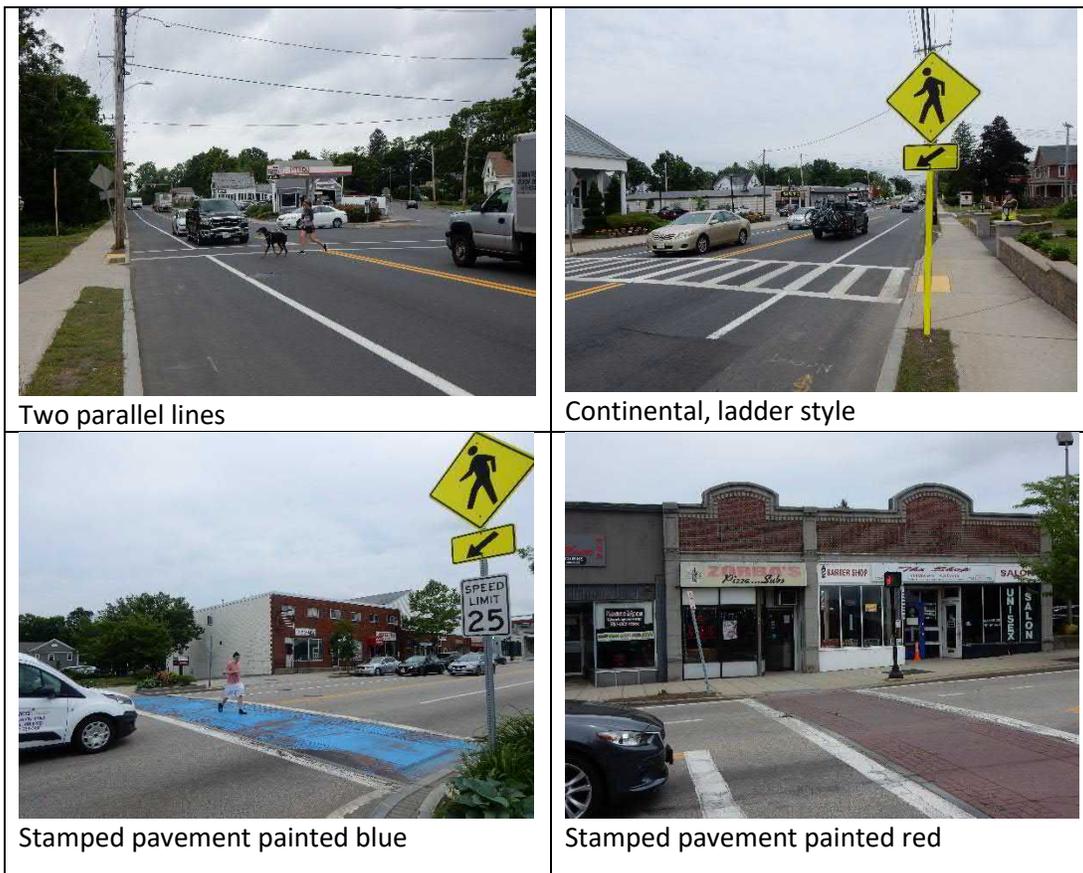
Figure 8- Existing Crosswalk Typologies

There are four types of crosswalk markings used in the study corridor. There is a lack of consistency in crosswalk type and color. Outside of the downtown area, only the intersection of North Main Street and Pond and Reed Streets has a stamped colored crosswalk. Figure 8 displays a photo example of each crosswalk typology found within the study area.

- Two parallel lines (8 locations)
- Continental, ladder style (10 locations)
- Stamped pavement painted blue with two parallel lines (2 locations)
- Stamped pavement painted red with two parallel lines (3 locations)

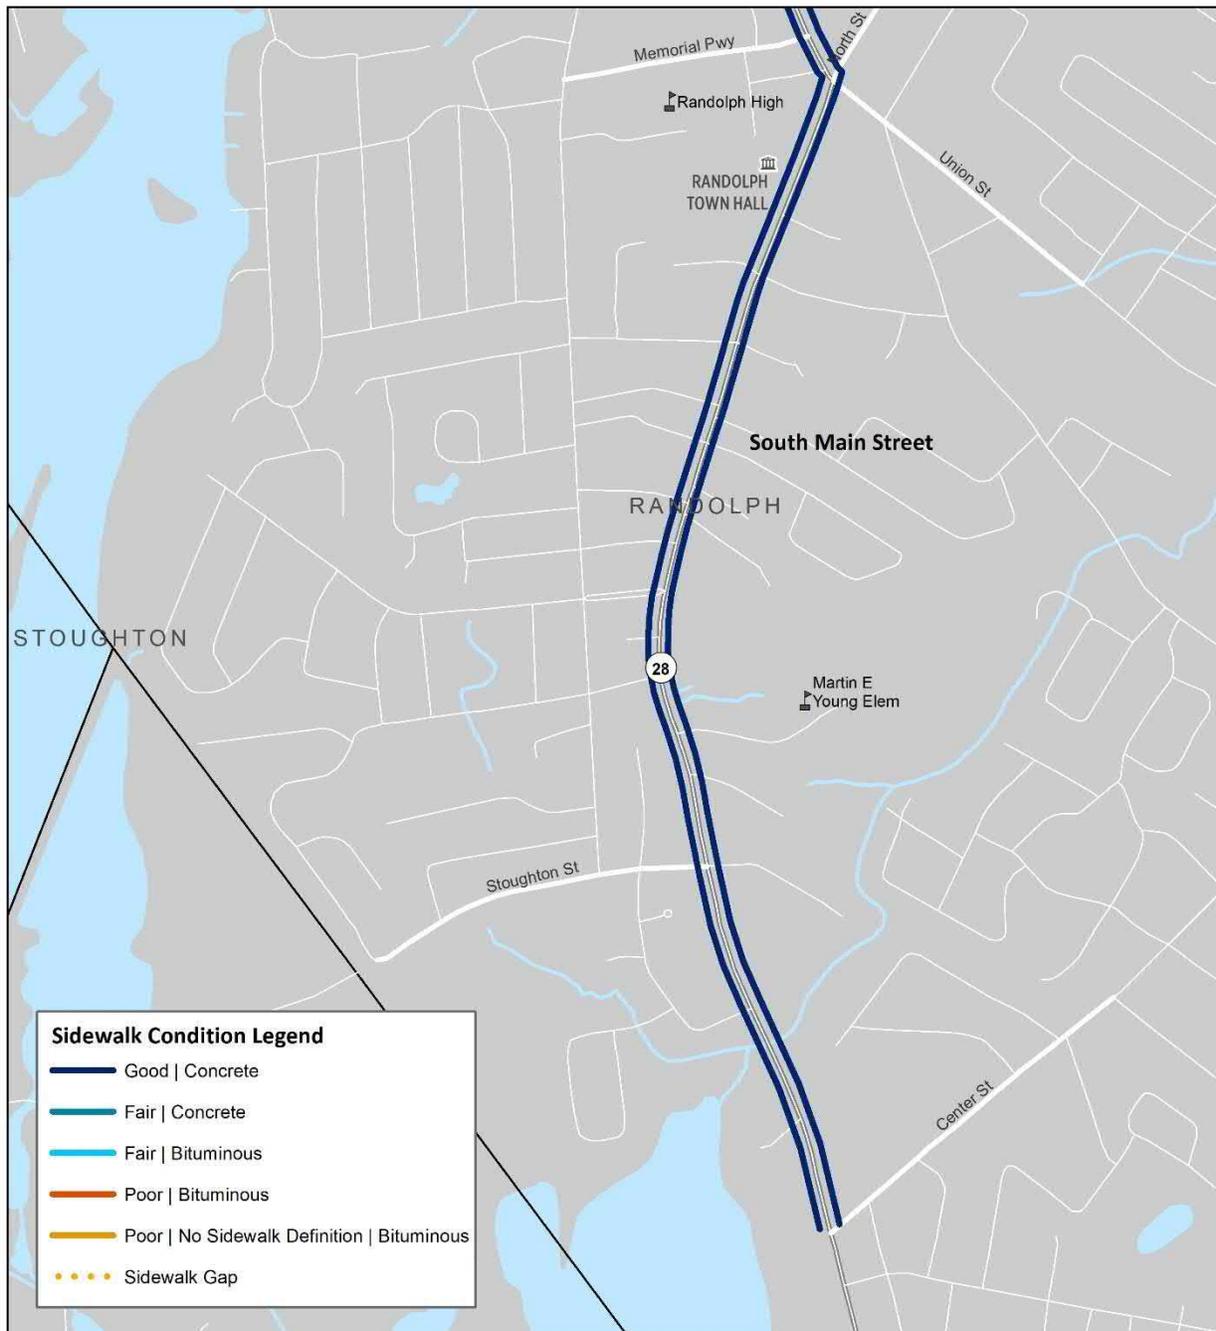
Figure 9 - Sidewalk Presence, Surface Materials, and Condition

There are concrete sidewalks with granite curbing on both sides of South Main Street throughout the study corridor. They are in good condition, have few to no obstructions, and do not feature a landscaped buffer between the sidewalk and the curb. Figure 9 displays a map of crosswalk surface materials and conditions throughout the Route 28 study corridor.

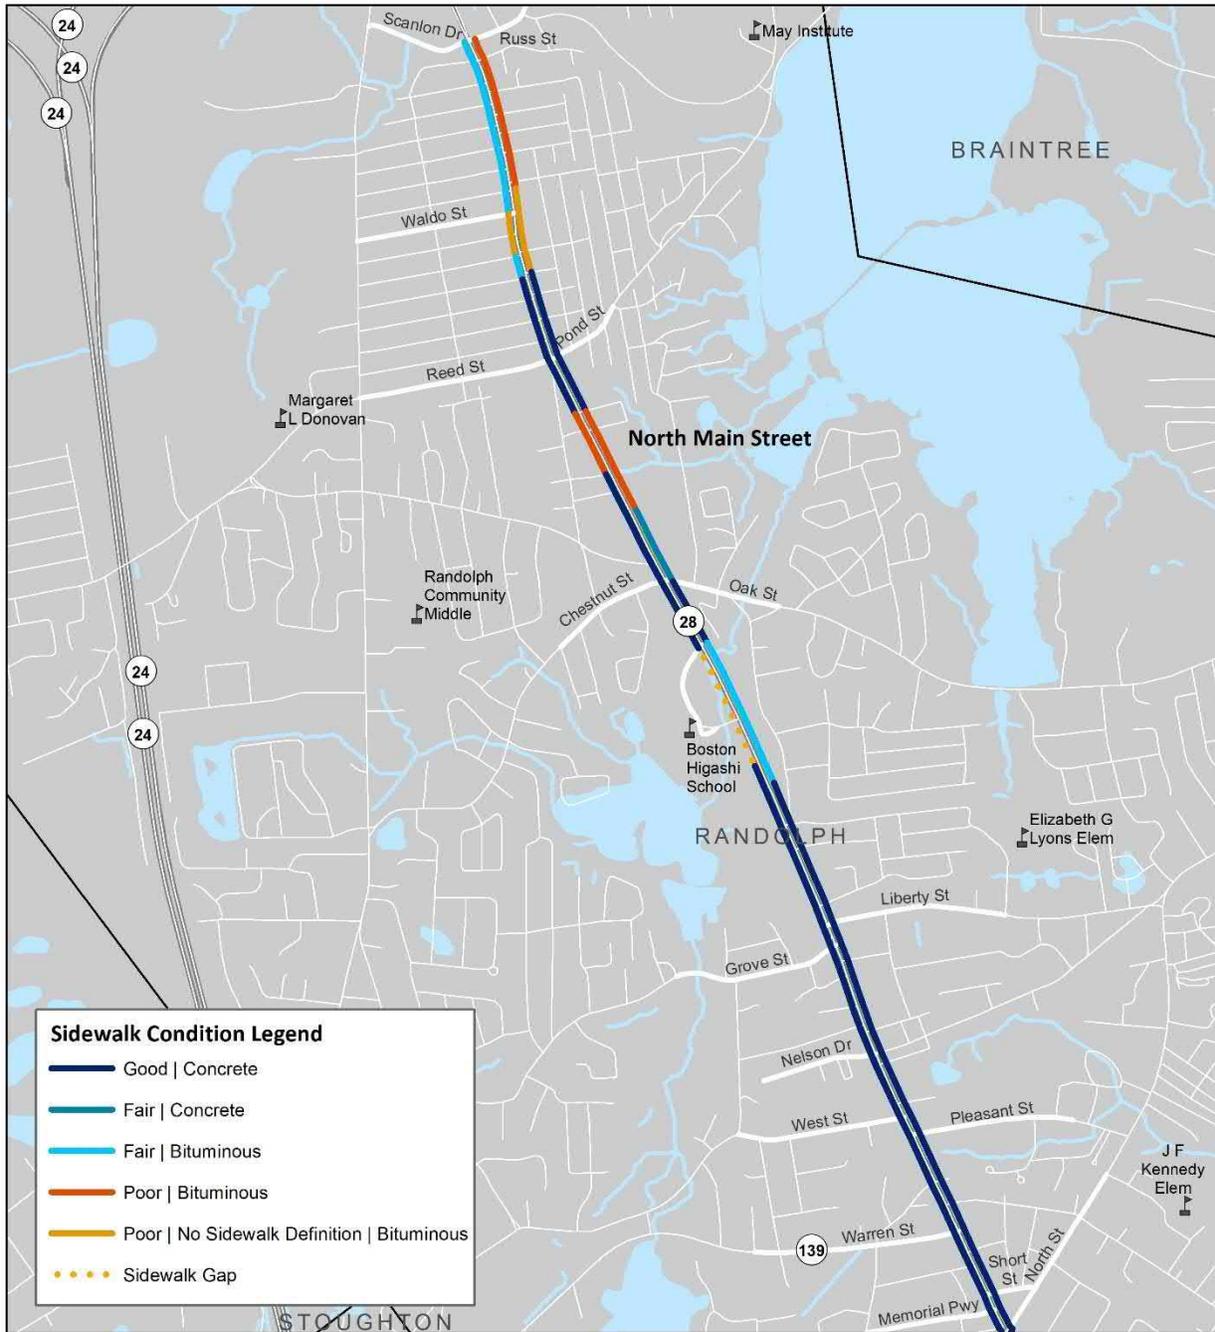
Figure 10 – Sidewalk Presence, Surface Materials, and Condition (continued)

While the concrete sidewalks with granite curbing are in good condition, many portions of asphalt sidewalks along North Main Street are in poor or fair condition. There is a sidewalk gap on the west side of North Main Street between #682 North Main Street and the Boston Higashi School north driveway. Trees, utility poles, and other occasional obstructions exist. There are some segments of asphalt sidewalk that need to be replaced or repaired. Between Stacey Street and Jones Street there is little to no sidewalk definition separating the sidewalk from the roadway.

Figure 10 displays a map indicating the presence or absence of sidewalks, their surface materials, and their general condition.

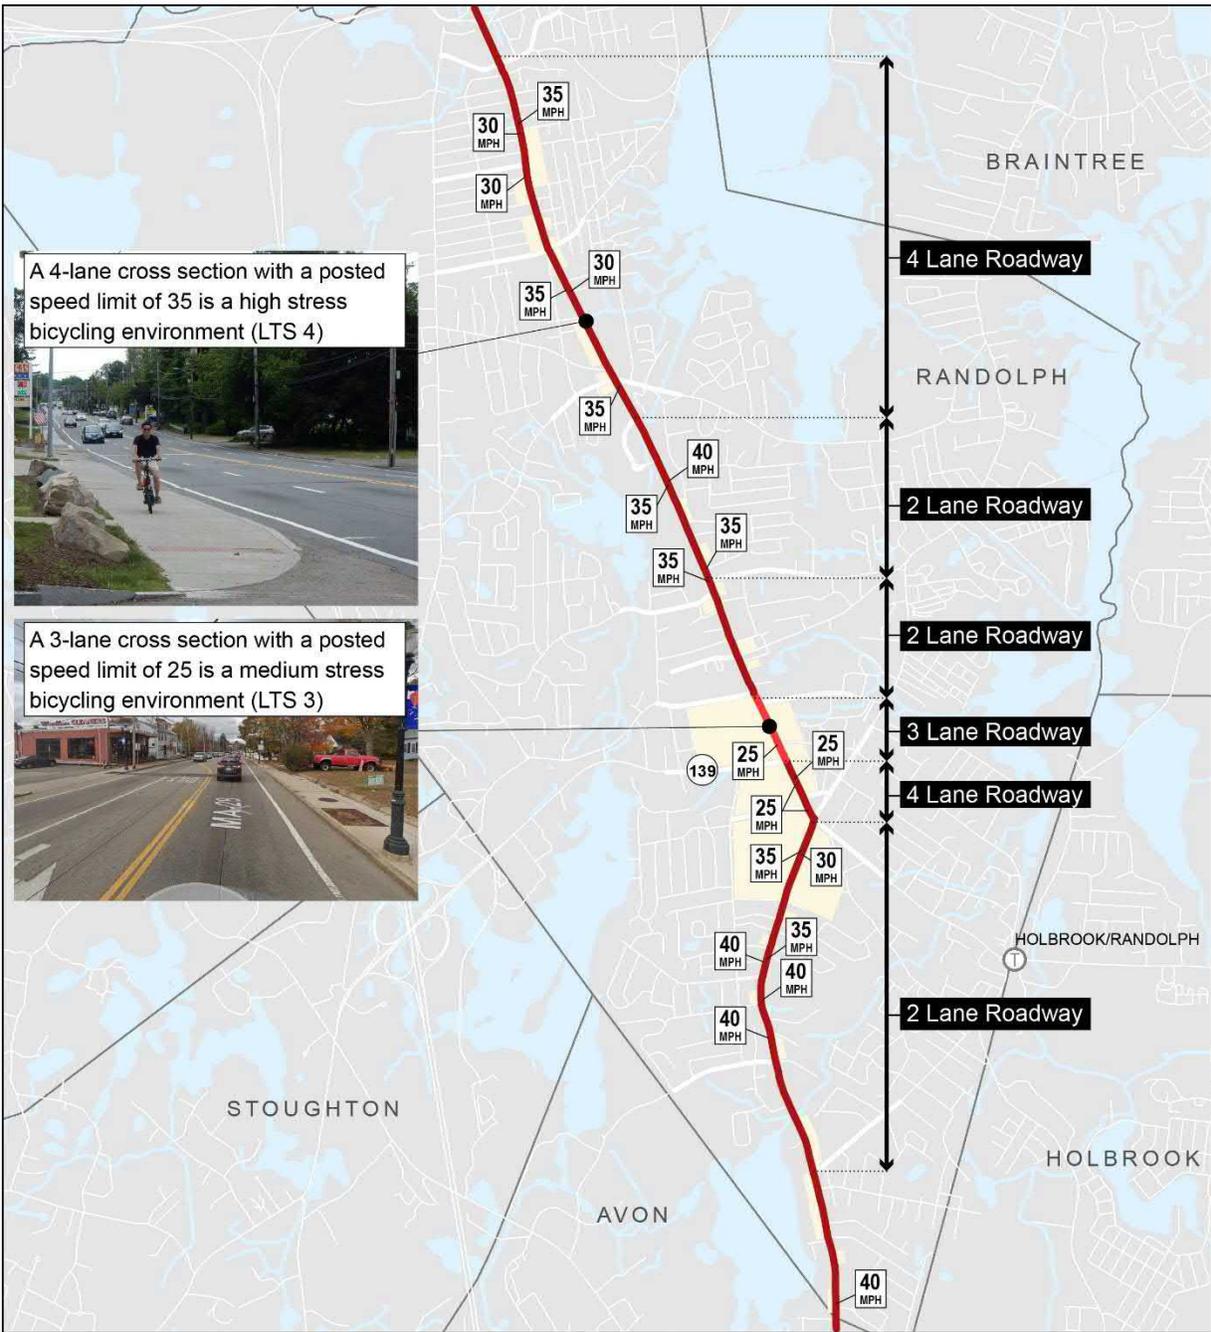
Figure 11– Bicycle Level of Traffic Stress, Roadway Lane Configuration, and Posted Speed Limits

Figure 11 displays a map indicating the BLTS score for each roadway segment based on posted speed and number of lanes. It should be noted that on a roadway segment with a different posted speed in the northbound or southbound directions, the high speed was chosen to be used for the BLTS analysis.

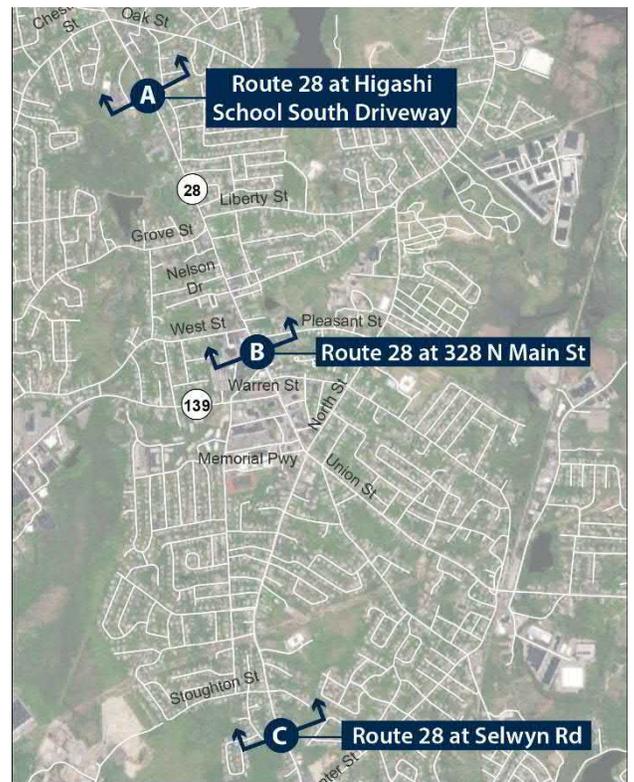
Figure 12 - Section Graphic Locations

Figure 12 at right shows the location of cross section graphics that depict proposed roadway improvements.

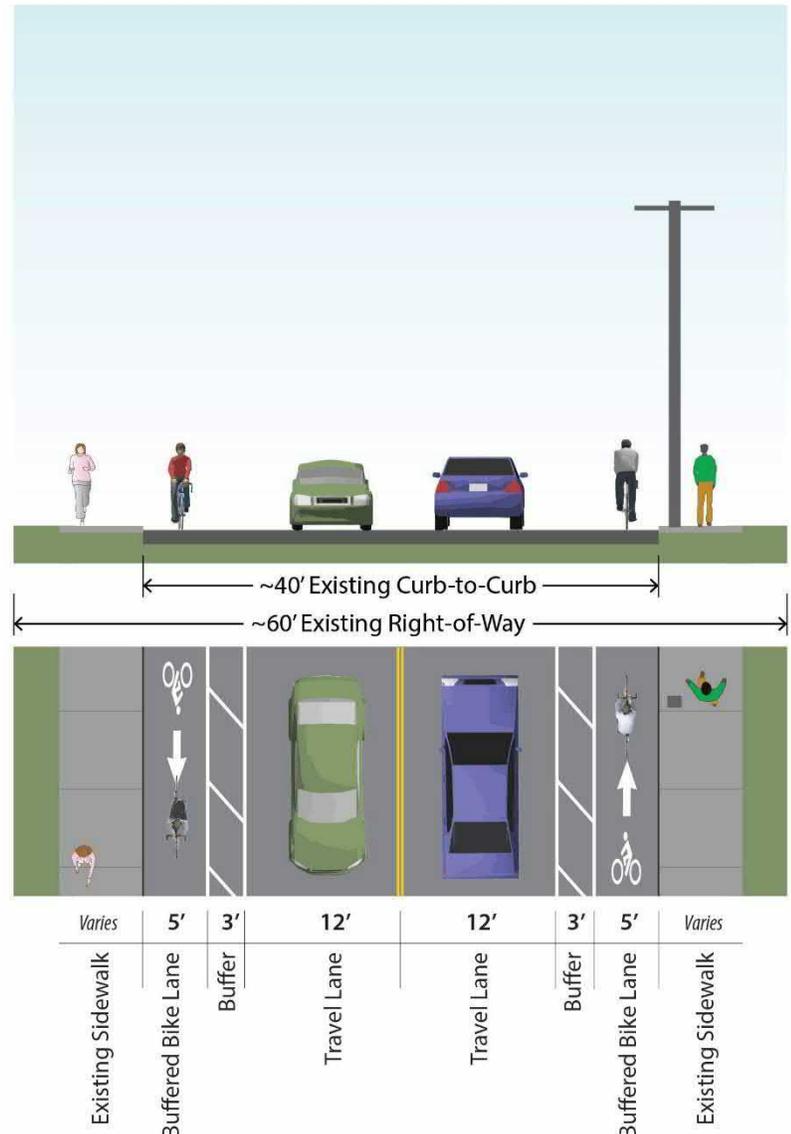
Figure 13 – Section A: Proposed Buffered Bike Lane Cross Section on South Main Street at Selwyn Road

Figure 13, Figure 14, and Figure 15 show the improvements developed for the South Main Street segment between Acorn Street and North Main Street at North Street. The improvements include:

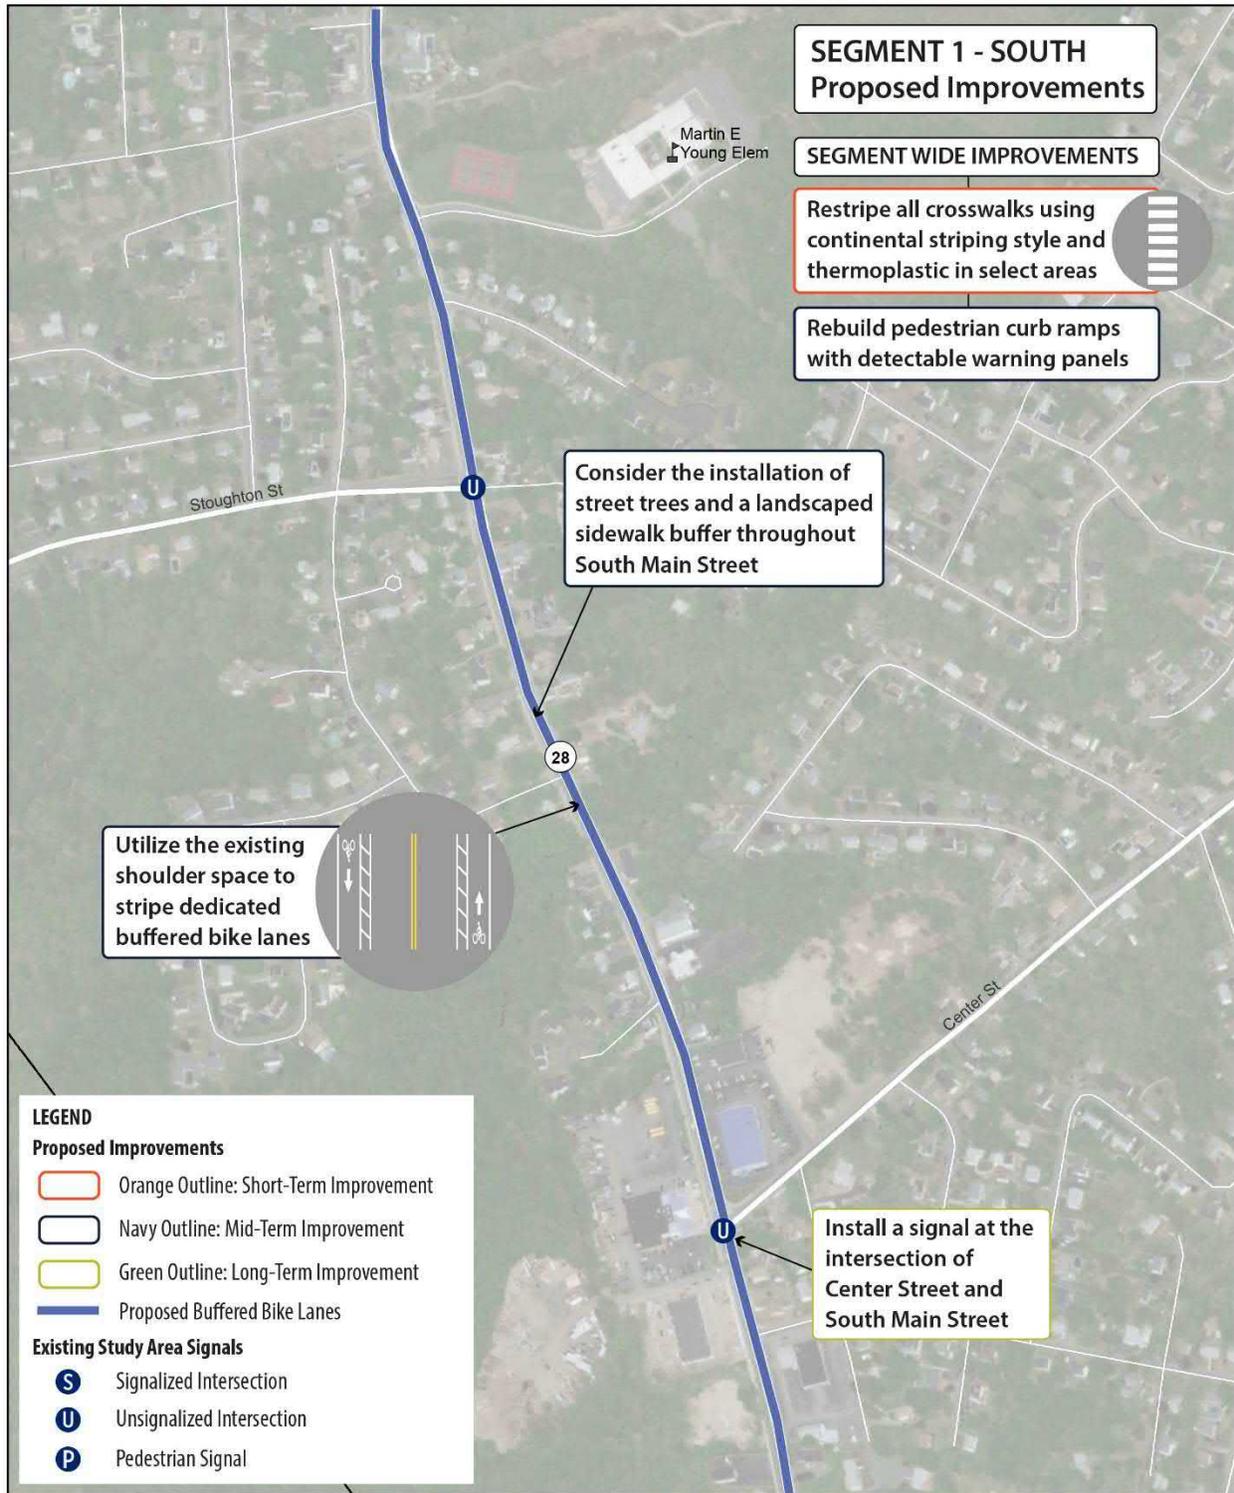
Figure 14 - Proposed Improvements Inset Map 1 (Segment 1-South)

Inset 1: South Main Street - Martin Young Elem. to Center Street

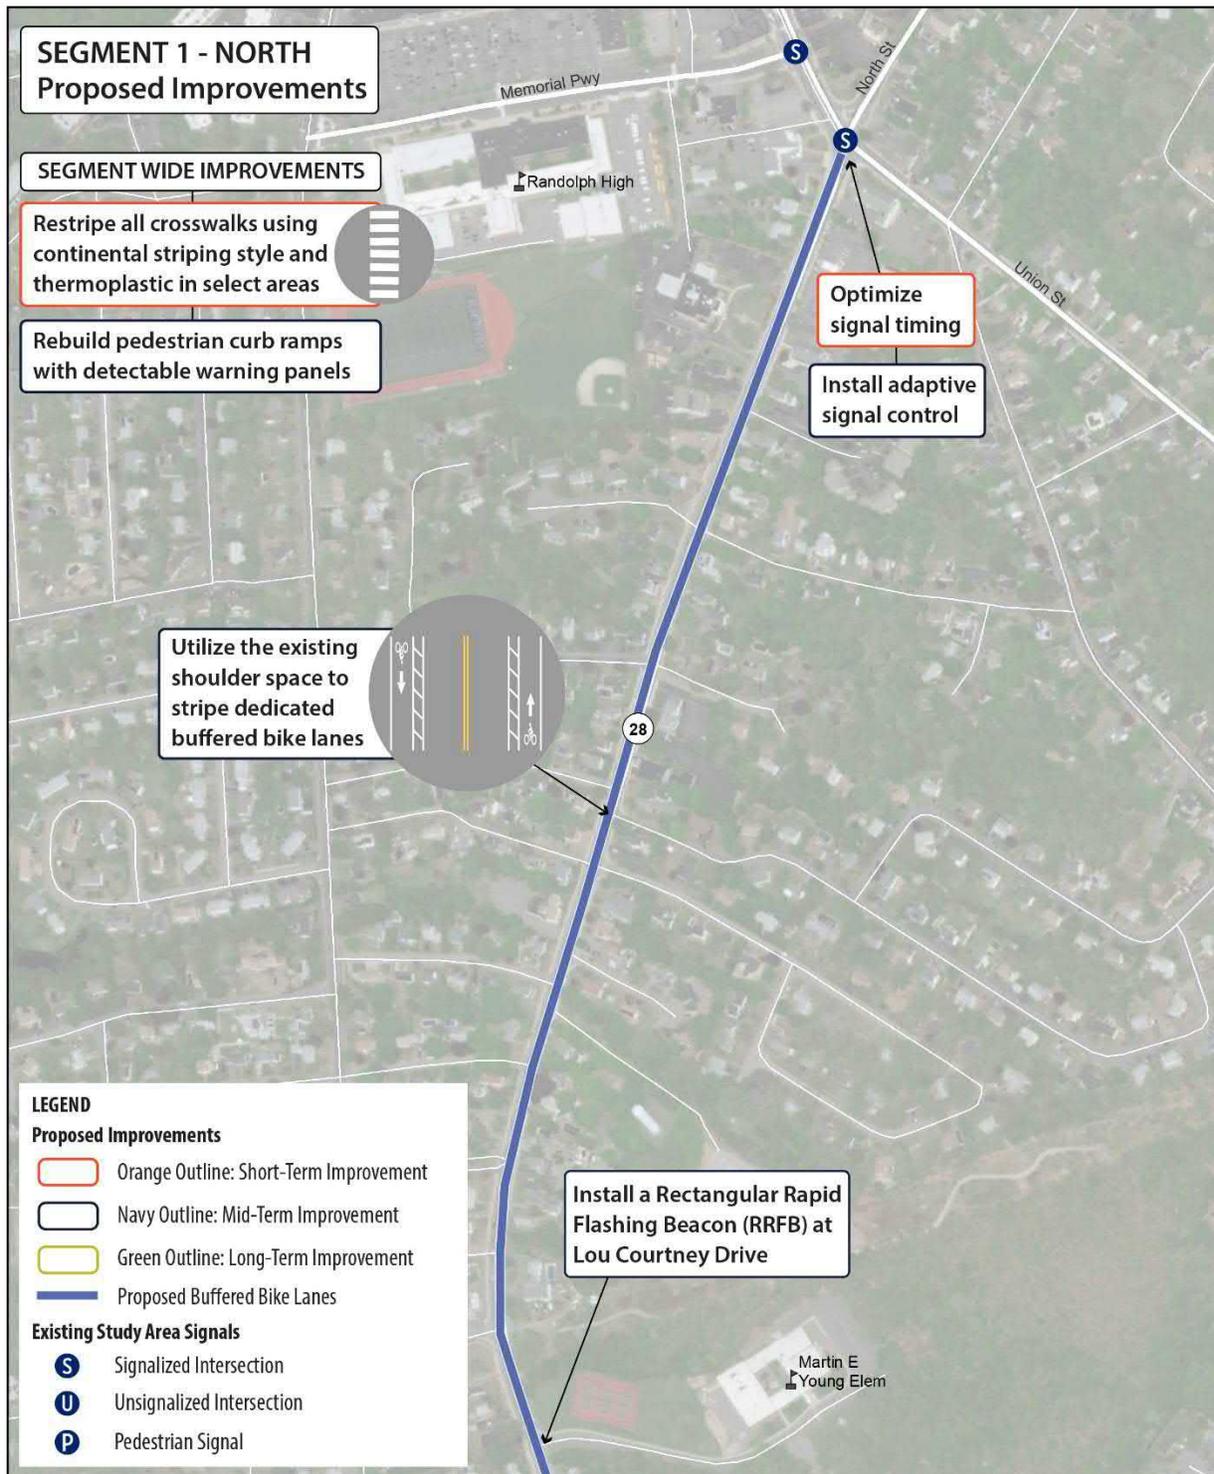
Figure 15 – Proposed Improvements Inset Map 2 (Segment 1-North)

Inset 2: South Main Street - North Street to Martin Young Elem.
