Route 28 Priority Corridor Study

Randolph, MA

Corridor Safety Analysis

TECHNICAL REPORT

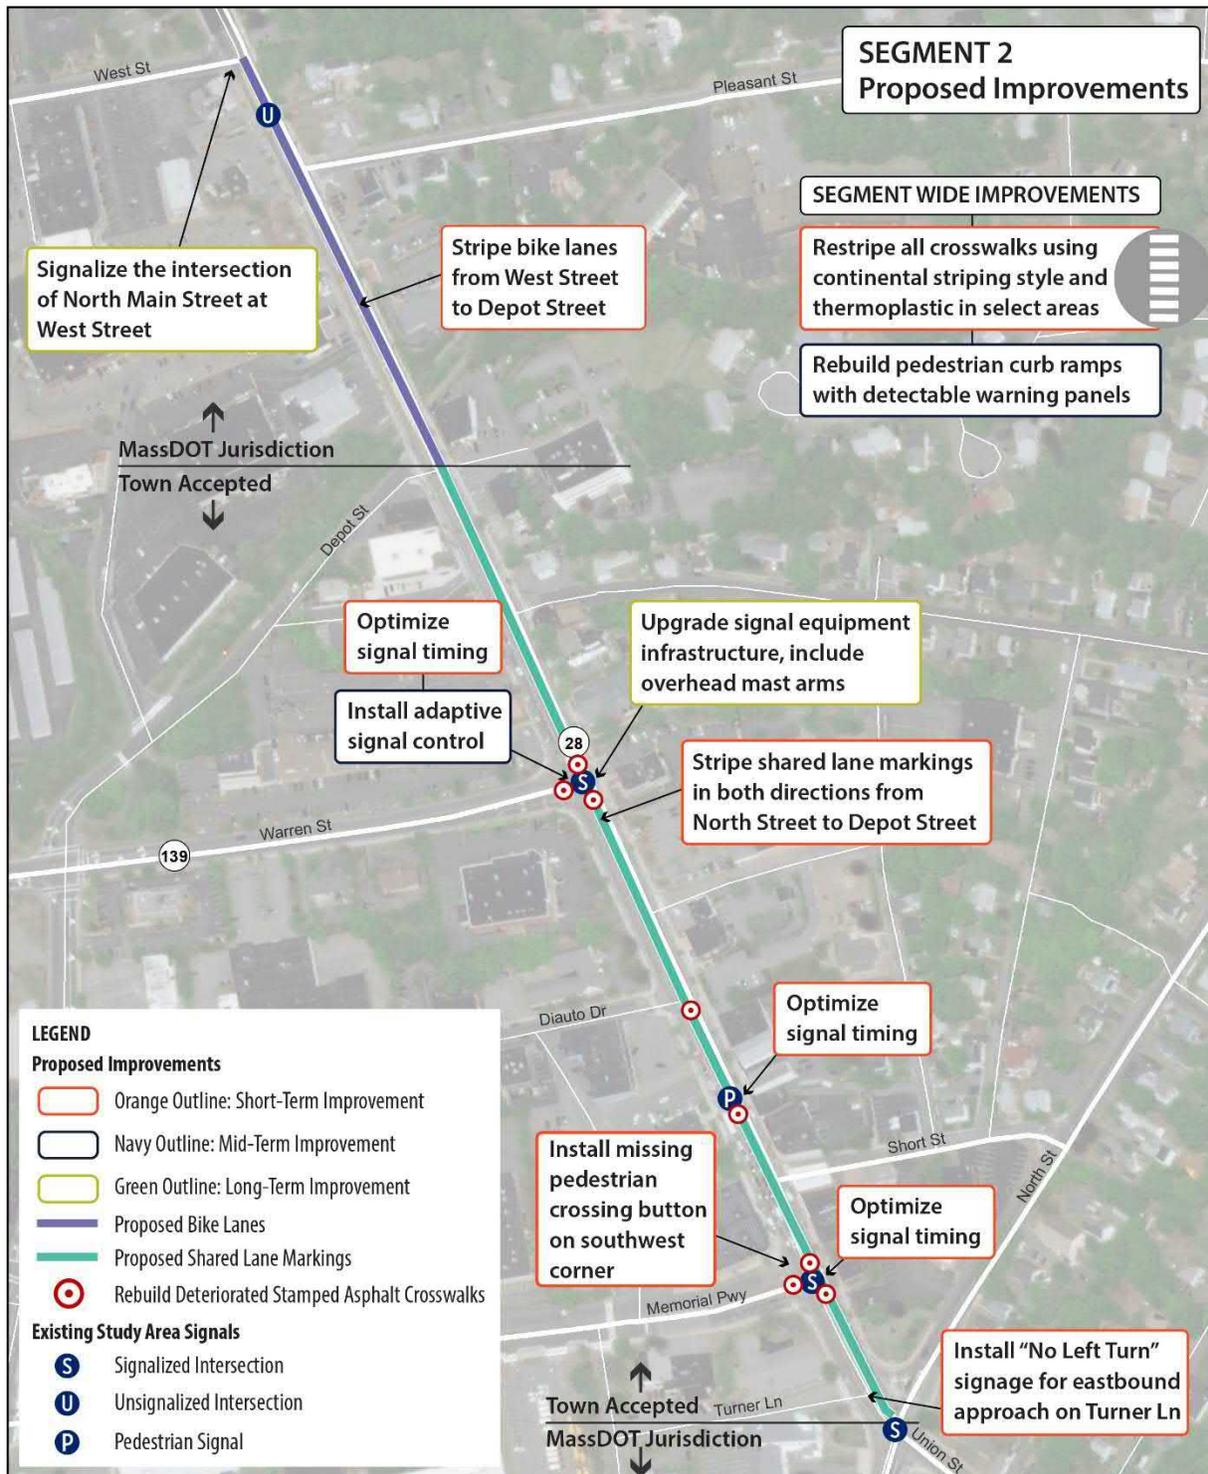
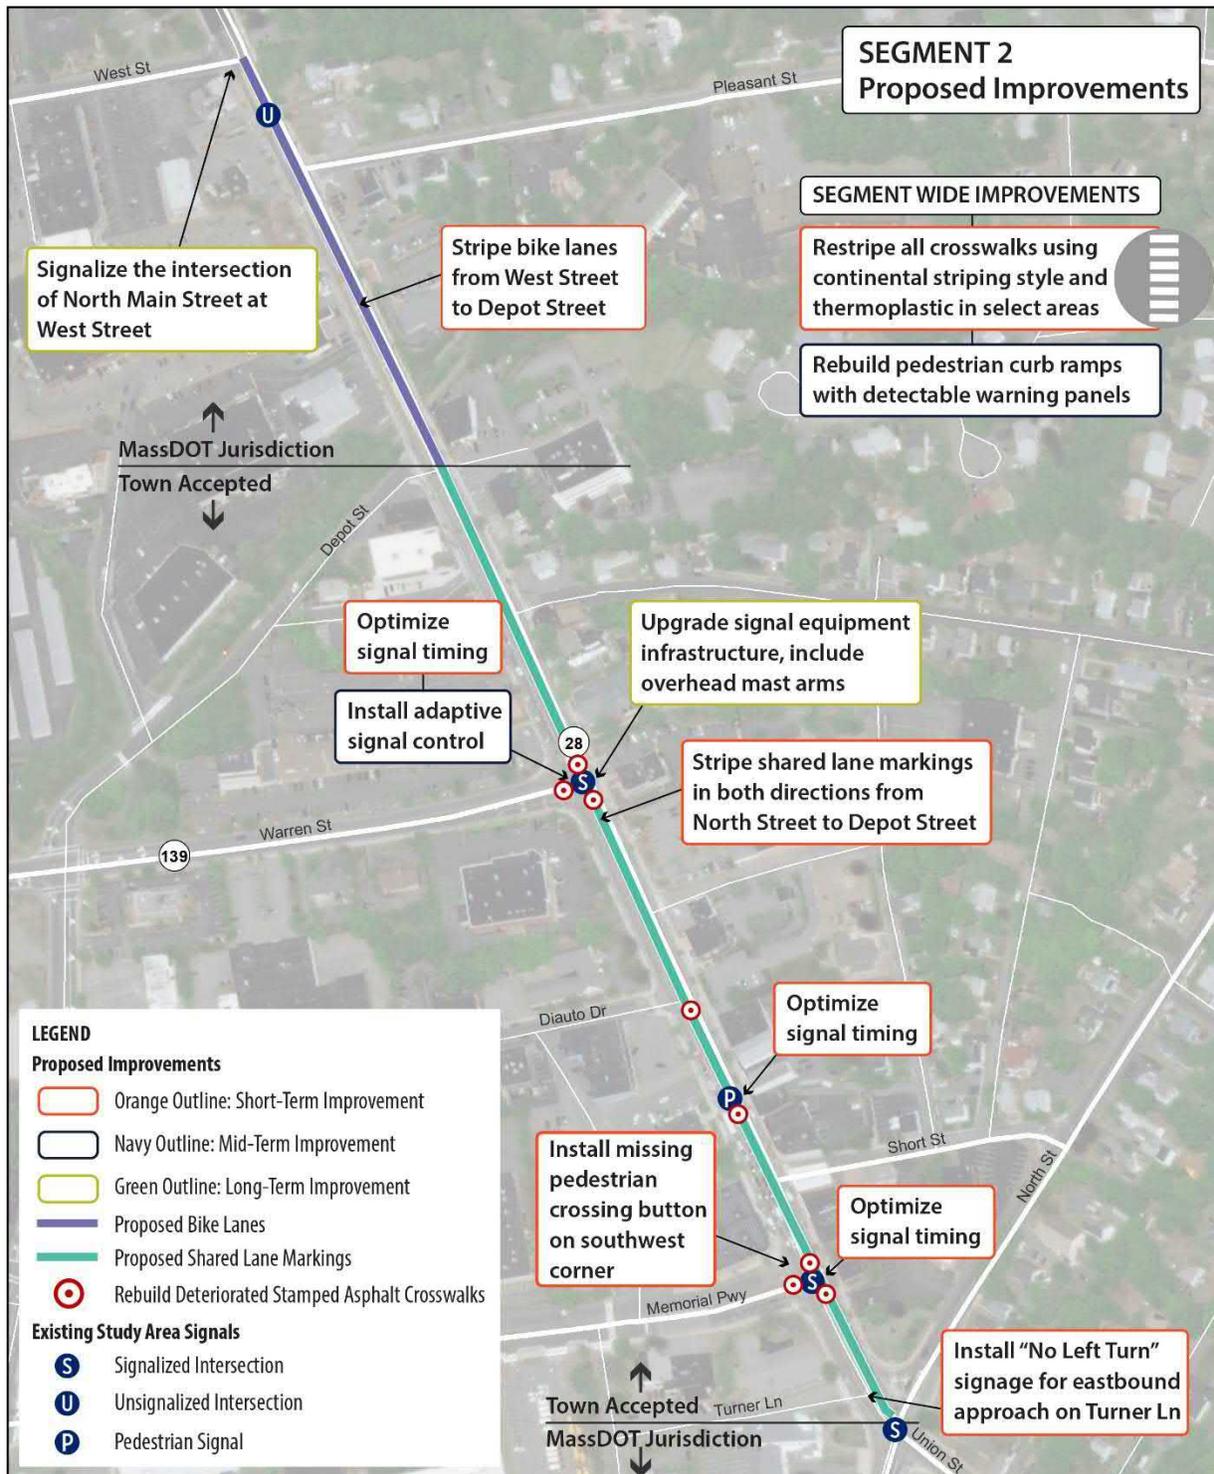
Figure 17 - Proposed Improvements Inset Map 3 (Segment 2)

- Warren Street (Rt. 139) including increasing All Red clearance phase
 - Pedestrian signal between Short Street and Diauto Drive
- Stripe bicycle lanes on both direction on North Main Street between Depot Street and West Street

Inset 3: North Main Street - Pleasant Street to North Street

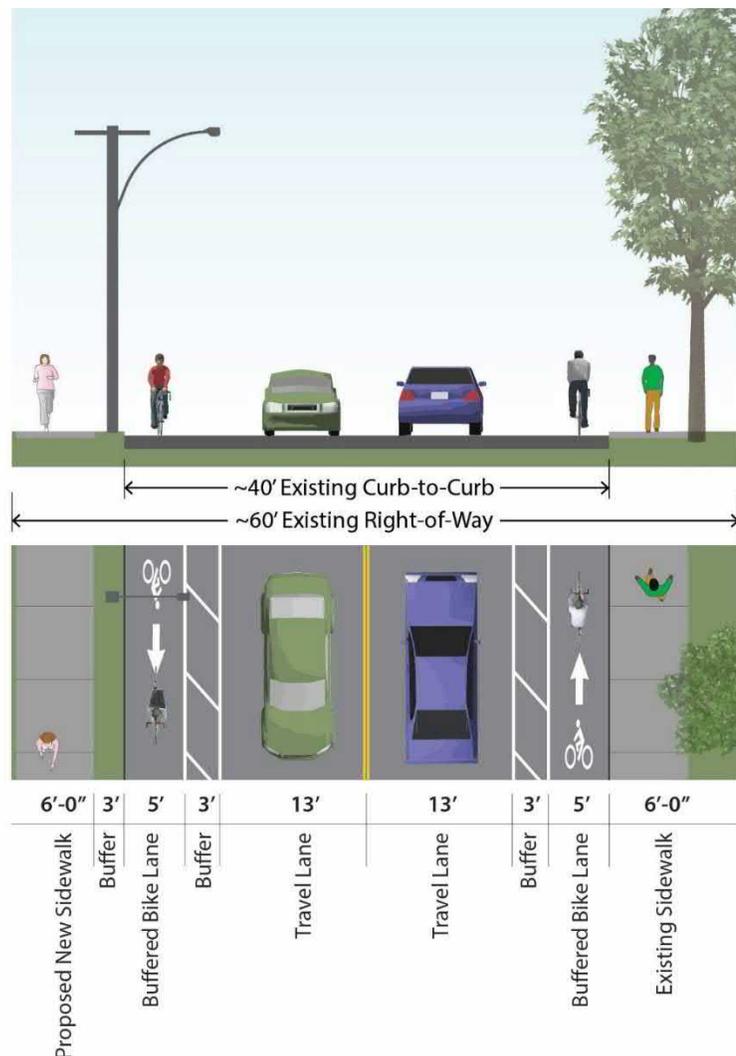
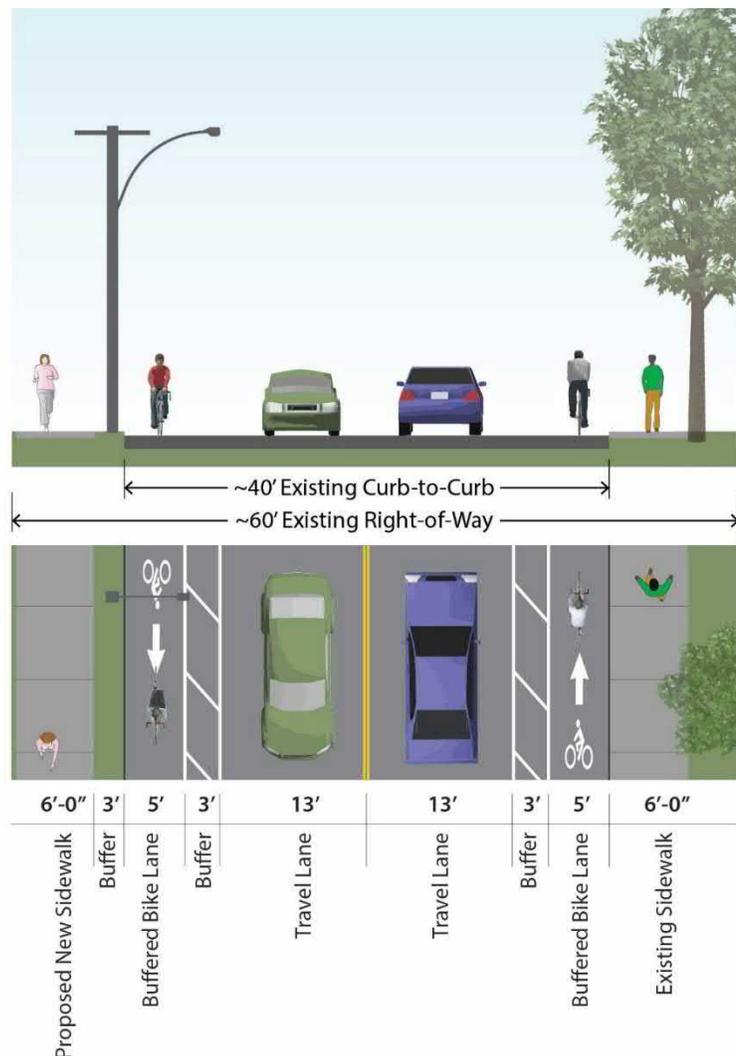
Figure 18 – Section C: Proposed Buffered Bike Lane Cross Section at Boston Higashi School South Driveway

- Realign crosswalk on Orchard Street to closer to North Main Street to improve visibility of pedestrians in crosswalk

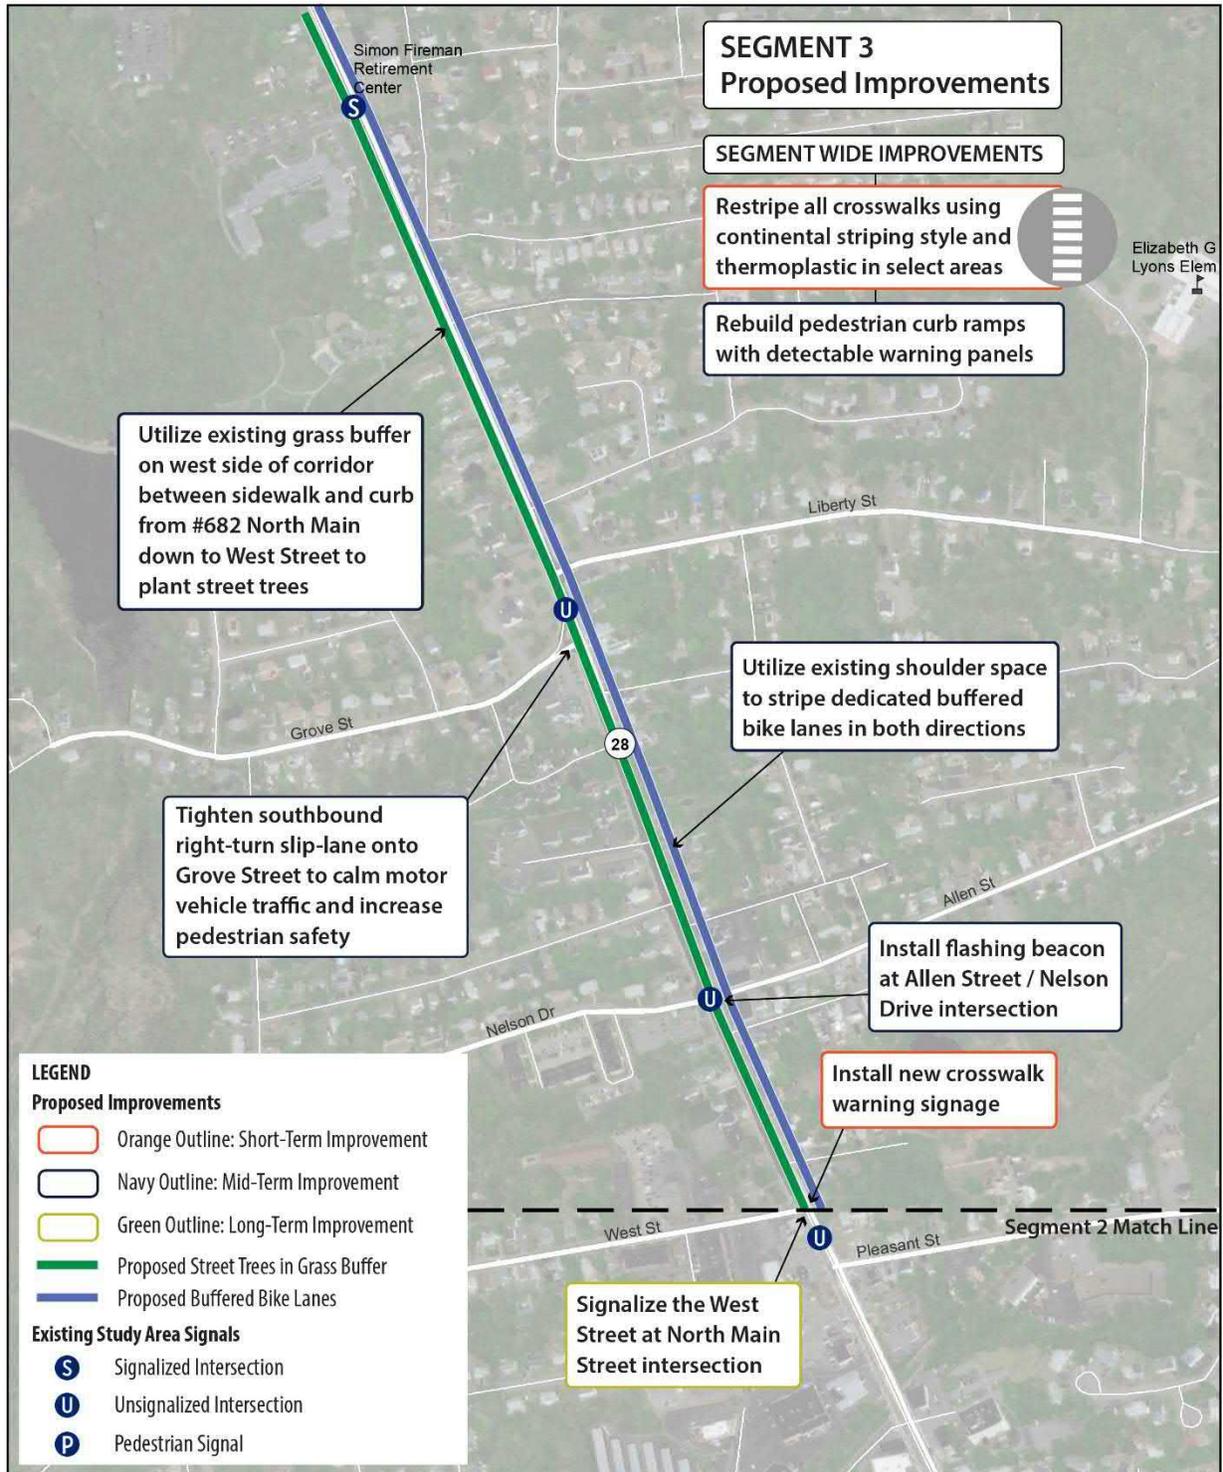
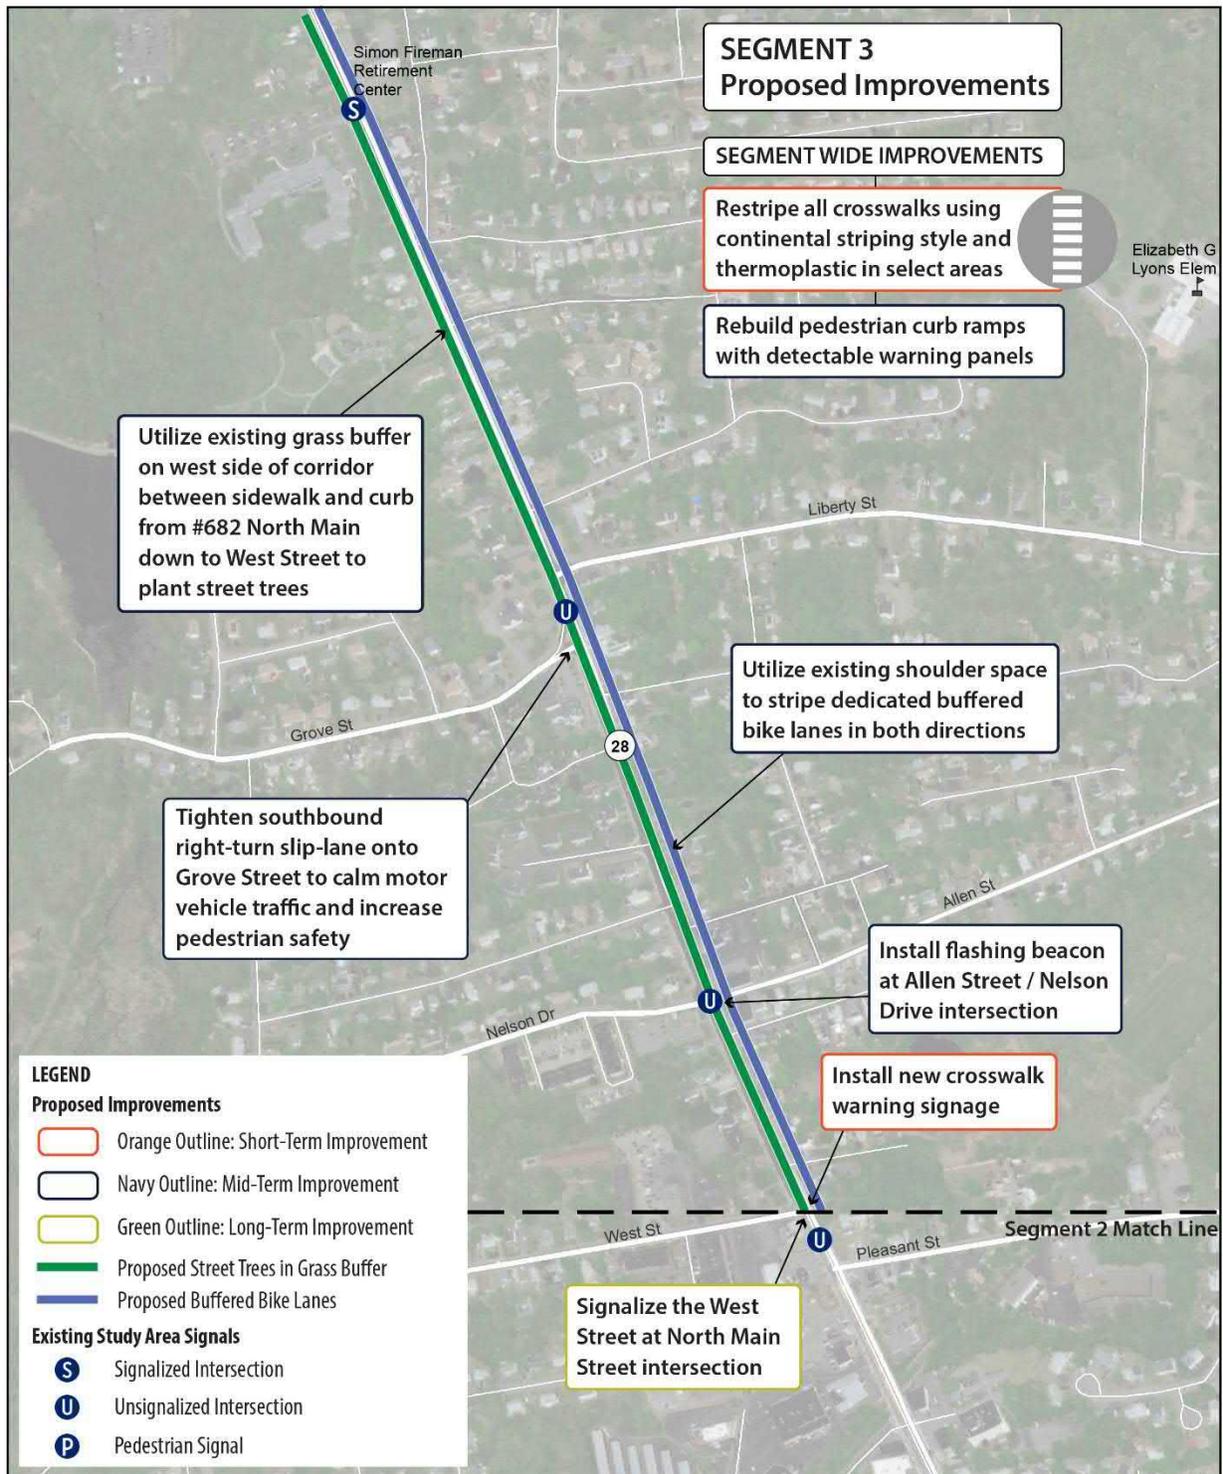
Figure 19 - Proposed Improvements Inset Map 4 (Segment 3)

- Replace asphalt sidewalk on the east side of North Main Street between #659 North Main Street and Boston Higashi School north driveway

Inset 4: North Main Street - Simon Fireman to Pleasant Street

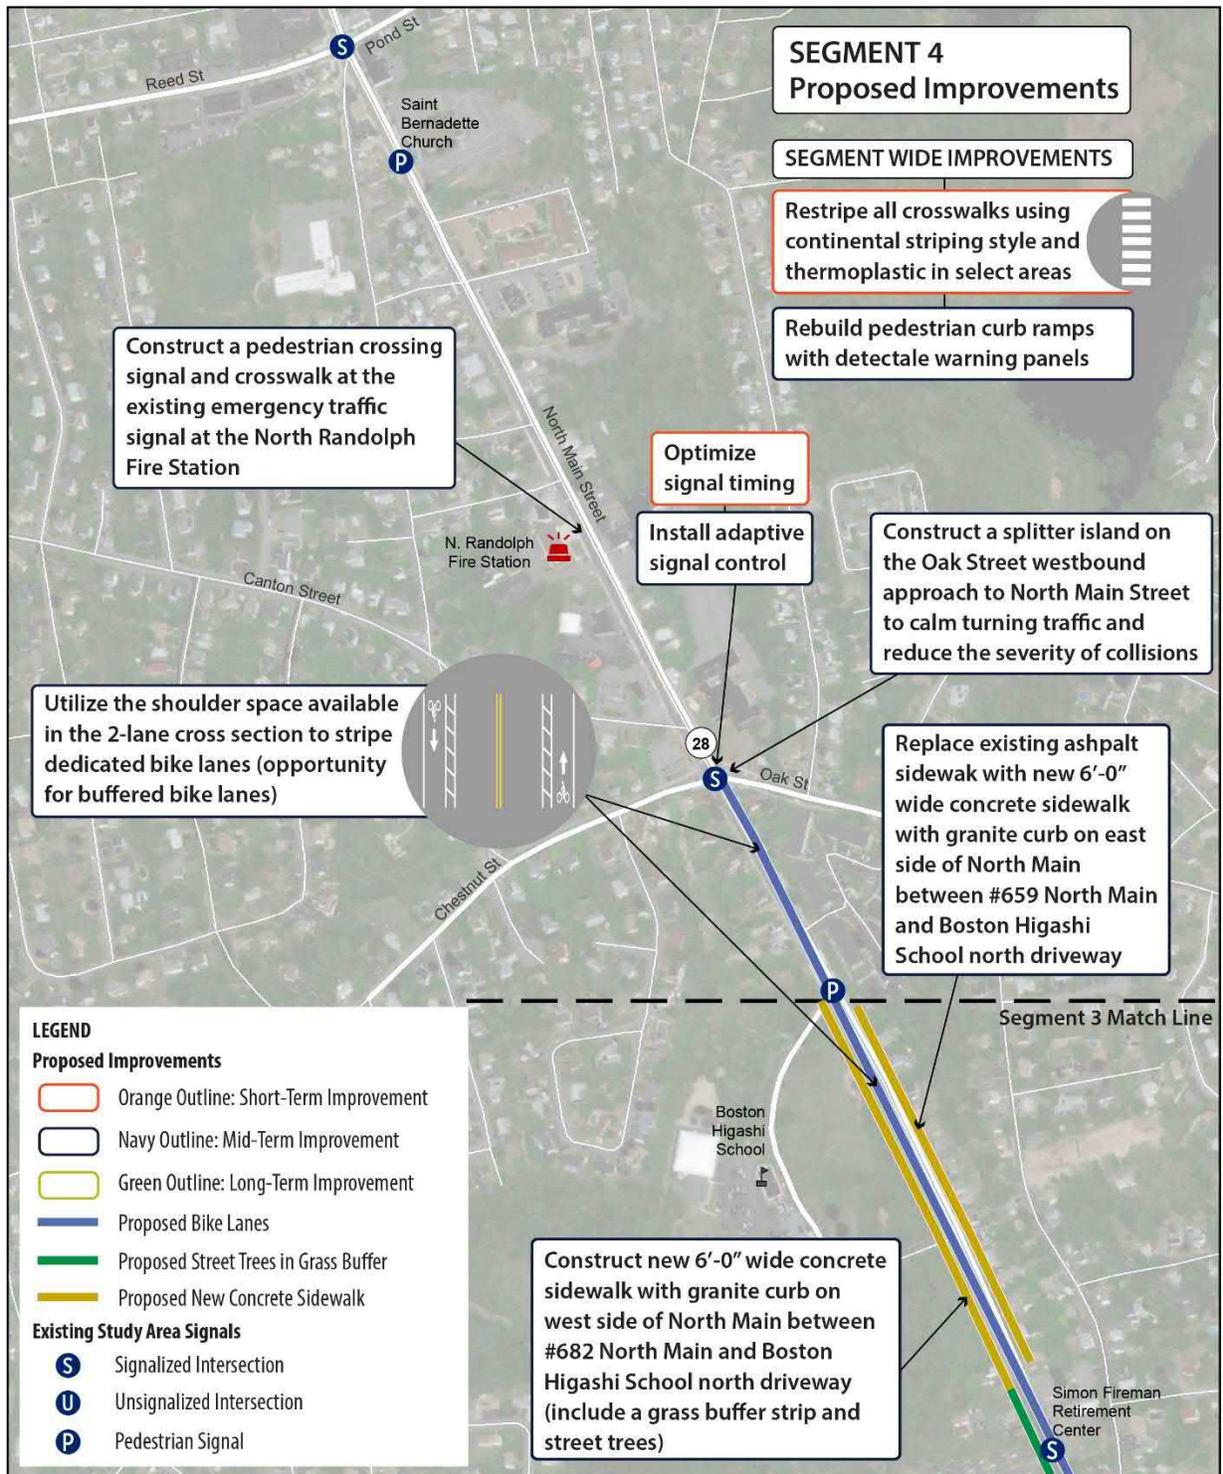
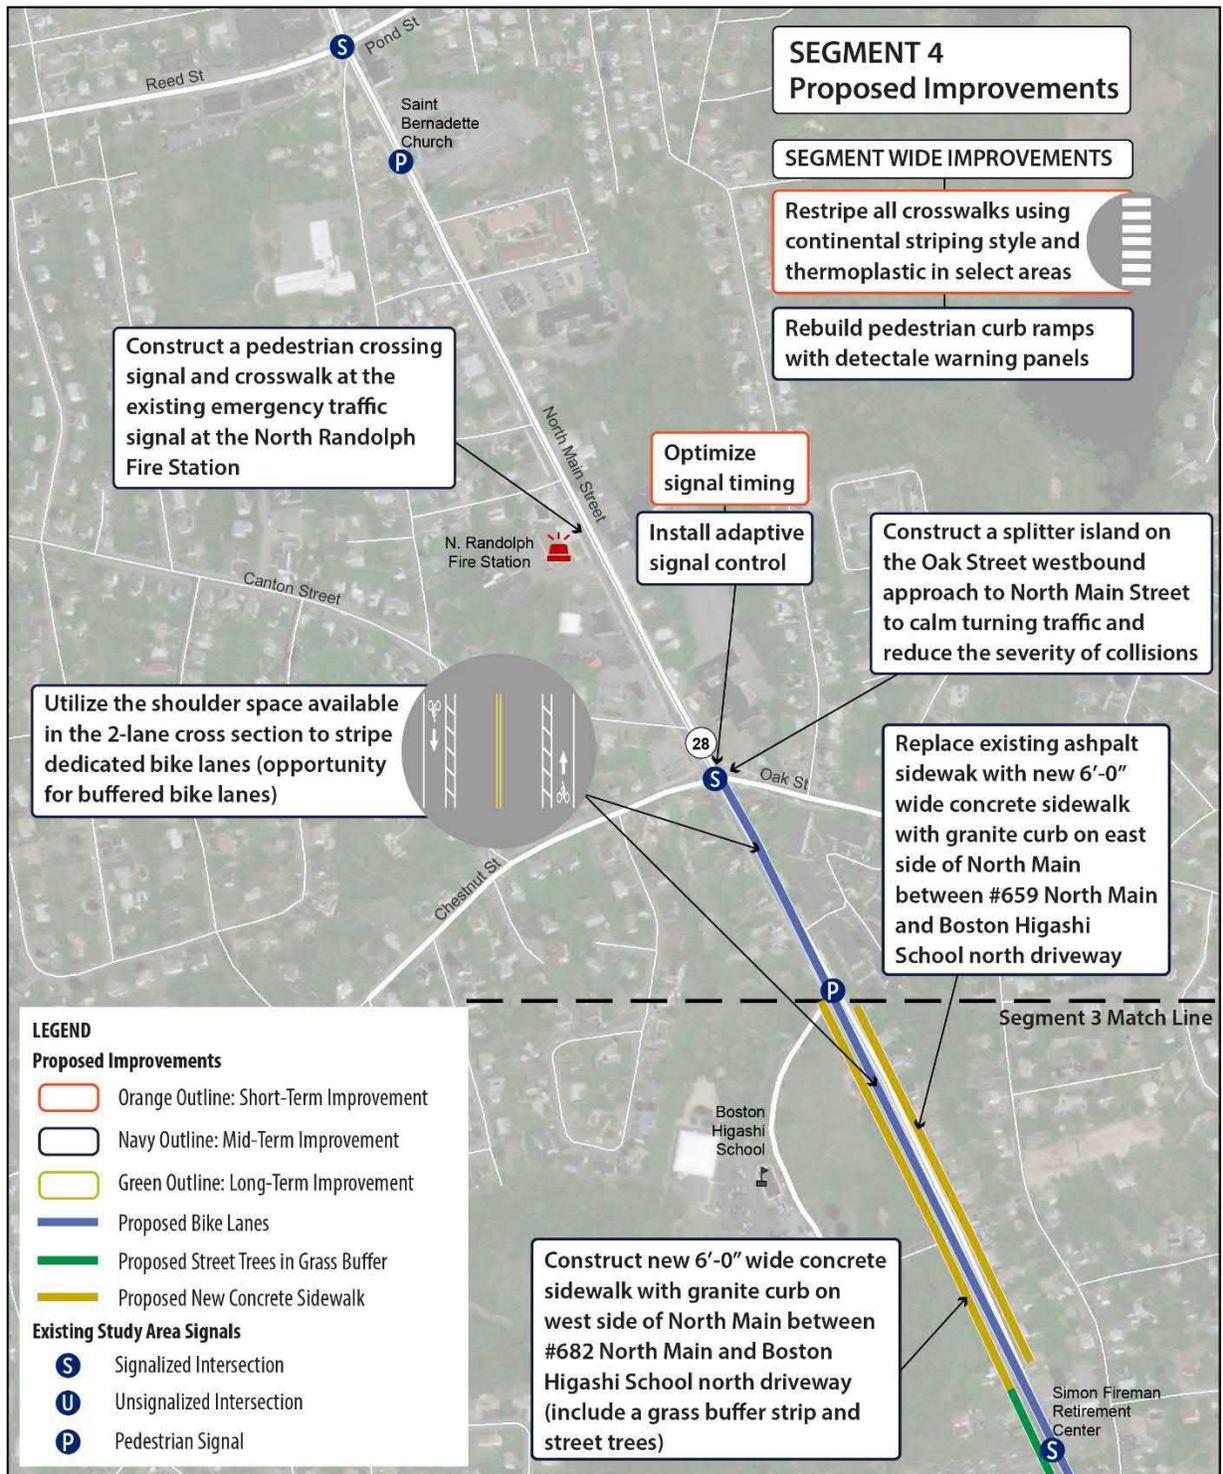
Figure 20 - Proposed Improvements Inset Map 5 (Segment 3 & 4)

Inset 5: North Main Street - Reed Street to Simon Fireman

- Install detectable warning panels at pedestrian curb ramps
- Replace the deteriorated sidewalk on the east side of North Main Street between Oliver Street and Wordsworth Street

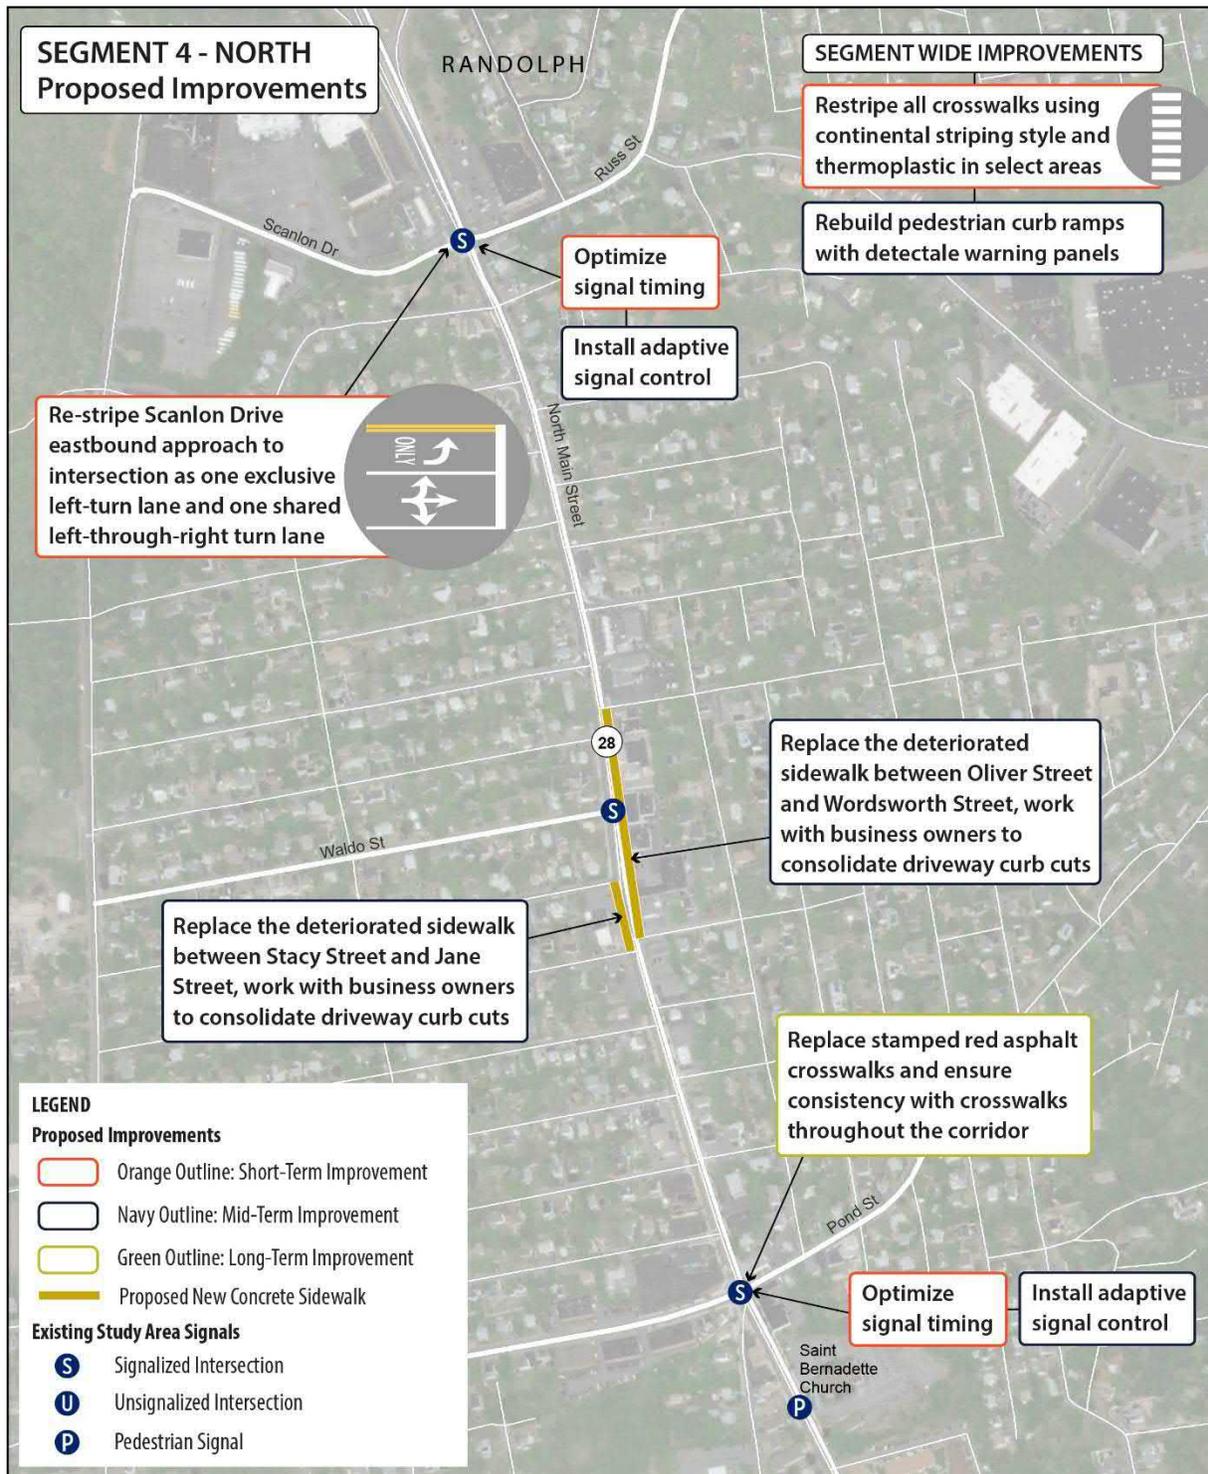
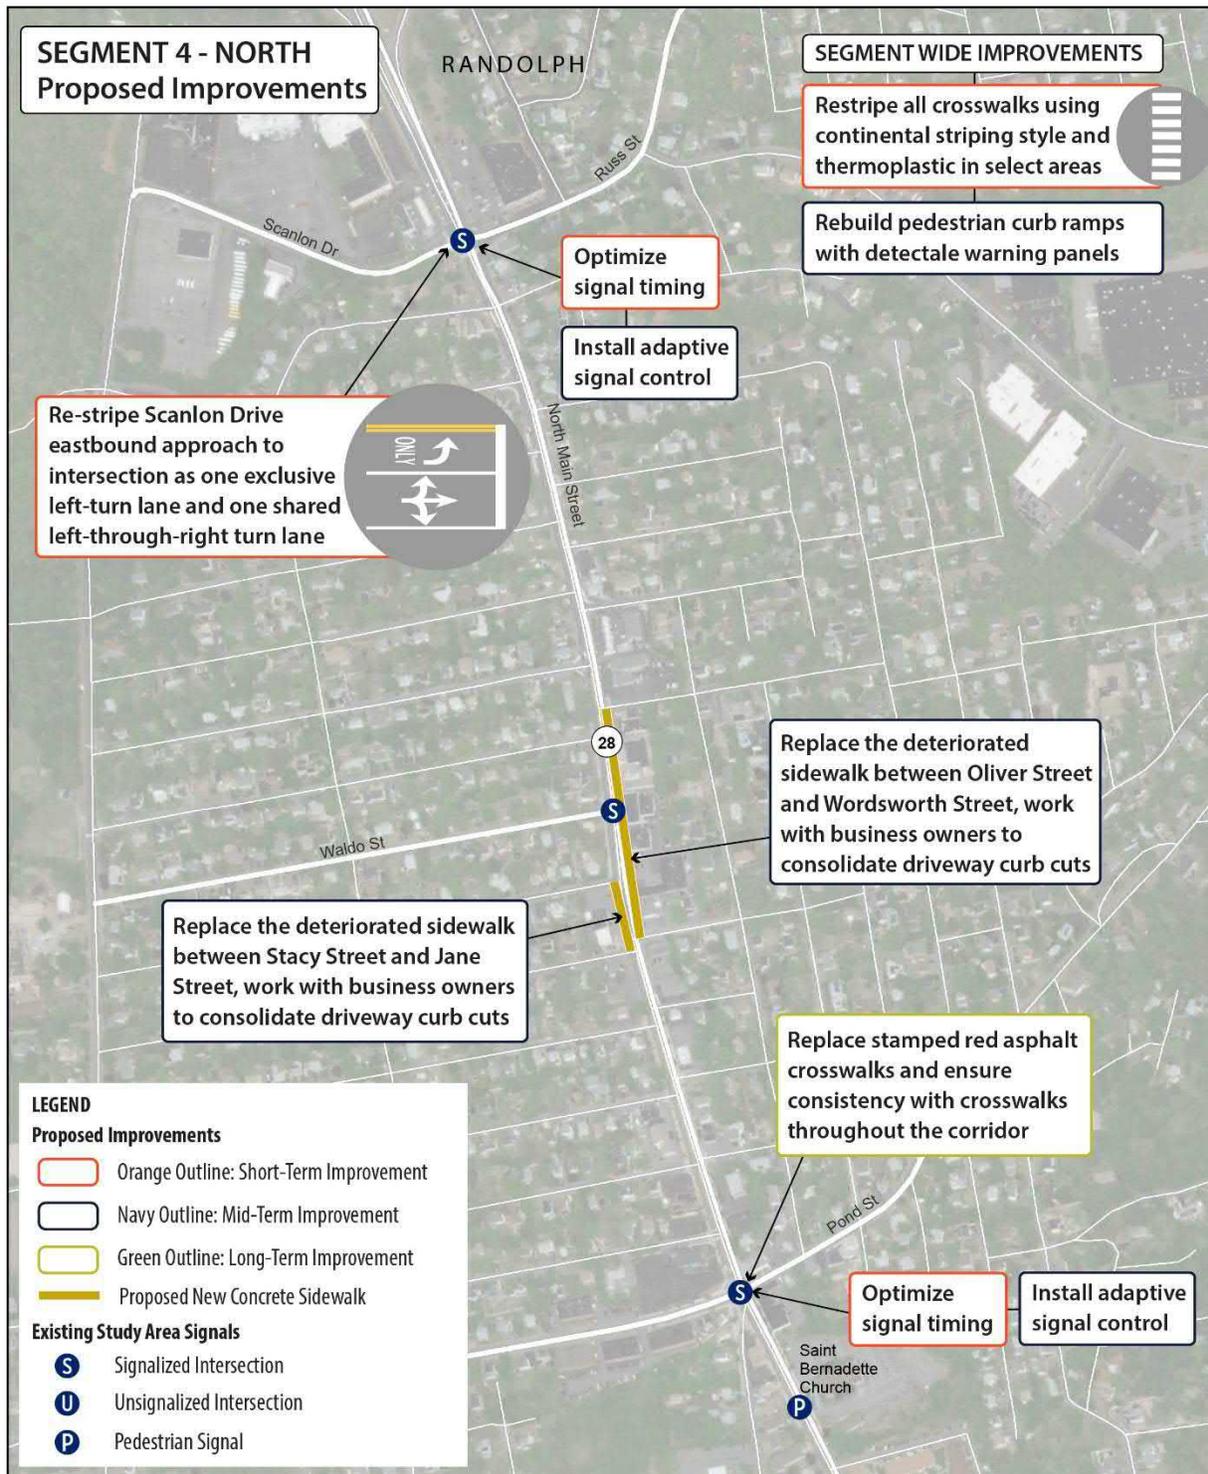
Figure 21 - Proposed Improvements Inset Map 6 (Segment 4-North)

- Replace the stamped red asphalt pavement crosswalks at North Main Street at Reed Street and Pond Street with continental striping

Inset 6: North Main Street - Scanlon Drive to Reed Street
