Town of Randolph, Massachusetts

PART A – Executive Summary

February 2023

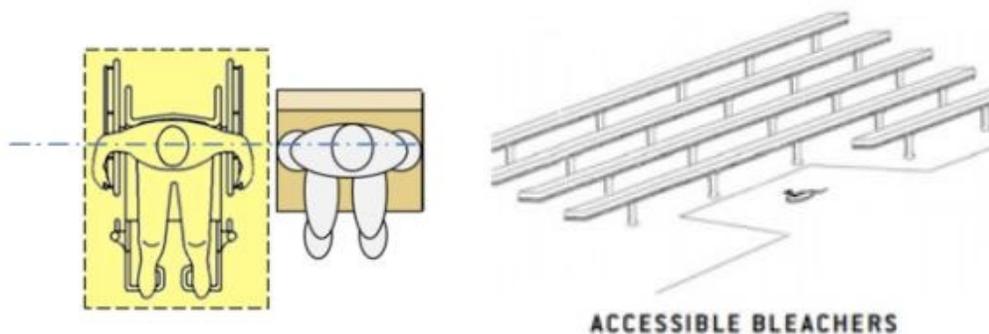
- Ensure an accessible route is provided on to the Zapustas ice rink and to rink amenities including locker rooms, shower rooms, the penalty box and team seating. Also ensure the provision of accessible locker, toilet and shower facilities for those using the rink and the provision of accessible toilet facilities for spectators.
- Ensure there is an accessible route to all elements in the parks/outdoor spaces (baseball fields, basketball courts, playgrounds, picnic areas, toilet facilities, etc.).
- Ensure there is a stable and firm clear floor space adjacent to the bench at team seating areas and spectator seating areas at the baseball fields, softball fields, soccer fields, basketball courts, etc., and that there is an accessible route to the seating. See the following diagrams:
