**Town of Randolph
North Randolph Fire Station**

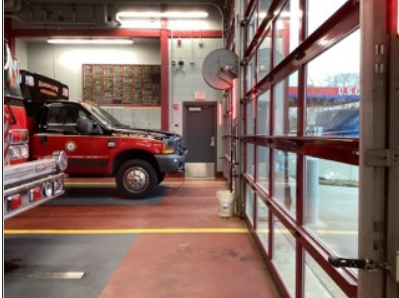
ID	Location	Floor	Room	Element	Type	Photo	Issues	Current Measure	Recommendations	Quantity	Price	Cost Estimation
Approach and Entrance												
Emergency Exit												
1	East Accessible Egress in Apparatus Room	1		Emergency Exit	N/A

Tactile sign not provided at exit Illuminated Int. Symbol of Acc. not provided (MAAB 2006)	- -	Provide tactile exit signs with raised characters and braille at exit doors. Mount signs between 48"- 60" above the finished floor located on the latch side of the door. Provide an illuminated sign with the International Symbol of Accessibility (ISA).	1	432	\$432
2	West Accessible Egress in Laundry Room Next to Apparatus Room	1		Emergency Exit	N/A

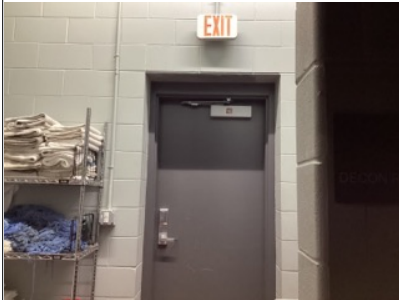
Tactile sign not provided at exit Illuminated Int. Symbol of Acc. not provided (MAAB 2006)	- -	Provide tactile exit signs with raised characters and braille at exit doors. Mount signs between 48"- 60" above the finished floor located on the latch side of the door. Provide an illuminated sign with the International Symbol of Accessibility (ISA).	1	432	\$432

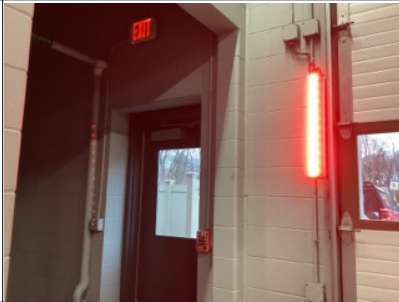
3	West Accessible Egress Next to Apparatus Room	1		Emergency Exit	N/A

Tactile sign not provided at exit Illuminated Int. Symbol of Acc. not provided (MAAB 2006)	- -	Provide tactile exit signs with raised characters and braille at exit doors. Mount signs between 48"- 60" above the finished floor located on the latch side of the door. Provide an illuminated sign with the International Symbol of Accessibility (ISA).	1	432	\$432
Toilet & Bathing Rooms												
Lavatory												
4	Single-User Toilet Room By Main Entrance	1		Lavatory	N/A

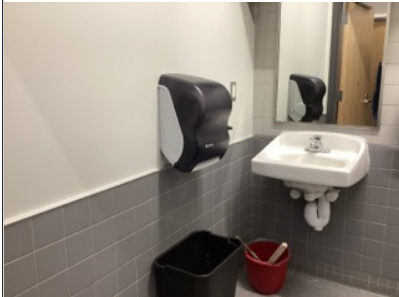
Clear floor space not provided at lavatory	-	Provide at least one lavatory with a 30" min. by 48" min. clear floor space positioned for a forward approach. (Relocate bucket.)	1	Labor	\$0
