**Town of Randolph
Friendly Food Pantry**

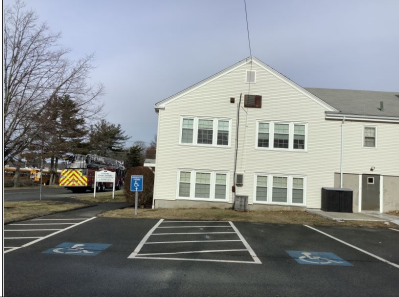
Total # of parking Total # of designated accessible parking spaces Total # of designated van accessible spaces Sign not provided Sign does not have the designation "Van Accessible" Sign bottom < 60" above finished grade	9 1 1 - - -	Ensure the sign at the car accessible space is located with the bottom of the sign 60" min. above the ground and the top 96" max. above the ground. At the van accessible space, include a sign with the International Symbol of Accessibility (ISA), and add the designation "Van Accessible".	1	-	\$0
Entrance												
2	Main Entrance, West Egress Door	Ext.		Entrance	Main Entrance

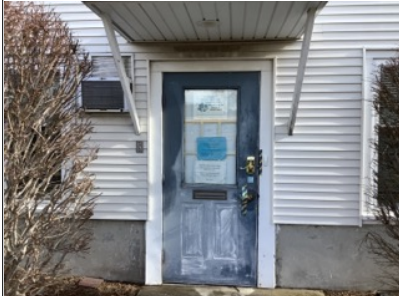
Closing speed not compliant	-	Adjust door closer so that from an open position of 90 degrees, the time required to move the door to a position of 12 degrees from the latch is 5 seconds min.	1	-	\$0

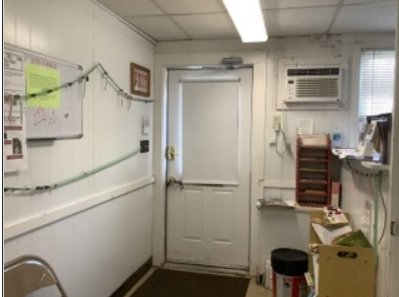
Tactile exit sign not provided Illuminated ISA symbol not provided (MAAB)	- -	Ensure tactile exit signs with raised characters and braille are provided at exit doors. Mount signs between 48" - 60" above the finished floor located on the latch side of the door. If the exit sign is replaced with an illuminated exit sign, provide an illuminated International Symbol of Accessibility (ISA).	1	432	\$432
Doors, Doorways, & Gates												
4	Main Entrance, West Egress Door	1		Doors, Doorways, & Gates	Emergency Egress

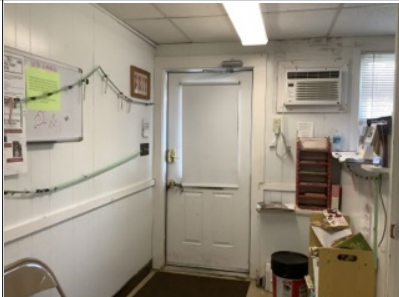
Maneuvering clearance(s) not provided	6.5"	Reverse the swing of the door and relocate the shelf to provide maneuvering clearance.	1	1884	\$1884
