**Town of Randolph  
Town Hall**

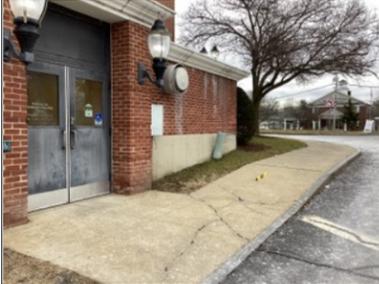
ID	Location	Floor	Room	Element	Type	Photo	Issues	Current Measure	Recommendations	Quantity	Price	Cost Estimation
<b>Approach and Entrance</b>												
<b>Exterior Access Route</b>												
1	Approaching Main Entrance	Ext.		Exterior Access Route	Sidewalk

Cross slope > 1:50 (2.00%) Running slope > 1:20 (5.00%)	4.3% 9.5%	Reduce cross slope to be no steeper than 1:50 (2.00%). Reduce running slope to be no steeper than 1:20 (5.00%).	1	-	\$0
2	Town Hall Elevator Entrance	Ext.		Exterior Access Route	109

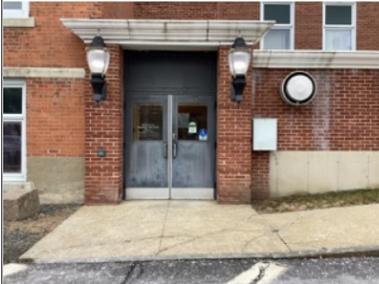
Route not maintained in operable working condition	-	Ensure the accessible route is maintained in operable working condition.	1	-	\$0
<b>Off-Street Parking Lot or Garage</b>												
3	Parking-By Town Hall Elevator	Ext.		Off-Street Parking Lot or Garage	Visitor

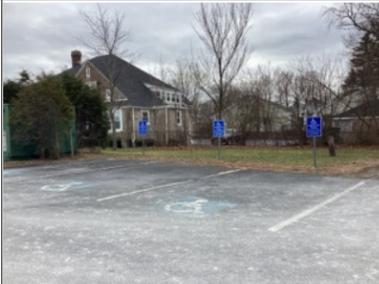
Total # of designated accessible parking spaces Total # of designated van accessible spaces Access aisle not provided Sign does not have the designation "Van Accessible" Sign bottom < 60" above finished grade	2 1 - - 39"	Provide a van accessible parking space and marked access aisle that are both at least 96" wide, and provide a car space access aisle that is at least 60" wide. (Re-stripe). Add the designation "Van Accessible" to the sign located at the van accessible space. Locate sign with the bottom of the sign 60" min. and the top of the sign 96" max. above the ground.	1	-	\$0

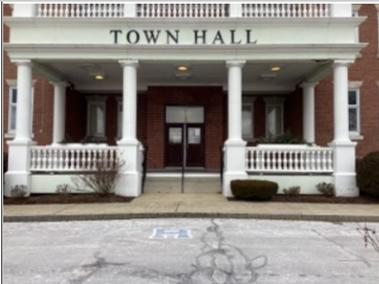
<b>Entrance</b>												
4	Main Entrance	Ext.		Entrance	Main Entrance

Directional sign to accessible entrance not provided	-	Provide a directional sign indicating the location of the nearest accessible entrance.	1	-	\$0

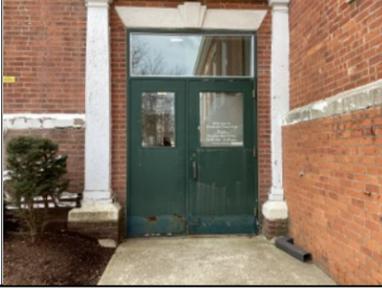
ID	Location	Floor	Room	Element	Type	Photo	Issues	Current Measure	Recommendations	Quantity	Price	Cost Estimation
5	Town Hall Entrance - North Side	Ext.		Entrance	Secondary Entrance

Directional sign to accessible entrance not provided	-	Provide a directional sign indicating the location of the nearest accessible entrance.	1	-	\$0
<b>Access to Goods and Services</b>												
<b>Means of Egress</b>												
6	South Stairwell	2		Means of Egress	N/A

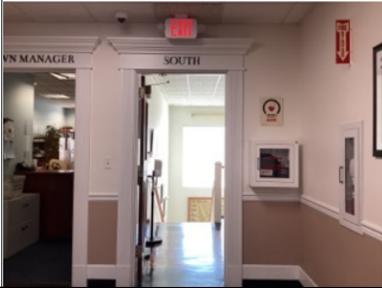
Tactile exit sign not provided	-	Ensure tactile exit signs with raised characters and braille are provided at exit doors. Mount signs between 48"- 60" above the finished floor located on the latch side of the door.	1	232	\$232
7	North Stairwell	2		Means of Egress	N/A

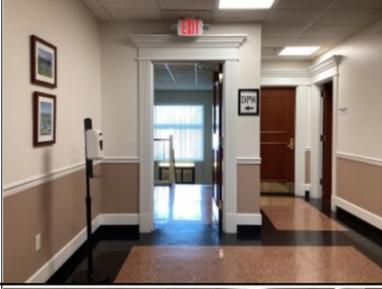
Tactile exit sign not provided	-	Ensure tactile exit signs with raised characters and braille are provided at exit doors. Mount signs between 48"- 60" above the finished floor located on the latch side of the door.	1	232	\$232

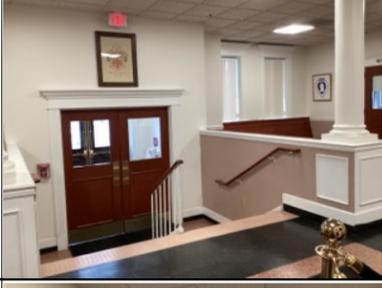
8	Main Egress to Stairs	1		Means of Egress	N/A

Tactile exit sign not provided Directional sign to accessible emergency exit not provided	- -	Ensure tactile exit signs with raised characters and braille are provided at exit doors. Mount signs between 48"- 60" above the finished floor located on the latch side of the door. Provide a directional sign indicating the location of the nearest accessible emergency exit.	1	232	\$232
9	South Exit to Tax Collector	1		Means of Egress	N/A

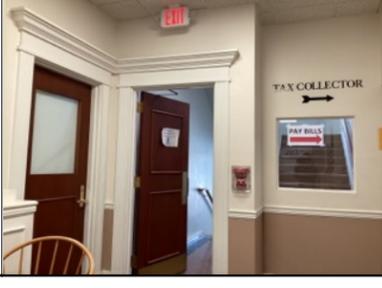
Tactile exit sign not provided Directional sign to accessible emergency exit not provided	- -	Ensure tactile exit signs with raised characters and braille are provided at exit doors. Mount signs between 48"- 60" above the finished floor located on the latch side of the door. Provide a directional sign indicating the location of the nearest accessible emergency exit.	1	432	\$432

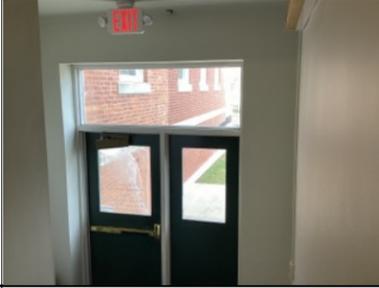
ID	Location	Floor	Room	Element	Type	Photo	Issues	Current Measure	Recommendations	Quantity	Price	Cost Estimation
10	Town Hall Exit -North Side	G		Means of Egress	N/A

Tactile exit sign not provided Directional sign to accessible emergency exit not provided	- -	Ensure tactile exit signs with raised characters and braille are provided at exit doors. Mount signs between 48"- 60" above the finished floor located on the latch side of the door. Provide a directional sign indicating the location of the nearest accessible emergency exit.	1	432	\$432
11	Town Hall Accessible Exit Near Stairs	G		Means of Egress	N/A

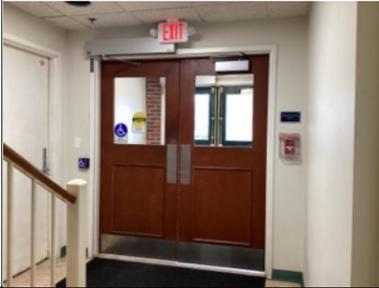
Illuminated ISA symbol not provided (MAAB)	-	Provide an illuminated sign with the International Symbol of Accessibility (ISA).	1	200	\$200
12	Exit by Police Station	Ground floor		Means of Egress	N/A

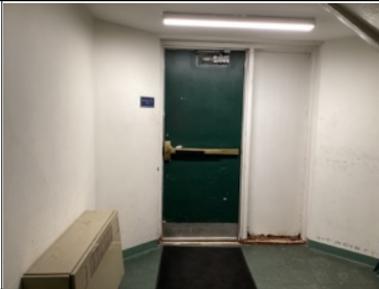
Directional sign to accessible emergency exit not provided	-	Provide a directional sign indicating the location of the nearest accessible emergency exit.	1	232	\$232

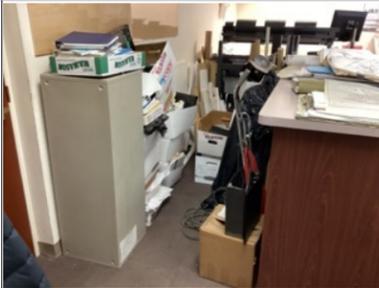
Route < 36" wide	19"	Ensure that a clear width of 36" min. is maintained at the accessible route.	1	Labor	\$0
14	Lobby	1		Interior Access Route	N/A

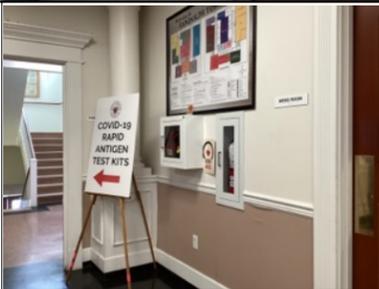
Obstructed by protruding objects	43"	Provide a cane-detectable barrier.	1	306	\$306

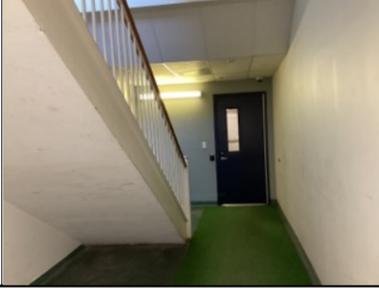
ID	Location	Floor	Room	Element	Type	Photo	Issues	Current Measure	Recommendations	Quantity	Price	Cost Estimation
15	Ground Floor Exit by Police	Ground floor		Interior Access Route	N/A

Obstructed by protruding objects Vertical clearance < 80" above finished floor	- -	Provide a cane-detectable barrier underneath stair.	1	960	\$960
<b>Doors, Doorways, &amp; Gates</b>												
16	Near Town Manager/HR	2		Doors, Doorways, & Gates	Circulation

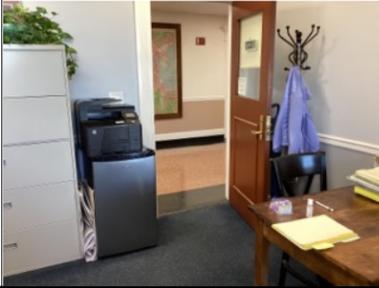
Maneuvering clearance(s) not provided	-	Relocate items to maintain the required 18" min. clear floor space on the pull side of the door.	1	Labor	\$0
17	Engineering Department	2		Doors, Doorways, & Gates	Circulation

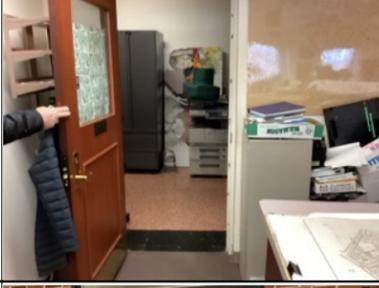
Maneuvering clearance(s) not provided	2"	Relocate items to maintain the required 18" min. clear floor space on the pull side of the door.	1	Labor	\$0
18	Main Entrance	Ext.		Doors, Doorways, & Gates	Other

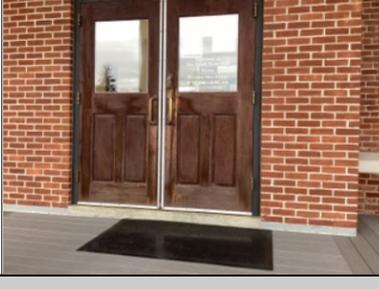
Threshold > 1/2" high	4"	Alter the threshold to be 1/2" high max.	1	150	\$150

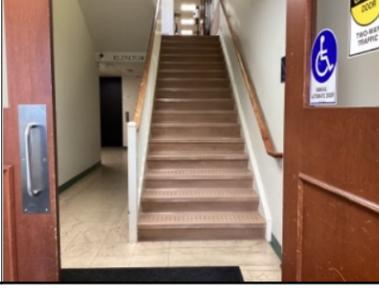
Handrails do not extend 12" from stairs	-	Bottom: Ensure handrails extend to one tread depth beyond the last riser.	1	-	\$0

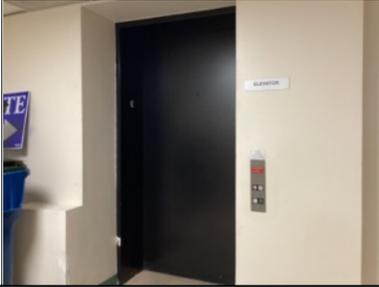
Tactile stars not provided at main entry level	-	Provide a tactile star on both sides of jambs at main floor. At other floors, provide appropriate number. Provide a tactile star at the main floor on the control panel within the car.	1	96	\$96
<b>Signage</b>												
21	Near Town Manager/HR	2		Signage	Designation

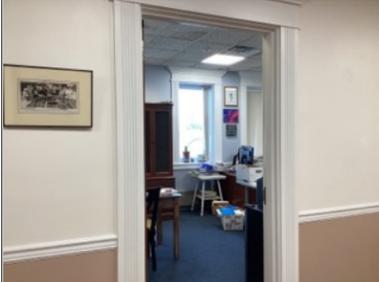
Signage is not provided	-	Locate compliant signage alongside the door on the latch side.	1	232	\$232
22	Main Egress to Stairs	1		Signage	Egress

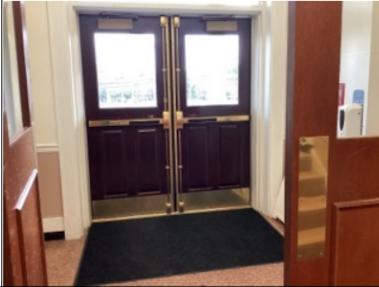
Raised characters not provided on sign Braille not provided on sign	- -	Provide text with raised characters duplicated in braille on sign.	1	232	\$232
23	Near Town Attorney	2		Signage	Informational

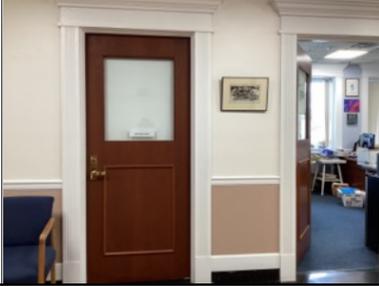
Raised characters not provided on sign Braille not provided on sign	- -	Provide text with raised characters duplicated in braille on sign.	1	232	\$232

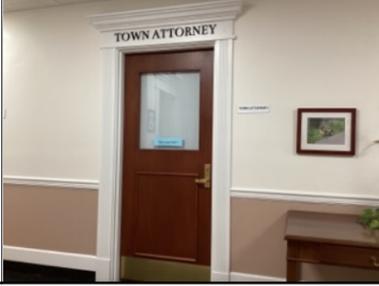
24	Town Attorney	2		Signage	Informational

Raised characters not provided on sign Braille not provided on sign		Provide text with raised characters duplicated in braille on sign.	1	232	\$232

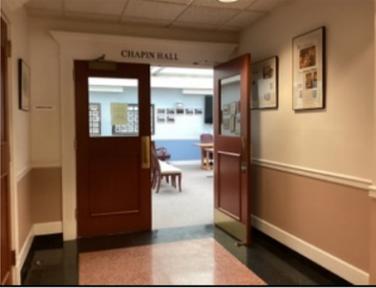
Raised characters not provided on sign Braille not provided on sign	- -	Provide text with raised characters duplicated in braille on sign.	1	232	\$232
26	Near Town Manager	2		Signage	Informational

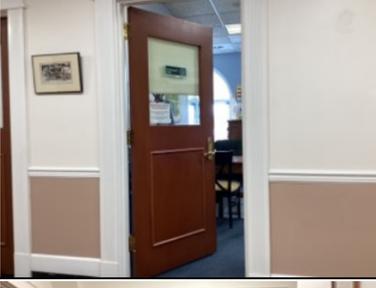
Raised characters not provided on sign Braille not provided on sign Sign not located on the latch side of the door	- - -	Provide text with raised characters duplicated in braille on sign. Mount signs so that the baseline of the lowest tactile character is 48" min. above finished floor and the baseline of the highest tactile character is 60" max. above the finished floor. Locate the sign at permanent rooms alongside the door on the latch side.	1	232	\$232
27	Engineering Department	2		Signage	Designation

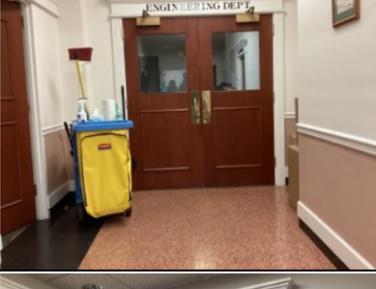
Raised characters not provided on sign Braille not provided on sign Sign not located on the latch side of the door		Provide text with raised characters duplicated in braille on sign. Locate the sign at permanent rooms alongside the door on the latch side.	1	232	\$232

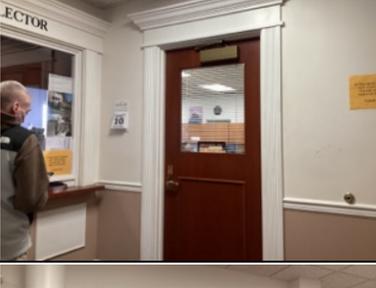
28	South-Tax Collector	1		Signage	Designation

Sign not located on the latch side of the door	-	Locate the sign at permanent rooms alongside the door on the latch side.	1	Labor	\$0
29	Lincoln Room	1		Signage	Designation

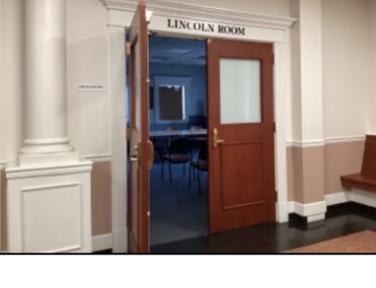
Signage lacks 18" by 18" clear floor space	-	Locate designation sign on the right side of the double door.	1	Labor	\$0

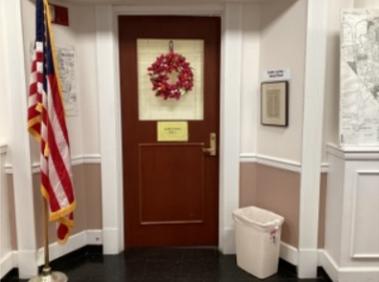
Signage lacks 18" by 18" clear floor space		Relocate trash receptacle to provide a clear floor space of 18" min. by 18" min.	1	Labor	\$0
31	South Stairwell	2		Signage	Designation

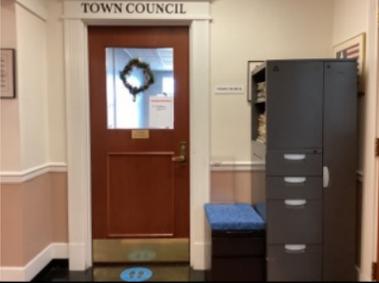
Signage lacks 18" by 18" clear floor space	-	Relocate trash bin to maintain the required 18" min. by 18" min. clear floor space at the designation sign.	1	Labor	\$0
33	Engineering	2		Signage	Designation

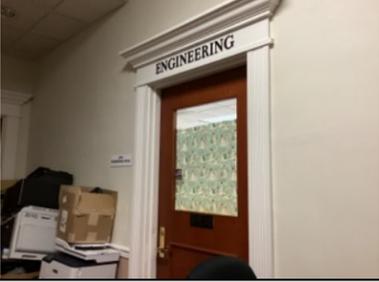
Signage lacks 18" by 18" clear floor space	-	Relocate stored items to provide a clear floor space of 18" min. by 18" min.	1	Labor	\$0
<b>Service Counter</b>												
34	Health Department	1		Service Counter	N/A

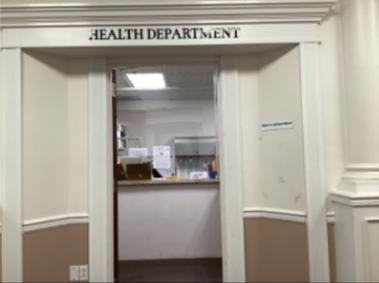
Counter > 36" high	42"	Provide a counter that is 36" max. above the ground or finished floor.	1	880	\$880

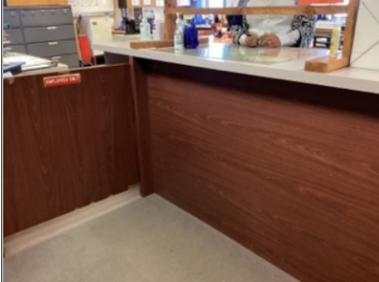
Counter > 36" high	40"	Provide a counter that is 36" max. above the ground or finished floor.	1	880	\$880
36	Town Council	2		Service Counter	N/A

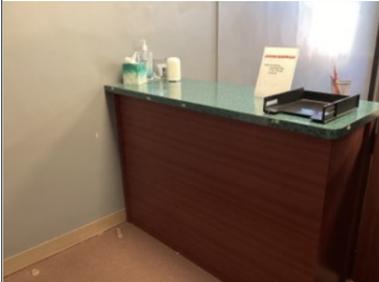
Counter > 36" high	40"	Provide a counter that is 36" max. above the ground or finished floor.	1	880	\$880
<b>Dining or Work Surfaces</b>												
37	Engineering	2		Dining or Work Surfaces	Work Surface

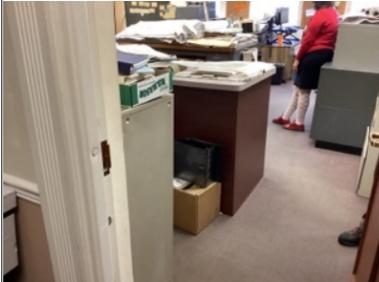
Knee or toe clearance not provided Top of dining/work surface < 28" or > 34"	- 40"	Provide at least one work surface with 27" min. knee and toe clearance.	1	700	\$700
<b>Assembly Area</b>												
38	Lincoln Room	1		Assembly Area	N/A

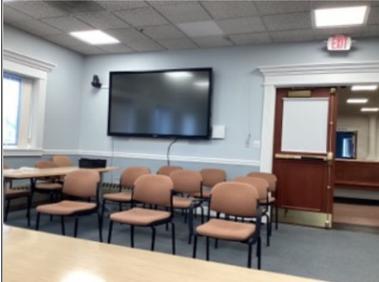
Assistive listening devices not provided	-	If audible communication is integral to the use of the space, provide an assistive listening system.	1	1214	\$1214

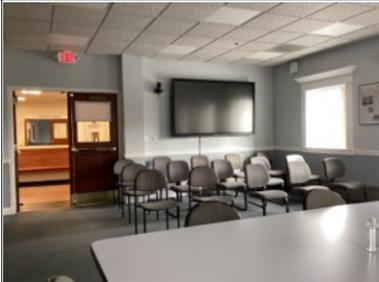
39	Washington Room	1		Assembly Area	N/A

Assistive listening devices not provided	-	If audible communication is integral to the use of the space, provide an assistive listening system.	1	1214	\$1214

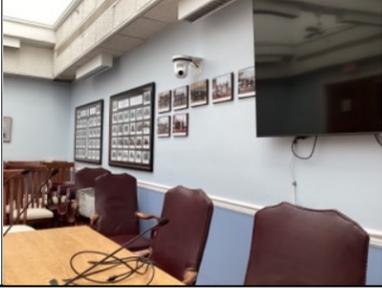
Assistive listening devices not provided	-	If audible communication is integral to the use of the space, provide an assistive listening system.	1	1214	\$1214
<b>Toilet &amp; Bathing Rooms</b>												
<b>Overall Access</b>												
41	Ladies/ Womens	1		Overall Access	Toilet Room

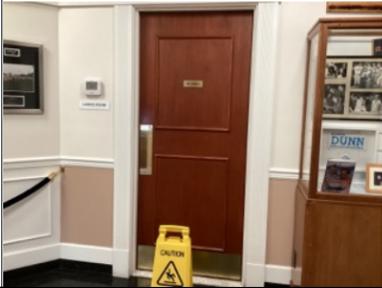
International Symbol of Acc. not provided	-	Provide a sign with the International Symbol of Accessibility (ISA).	1	232	\$232
42	Men's Toilet Room - Lobby	1		Overall Access	Toilet Room

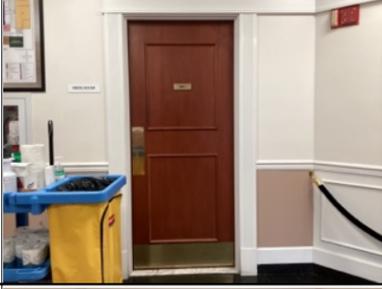
International Symbol of Acc. not provided	-	Provide a sign with the International Symbol of Accessibility (ISA).	1	232	\$232
43	Men's Toilet Room	2		Overall Access	Toilet Room

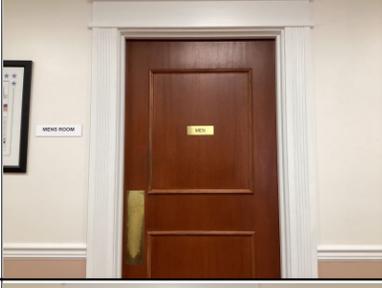
International Symbol of Acc. not provided	-	Provide a sign with the International Symbol of Accessibility (ISA).	1	232	\$232

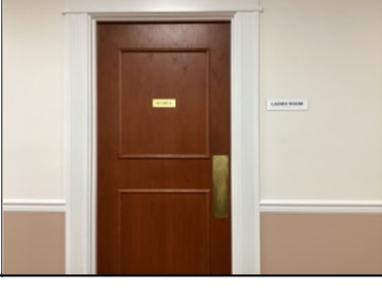
44	Women's Toilet Room	2		Overall Access	Toilet Room

International Symbol of Acc. not provided	-	Provide a sign with the International Symbol of Accessibility (ISA).	1	232	\$232

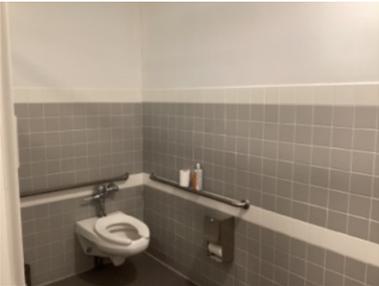
Side or rear grab bar < 33" or >36" high	30"	Locate grab bars between 33"- 36" above the finished floor.	1	396	\$396
46	Men's Toilet Room - Lobby	1		Toilet Compartment	Accessible Compartment

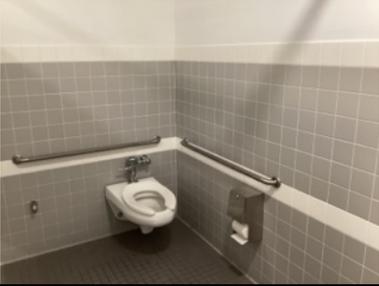
Side or rear grab bar < 33" or >36" high	30"	Locate grab bars between 33"- 36" above the finished floor.	1	396	\$396
47	Men's Toilet Room	2		Toilet Compartment	Accessible Compartment

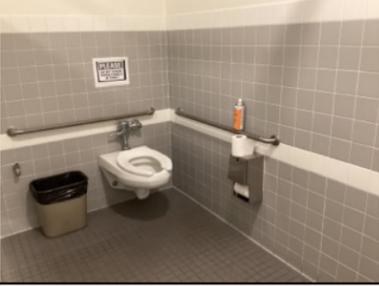
Side or rear grab bar < 33" or >36" high	30"	Locate grab bars between 33"- 36" above the finished floor.	1	396	\$396
48	Women's Toilet Room	2		Toilet Compartment	Accessible Compartment

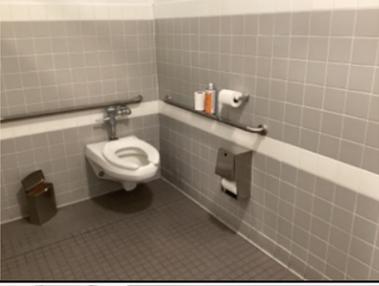
Side or rear grab bar < 33" or >36" high	30"	Locate grab bars between 33"- 36" above the finished floor.	1	396	\$396

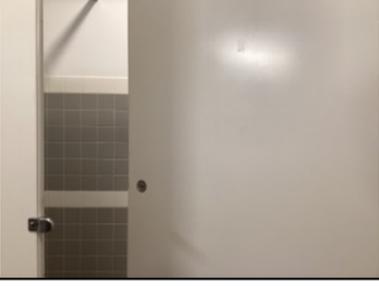
49	Men's and Women's Toilet Room - Lobby	1		Toilet Compartment	Accessible Compartment

Door pull not provided	-	Provide a door pull on each side of the door between 34" to 48" above the finished floor that does not require tight grasping, pinching or twisting of the wrist.	2	70	\$140

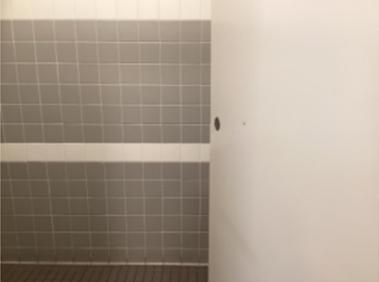
Door pull not provided	-	Provide a door pull on each side of the door between 34" to 48" above the finished floor that does not require tight grasping, pinching or twisting of the wrist.	1	70	\$70
51	Women's Toilet Room	2		Toilet Compartment	Ambulatory Compartment

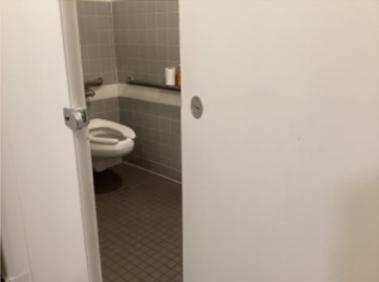
Door pull not provided	-	Provide a door pull on each side of the door between 34" to 48" above the finished floor that does not require tight grasping, pinching or twisting of the wrist.	1	70	\$70
<b>Best Practice</b>												
<b>Chair</b>												
52	Women's Toilet Room	2		Chair	N/A

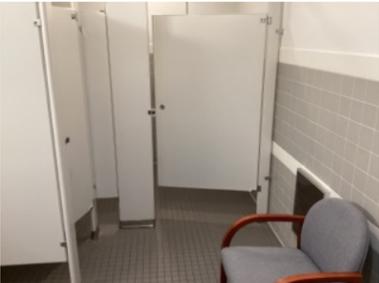
Recommend ensuring that the location of the chair is maintained in a position that does not interfere with the maneuvering clearance at the toilet room exit door or with the accessible route to the toilet compartments.	1	-	\$0

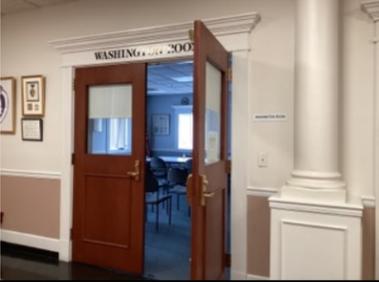
Recommend, if both doors are active, if a leaf is held open, make the other leaf the open door in order to provide a clear floor space of 18" min. by 18" min. at the sign located on the wall.	1	-	\$0
54	Chapin Hall	2		Designation Sign	N/A

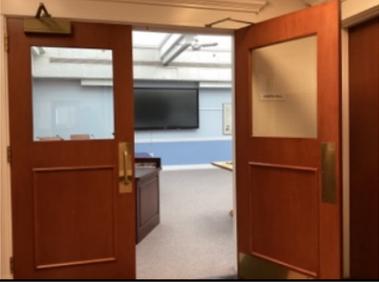
Recommend, if both doors are active, if a leaf is held open, make the other leaf the open door in order to provide a clear floor space of 18" min. by 18" min. at the sign located on the wall.	1	-	\$0
