**Town of Randolph
Turner Free Library**

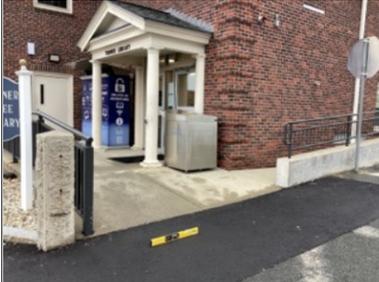
ID	Location	Floor	Room	Element	Type	Photo	Issues	Current Measure	Recommendations	Quantity	Price	Cost Estimation
Approach and Entrance												
Exterior Access Route												
1	Main Entrance	Ext.		Exterior Access Route	Exterior

Cross slope > 1:50 (2.00%)	5.6%	Reduce cross slope to be no steeper than 1:50 (2.00%).	1	-	\$0
2	Near North Main Entrance	Ext.		Exterior Access Route	Sidewalk

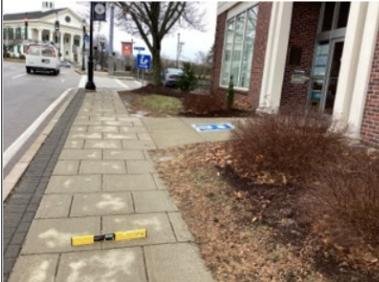
Cross slope > 1:50 (2.00%)	3.6%	Reduce cross slope to be no steeper than 1:50 (2.00%).	1	-	\$0
3	Northwest Side Bike Rack	Ext.		Exterior Access Route	Exterior

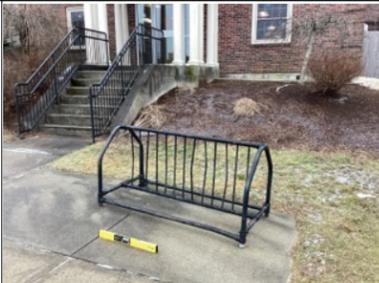
Cross slope > 1:50 (2.00%)	4.0%	Reduce cross slope to be no steeper than 1:50 (2.00%).	1	-	\$0
4	Near Memorial Street Ramp to Main Entrance	Ext.		Exterior Access Route	71

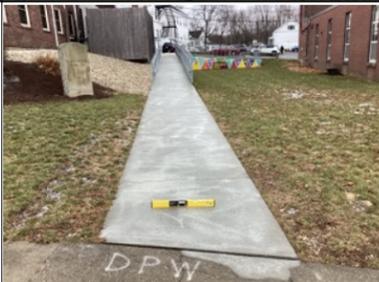
Cross slope > 1:50 (2.00%)	5%	Reduce cross slope to be no steeper than 1:50 (2.00%).	1	-	\$0
5	North Main Street Entrance	Ext.		Exterior Access Route

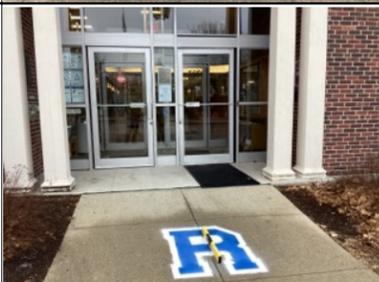
Cross slope > 1:50 (2.00%) Running slope > 1:20 (5.00%)	3.4% 9.6%	Reduce cross slope to be no steeper than 1:50 (2.00%). Reduce running slope to be no steeper than 1:20 (5.00%).	1	-	\$0

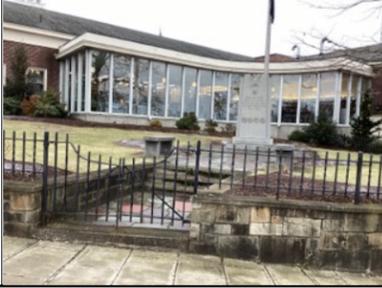
ID	Location	Floor	Room	Element	Type	Photo	Issues	Current Measure	Recommendations	Quantity	Price	Cost Estimation
6	War Memorial	Ext.		Exterior Access Route	Exterior

Accessible route not provided	-	Ensure an accessible route is provided.	1	-	\$0
Off-Street Parking Lot or Garage												
7	Parking Lot	Ext		Off-Street Parking Lot or Garage	Visitor

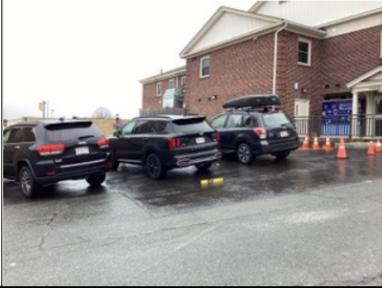
Total # of designated accessible parking spaces Total # of designated van accessible spaces Running or cross slope at space > 1:50 (2.00%)	0 0 9.6% - -	Provide a van accessible parking space that is 96" wide min. with an access aisle that is 96" wide min. Provide identification signage with the International Symbol of Accessibility (ISA) and the designation "Van Accessible". Ensure the bottom of the sign is 60" min. above the ground and the top 96" max. above the ground. Reduce running or cross slope to be no steeper than 1:50 (2.00%) in all directions.	1	-	\$0

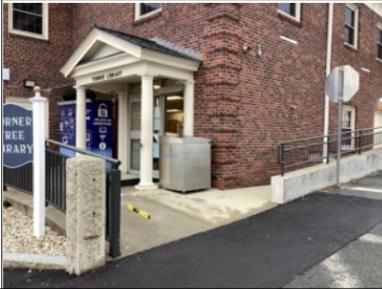
Exterior Ramp												
8	Main Entrance	Ext.		Exterior Ramp	N/A

Running slope > 1:12 (8.33%) Handrails not provided at both sides if rise is > 6"	11% -	Reduce running slope to be no steeper than 1:12 (8.33%). Provide handrails on both sides.	1	-	\$0
9	Memorial Street Ramp to Main Entrance	Ext.		Exterior Ramp	N/A

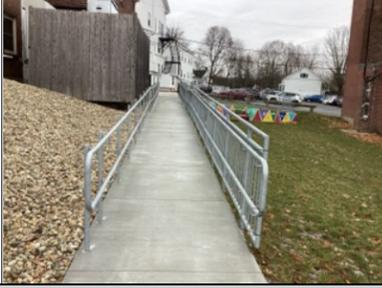
Edge protection < 4" high	-	Provide edge protection that prevents the passage of a 4" diameter sphere, where any portion of the sphere is within 4" of the finished floor or ground surface.	1	-	\$0
Exterior Stair												
10	War Memorial	Ext.		Exterior Stair	N/A

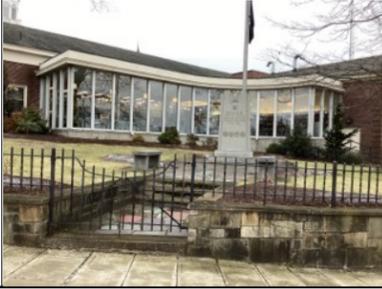
Handrail not provided on both sides	-	Provide a handrail on one side.	1	-	\$0

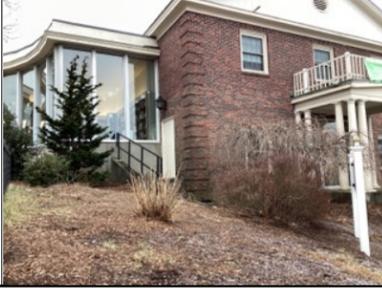
ID	Location	Floor	Room	Element	Type	Photo	Issues	Current Measure	Recommendations	Quantity	Price	Cost Estimation
11	Northwest Side Egress Near Memorial Parkway	Ext.		Exterior Stair	N/A

Handrail not provided on both sides	-	Provide a handrail on one side.	1	-	\$0
Entrance												
12	Northwest Side Bike Rack	Ext.		Entrance	Secondary Entrance

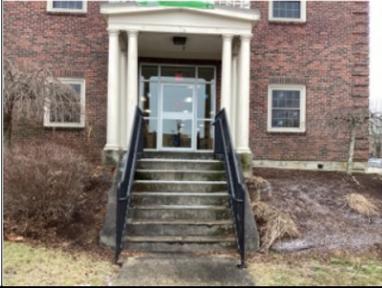
Directional sign to accessible entrance not provided	-	Provide a directional sign indicating the location of the nearest accessible entrance.	1	346	\$346
13	Main Entrance	Ext.		Entrance	Main Entrance

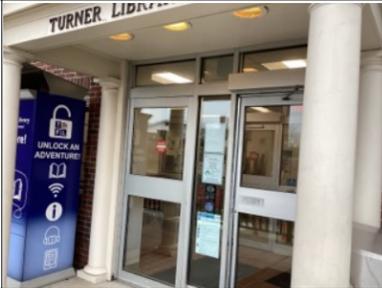
International Symbol of Accessibility not provided	-	Provide a sign with the International Symbol of Accessibility (ISA).	1	-	\$0
14	North Main Street Entrance	Ext.		Entrance	Secondary Entrance

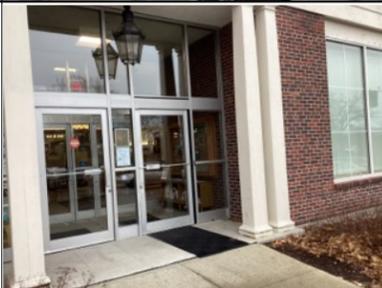
International Symbol of Accessibility not provided	-	Provide a sign with the International Symbol of Accessibility (ISA).	1	-	\$0
Access to Goods and Services

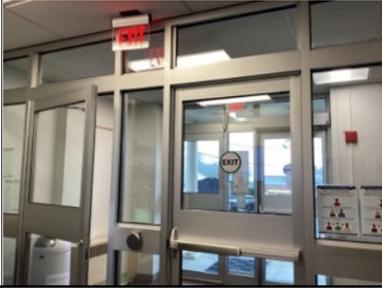
Means of Egress												
15	Main Entrance/Exit	1		Means of Egress	N/A

Tactile exit sign not provided Illuminated ISA symbol not provided (MAAB)	- -	Ensure tactile exit signs with raised characters and braille are provided at exit doors. Mount signs between 48"- 60" above the finished floor located on the latch side of the door. When the exit sign is replaced with a new illuminated exit sign, provide an illuminated International Symbol of Accessibility (ISA).	1	432	\$432

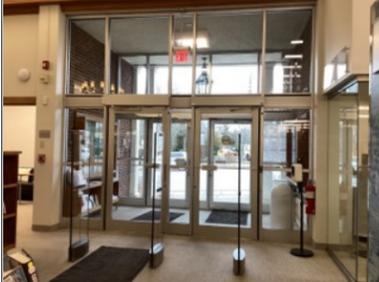
ID	Location	Floor	Room	Element	Type	Photo	Issues	Current Measure	Recommendations	Quantity	Price	Cost Estimation
16	North Main Street Egress	2		Means of Egress	N/A

Tactile exit sign not provided Illuminated ISA symbol not provided (MAAB)	- -	Ensure tactile exit signs with raised characters and braille are provided at exit doors. Mount signs between 48"- 60" above the finished floor located on the latch side of the door. When the exit sign is replaced with a new illuminated exit sign, provide an illuminated International Symbol of Accessibility (ISA).	1	432	\$432
17	Memorial Egress	1		Means of Egress	N/A

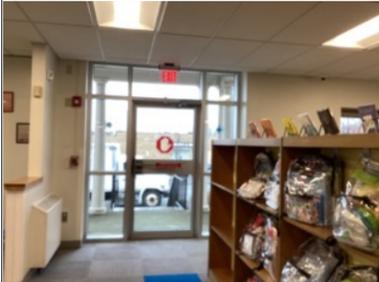
Tactile exit sign not provided Directional sign to accessible emergency exit not provided	- -	Ensure tactile exit signs with raised characters and braille are provided at exit doors. Mount signs between 48"- 60" above the finished floor located on the latch side of the door. Provide a directional sign indicating the location of the nearest accessible emergency exit.	1	464	\$464

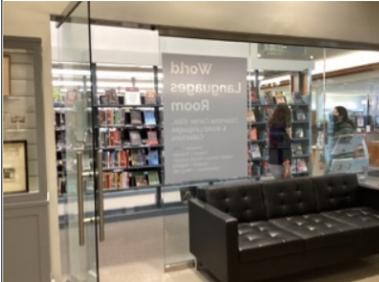
Doors, Doorways, & Gates												
18	World Languages Room	2		Doors, Doorways, & Gates	Other

Maneuvering clearance(s) not provided	9"	Relocate the sofa to provide 18" min. maneuvering clearance on the pull side of the door.	1	Labor	\$0
19	Women's Toilet Room	3		Doors, Doorways, & Gates	Toilet Room

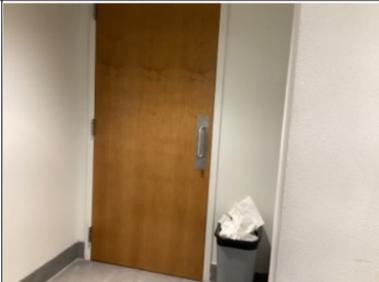
Maneuvering clearance(s) not provided	-	Relocate the trash can to provide 18" min. maneuvering clearance on the pull side of the door.	1	Labor	\$0
20	Women's and Men's Toilet Room	3		Doors, Doorways, & Gates	Toilet Room

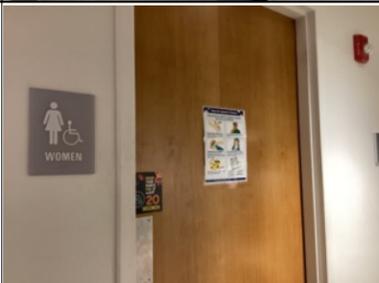
Door requires > 5 lbs. of force to open	16	Adjust closers so doors do not require more than 5 pounds of force to open.	2	Labor	\$0

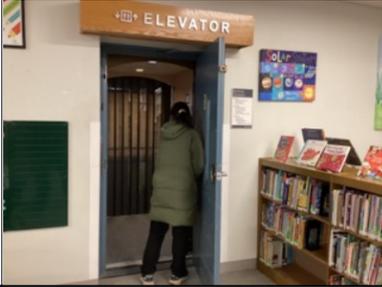
ID	Location	Floor	Room	Element	Type	Photo	Issues	Current Measure	Recommendations	Quantity	Price	Cost Estimation
Signage												
21	Limited Use Limited Application (LULA) Elevator	1		Signage	Informational

Raised characters not provided on sign Braille not provided on sign Sign not located on the latch side of the door	- - -	Provide text with raised characters duplicated in braille on sign. Locate the sign at permanent rooms alongside the door on the latch side.	1	232	\$232
22	Girls' and Boys' Toilet Rooms	1		Signage	Designation

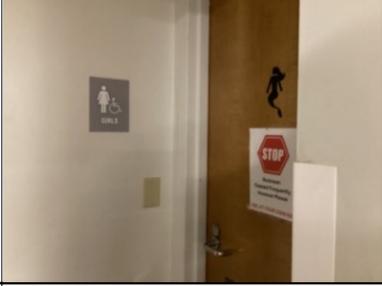
International Symbol of Accessibility (ISA) not correct for toilet rooms		Remove sign with International Symbol of Accessibility (ISA) at these boys' and girls' toilet rooms as they are not accessible.	1	-	\$0
23	Girls' and Boys' Toilet Rooms	1		Signage	Designation

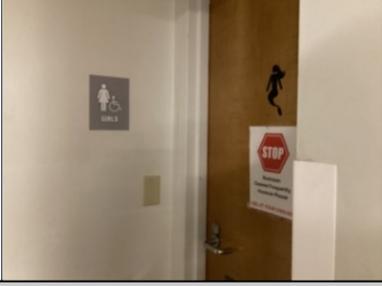
Directional sign to access toilet not provided International Symbol of Accessibility (ISA) not correct for toilet rooms	-	Install a sign indicating the location of the nearest accessible toilet room. (These toilet rooms have doors that are just 27" wide, and they lack the minimum required turning space and accessible plumbing fixtures.) Remove sign with International Symbol of Accessibility (ISA) at these boys' and girls' toilet rooms as they are not accessible.	2	232	\$464

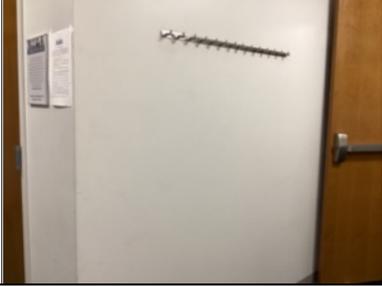
Operable Parts												
24	By Teen Room	3		Operable Parts	Clothes Rod/Hooks

Side reach > 54"	65"	Provide a coat hook 48" above the finished floor.	1	150	\$150
Assembly Area												
25	Shurtleff Room	3		Assembly Area	N/A

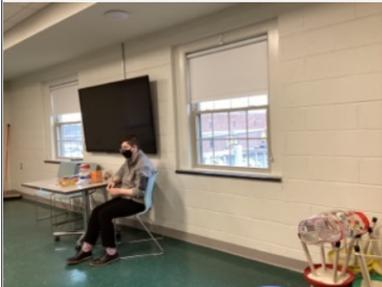
Assistive listening devices not provided	-	If audible communication is integral to the use of the space, provide an assistive listening system.	1	1214	\$1214

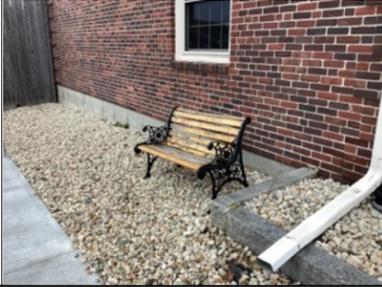
ID	Location	Floor	Room	Element	Type	Photo	Issues	Current Measure	Recommendations	Quantity	Price	Cost Estimation
Exterior Benches												
26	Near Main Entrance	Ext.		Exterior Benches	N/A

No accessible route to one bench in area	-	Relocate bench to an accessible route.	1	-	\$0
Toilet & Bathing Rooms												
Lavatory												
27	All Gender Toilet Room	1		Lavatory	N/A

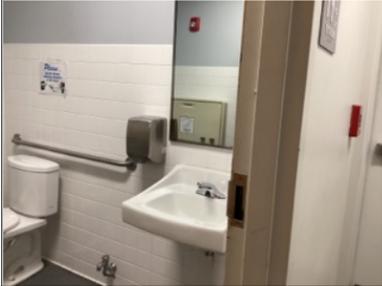
Toe or knee clearances not provided	25"	Provide at least one lavatory with knee and toe clearance positioned for a forward approach.	1	1686	\$1686
Single-User Toilet												
28	All Gender Toilet Room	1		Single-User Toilet	N/A

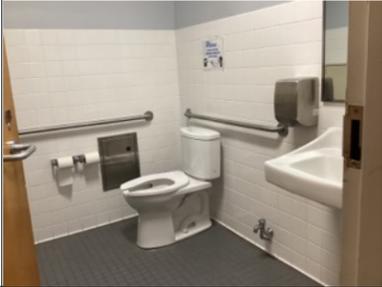
Flush control not on open side	-	Relocate the flush control to the open side.	1	374	\$374
Toilet Compartment												
29	Women's and Men's Toilet Room	3		Toilet Compartment	Accessible Compartment

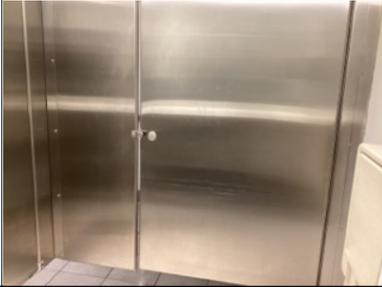
Door pull not provided	-	Provide a door pull on each side of the door between 34" to 48" above the finished floor that does not require tight grasping, pinching or twisting of the wrist.	2	70	\$140

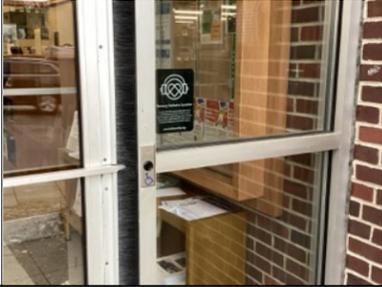
ID	Location	Floor	Room	Element	Type	Photo	Issues	Current Measure	Recommendations	Quantity	Price	Cost Estimation
30	North Main Street Entrance	Ext.			N/A

Recommend providing a larger automatic door opener with a more visible International Symbol of Accessibility (ISA) or providing a larger symbol on the glass part of the door indicating a power door is present.	1	-	\$0
Directional Sign to Nearest Accessible Exit												
31	Memorial Street Egress to Stairs	Ext.		Directional Sign to Nearest Accessible Exit	N/A

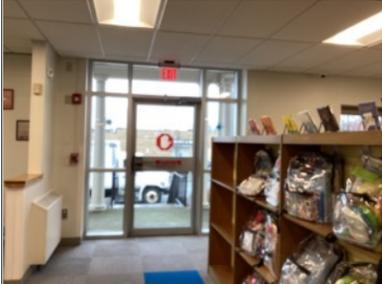
Recommend providing text on the required directional sign guiding visitors to the nearest accessible exit that yields wording similar to, "Nearest Accessible Exit at Main Entrance"	1	-	\$0
Glass Manifestations												
32	Study and Meeting Area	2		Glass Manifestations	N/A

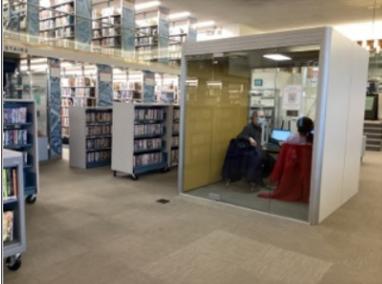
Recommend providing manifestation on glass to reduce likelihood of a collision with the glass surface.	1	-	\$0

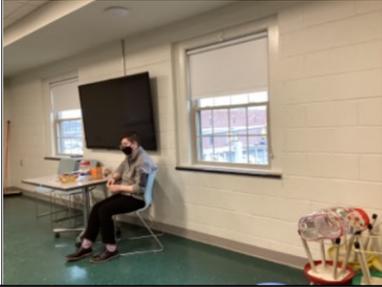
ID	Location	Floor	Room	Element	Type	Photo	Issues	Current Measure	Recommendations	Quantity	Price	Cost Estimation
Public Address System												
34	Shurtleff Room	3		Public Address System	310

-	Recommend, at the suggestion of the head librarian, providing a better public address system throughout the library.	1	-	\$0
Staircase												
35	Stairs From Floors 1 to 2	1		Staircase	N/A

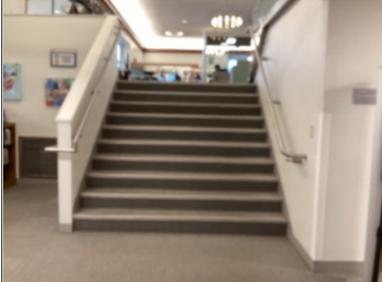
Recommend providing contrasting color strips at the edge of each step at all stairs.	1	-	\$0
