Town of Randolph
Belcher Park and Cochato Camp House

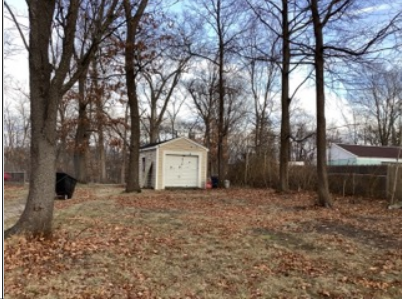
ID	Location	Floor	Room	Element	Type	Photo	Issues	Current Measure	Recommendations	Quantity	Price	Cost Estimation
Approach and Entrance												
Exterior Access Route												
1	Shed	Ext.		Exterior Access Route	Exterior

Accessible route not provided		If the shed is used by members of the public, ensure that it is located on an accessible route.	1	-	\$0
Off-Street Parking Lot or Garage												
2	Parking	Ext.		Off-Street Parking Lot or Garage	N/A

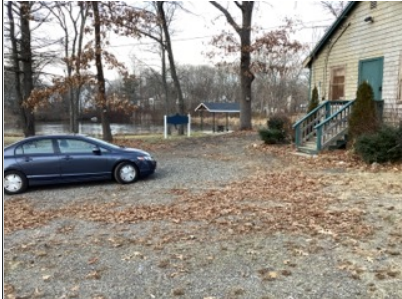
Total # of parking Total # of designated accessible parking spaces Total # of designated van accessible spaces Access aisle not provided Sign not provided	8 - - -	Provide a van accessible parking space with a marked access aisle that is at least 96" wide. Provide a sign with the International Symbol of Accessibility (ISA) with the bottom of the sign 60" min. above the ground. Add the designation "Van Accessible" to the sign located at the van accessible space. Ensure the slope at the parking space and access aisle is no greater than 2.00 % (1:50) in all directions.	1	-	\$0

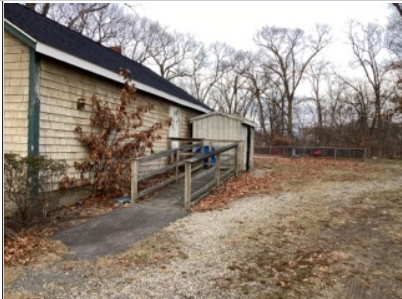
Exterior Ramp												
3	Ramp to Side Entrance	Ext.		Exterior Ramp	N/A

Not maintained in operable working condition	-	Ensure the ramp is maintained in operable working condition. Provide a compliant ramp 48" wide min. with handrails, landings and edge protection.	1	-	\$0
Entrance												
4	Main Entrance	Ext.		Entrance	Main Entrance

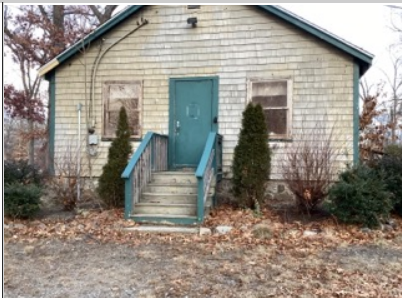
Directional sign to accessible entrance not provided	-	Provide a directional sign indicating the location of the nearest accessible entrance.	1	346	\$346
Access to Goods and Services

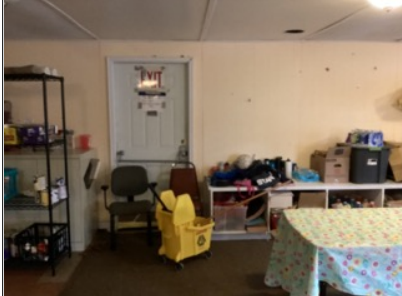
ID	Location	Floor	Room	Element	Type	Photo	Issues	Current Measure	Recommendations	Quantity	Price	Cost Estimation
Means of Egress												
5	Egress to Ramp			Means of Egress	N/A

Tactile exit sign not provided		Ensure tactile exit signs with raised characters and braille are provided at exit doors. Mount signs between 48"- 60" above the finished floor located on the latch side of the door.	1	232	\$232
6	Main Egress to Stairs	1		Means of Egress	N/A

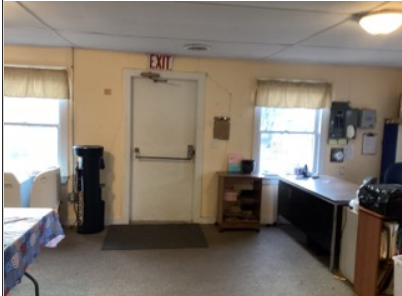
Threshold > 1/2" high Tactile exit sign not provided Directional sign to accessible emergency exit not provided		Ensure tactile exit signs with raised characters and braille are provided at exit doors. Mount signs between 48"- 60" above the finished floor located on the latch side of the door. Provide a directional sign indicating the location of the nearest accessible emergency exit. Alter the threshold to be 1/2" high max.	1	614	\$614
Doors, Doorways, & Gates

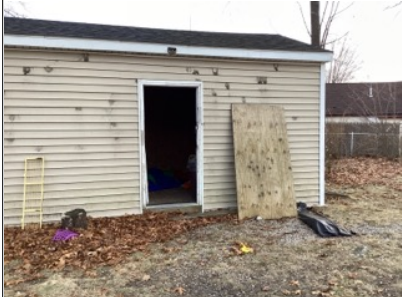
7	Shed	Ext.		Doors, Doorways, & Gates	Other

Threshold > 1/2" high	6"	If the shed is used by members of the public, alter the threshold to be 1/2" high max.	1	150	\$150
8	Toilet Room Door	1		Doors, Doorways, & Gates	Toilet Room

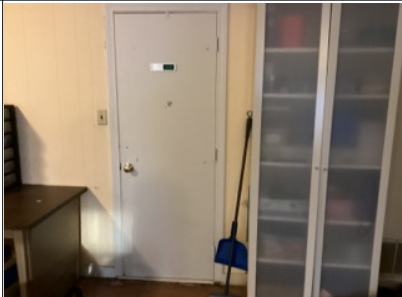
Hardware not operable with a closed fist Clear width at door < 32"	25"	Widen the door so that there is 32" min. clear width. Provide hardware that can be operable with one hand and not require tight grasping, pinching, or twisting of the wrist. Note: Cost to widen door and replace door hardware is included in the cost for a new accessible all gender single-user toilet room shown in ID #14.	1	-	\$0
Stairways												
9	Main Entrance	Ext.		Stairways	Egress

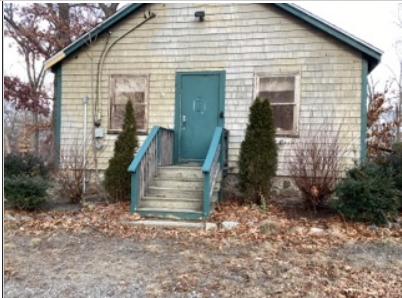
Handrails do not extend 12" from stairs Handrails have non-compliant cross section	- -	Bottom: Ensure handrails extend to one tread depth beyond the last riser. Provide handrails with 1 1/4" - 2" circular cross sections.	1	-	\$0

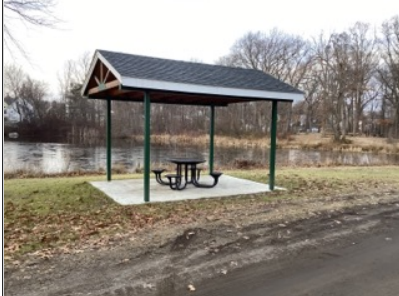
ID	Location	Floor	Room	Element	Type	Photo	Issues	Current Measure	Recommendations	Quantity	Price	Cost Estimation
Dining or Work Surfaces												
10	Picnic Pavilion by Pond	Ext.		Dining or Work Surfaces	Dining Surface

Not on a accessible route Knee or toe clearance not provided		Ensure an accessible route is provided to the picnic pavilion Provide at least one dining surface (picnic table) with 27" min. knee and toe clearance.	1	-	\$0
11	Picnic Pavilion by Parking	Ext.		Dining or Work Surfaces	Dining Surface

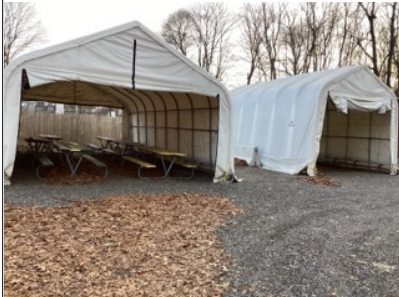
At least one or 5% accessible tables not provided Knee or toe clearance not provided		If these picnic tables are used by members of the public, ensure at least one picnic table is accessible and that it is located on an accessible route.	1	-	\$0
Kitchens and Kitchenettes												
12	Kitchen	1		Kitchens and Kitchenettes	N/A

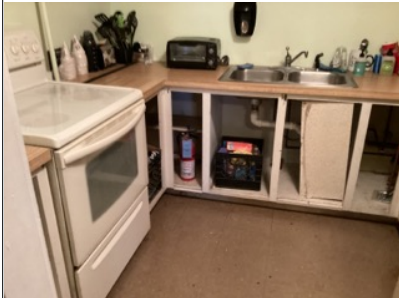
Knee/toe clearance not provided at sink	-	Provide a sink with knee and toe clearance positioned for a forward approach.	1	3094	\$3094

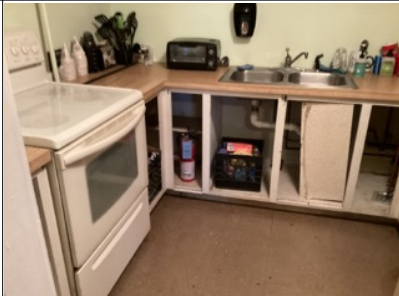
13	Kitchen	1		Kitchens and Kitchenettes	N/A

Knee/toe clearance not provided at cooktop Control panels at cooktop not at front Knee/toe clearance not provided at countertop Wall oven type not provided	- - - -	Provide a cooktop with knee and toe clearance positioned for a forward approach. Provide a cooktop with controls that do not require reaching across burners. Ensure knee and toe clearance are provided at the countertop (if forward approach). Ensure that a wall type oven is provided. Note: Both bottom and side-hinged wall ovens require a retractable "bread board" type shelf.	1	3200	\$3200
Toilet & Bathing Rooms

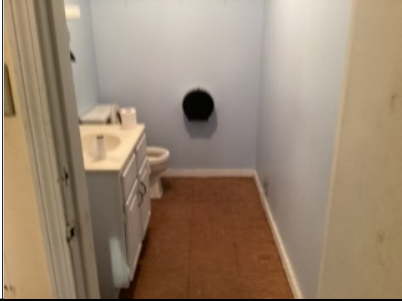
ID	Location	Floor	Room	Element	Type	Photo	Issues	Current Measure	Recommendations	Quantity	Price	Cost Estimation
Overall Access												
14	Toilet Room	1		Overall Access	Toilet Room

Turning space not provided Accessible plumbing fixtures or stalls not provided	- -	Renovate to provide an accessible single-user toilet room.	1	24604	\$24604
Play and Sport Areas												
Play Areas												
15	Playground Entrance	1		Play Areas	N/A

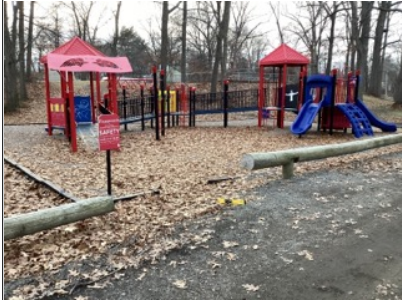
Accessible route not provided to playground	21%	Install an accessible route to the playground.	1	-	\$0
16	Playground	Ext.		Play Areas	N/A

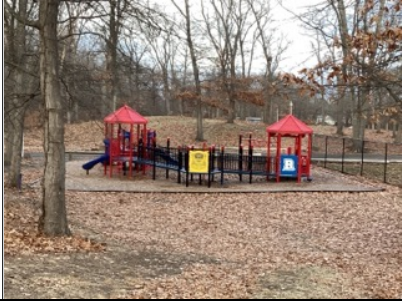
Accessible route not provided to playground Accessible route not provided around playground Accessible route not provided to play components	4"	Install an accessible route around the playground. Provide a compliant impact-attenuating surface to and around the play components.	1	-	\$0
Court												
17	Basketball Court	Ext.		Court	Basketball

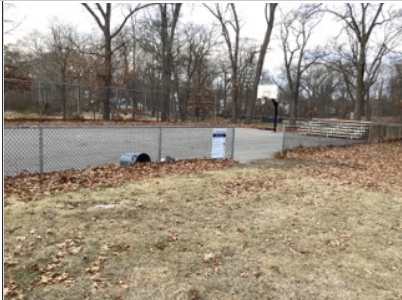
Court is not connected to an accessible route		Provide a stable, firm and slip resistant accessible route to the basketball court.	1	-	\$0

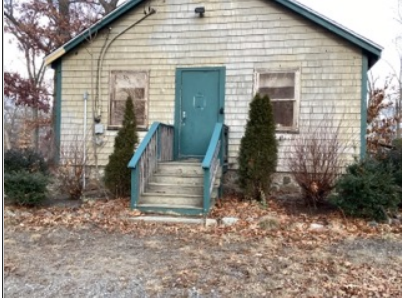
ID	Location	Floor	Room	Element	Type	Photo	Issues	Current Measure	Recommendations	Quantity	Price	Cost Estimation
Exterior Stairs												
18	Main Entrance	Ext.		Exterior Stairs	N/A

Recommend providing contrasting colored strips on the exterior stairs.	1	-	\$0
