Attachment #2 - Detail of Cornice/Soffit Trim Construction:

Attachment #3 – Reflected Ceiling View showing damaged area:

Attachment #4 - Photographs of Items described in Scope of Work:

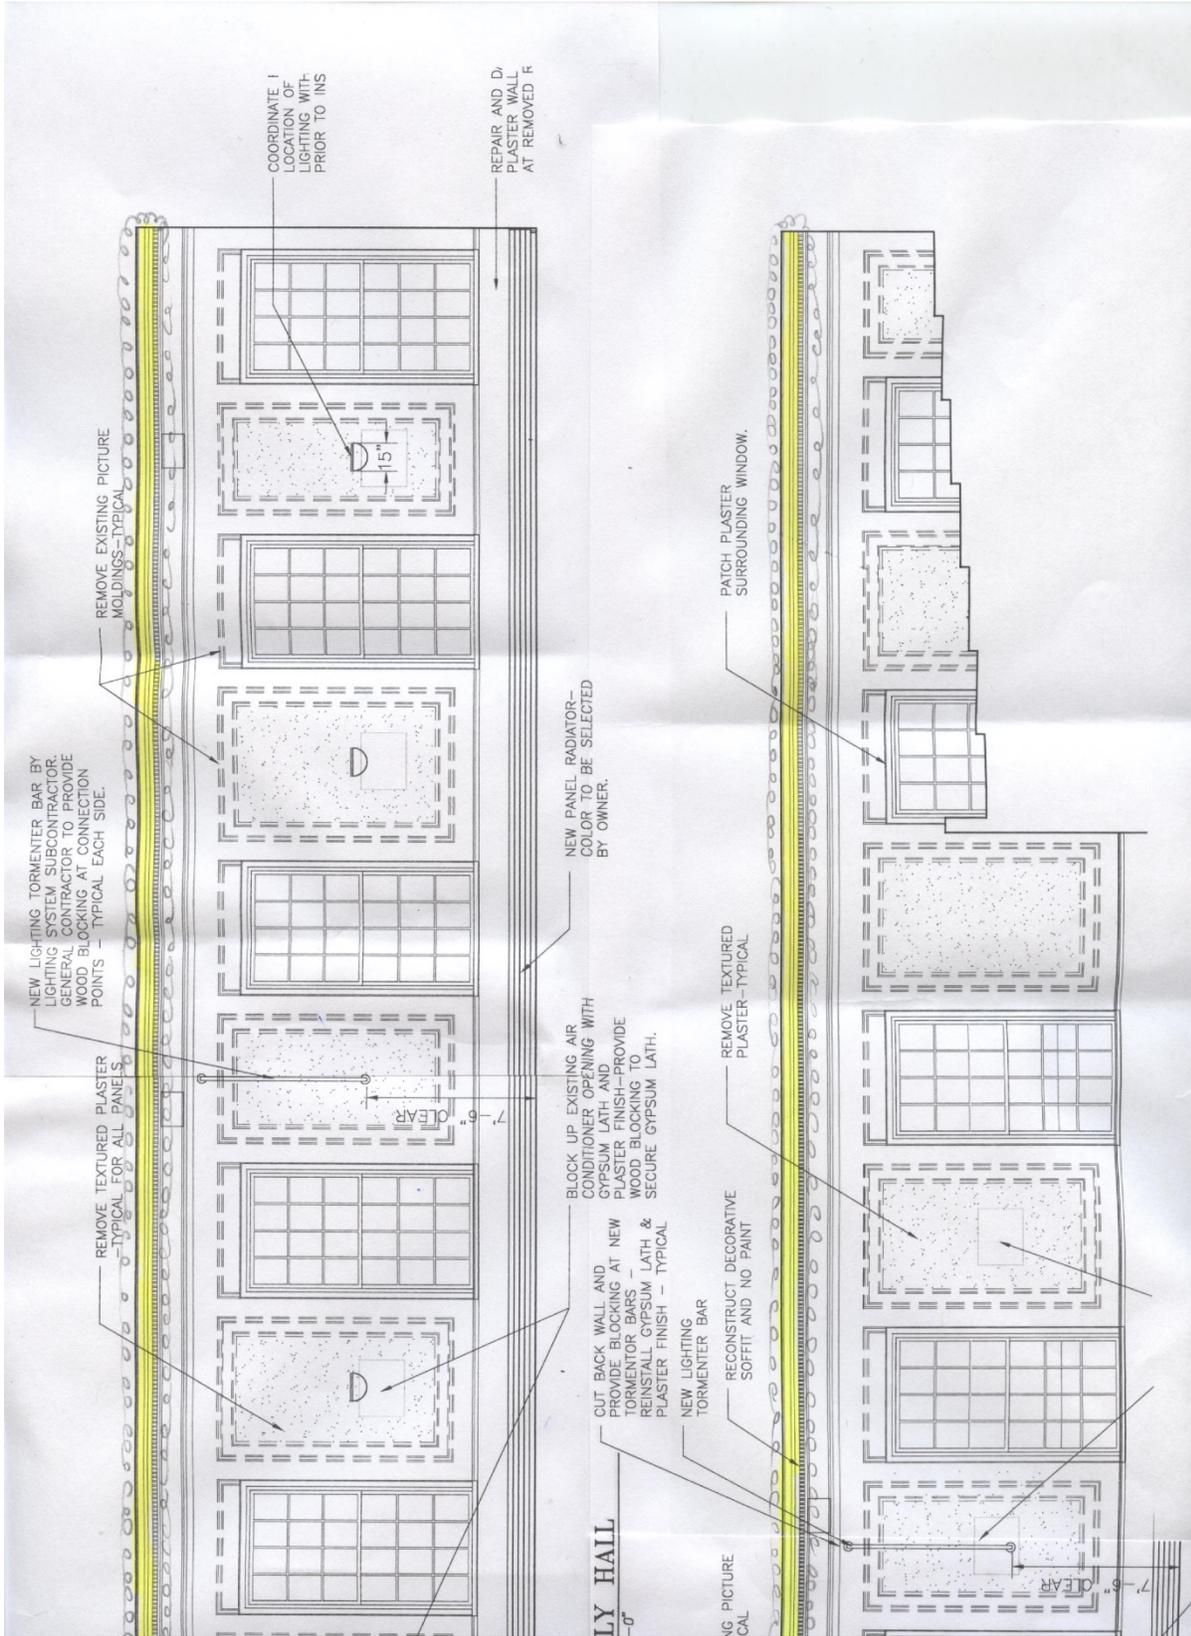
REMOVE TEXTURED PLASTER - TYPICAL FOR ALL PANELS

REMOVE EXISTING PICTURE MOLDING - TYPICAL

REPAIR AND DRY PLASTER WALL AT REMOVED F

REMOVE TEXTURED PLASTER - TYPICAL

PATCH PLASTER SURROUNDING WINDOW.

NEW LIGHTING TORMENTER BAR BY LIGHTING SYSTEM SUBCONTRACTOR. GENERAL CONTRACTOR TO PROVIDE WOOD BLOCKING AT CONNECTION POINTS - TYPICAL EACH SIDE.

COORDINATE LOCATION OF LIGHTING WITH PINS PRIOR TO INS

NEW PANEL RADIATOR - COLOR TO BE SELECTED BY OWNER.

BLOCK UP EXISTING AIR CONDITIONER OPENING WITH GYPSUM LATH AND PLASTER FINISH - PROVIDE WOOD BLOCKING TO SECURE GYPSUM LATH.

CUT BACK WALL AND PROVIDE BLOCKING AT NEW TORMENTER BARS - REINSTALL GYPSUM LATH & PLASTER FINISH - TYPICAL

RECONSTRUCT DECORATIVE SOFFIT AND NO PAINT
