**Town of Randolph
Corkin Building**

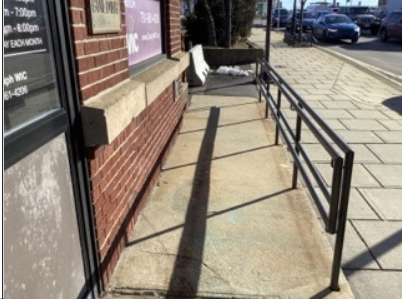
Handrails < 34" or > 38" above ramp surface Handrails not provided at both sides if rise is > 6"	32" -	Alter so the handrails are 34"- 38" high above the ground or finished floor. Provide handrails on both sides.	1	-	\$0
Exterior Stair												
2	Main Entrance	Ext.		Exterior Stair	N/A

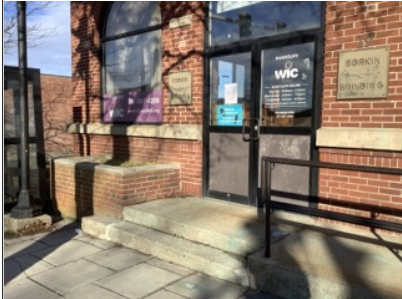
Handrails not provided	-	Provide handrail on one side.	1	-	\$0
Entrance												
3	Main Entrance	Ext.		Entrance	Main Entrance

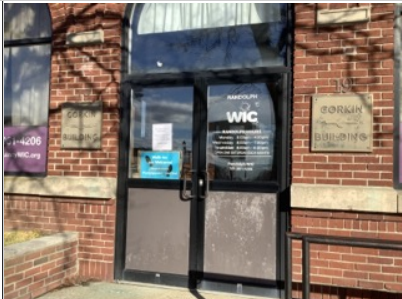
Door requires > 15 lbs. of force to open	21 lbs	Adjust closers so doors do not require more than 15 pounds of force.	1	Labor	\$0
Access to Goods and Services												
Means of Egress												
4	Main Entrance	1		Means of Egress	N/A

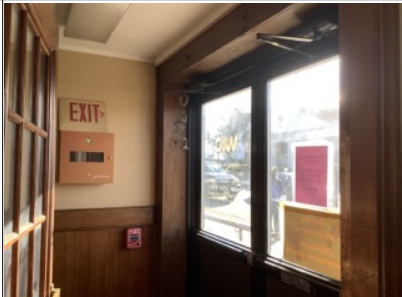
Tactile exit sign not provided Illuminated ISA symbol not provided (MAAB)	- -	Ensure tactile exit signs with raised characters and braille are provided at exit doors. Mount signs between 48"- 60" above the finished floor located on the latch side of the door. If the exit sign is replaced with an illuminated exit sign, provide an illuminated International Symbol of Accessibility (ISA).	1	232	\$232

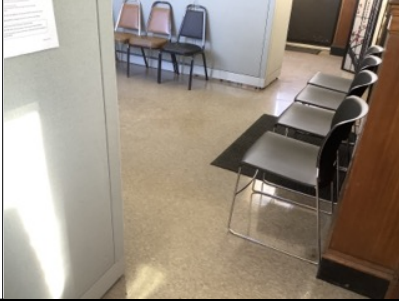
Route < 36" wide	24.4"	Relocate chair to ensure that a clear width of 36" min. is maintained at the accessible route.	1	Labor	\$0
Doors, Doorways, & Gates												
6	Lobby	1		Doors, Doorways, & Gates	Circulation

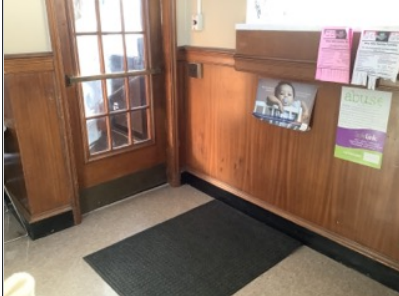
Mat not securely attached	-	Secure the mat to prevent tripping hazard.	1	Labor	\$0
7	Single-User Toilet Room	1		Doors, Doorways, & Gates	Toilet Room

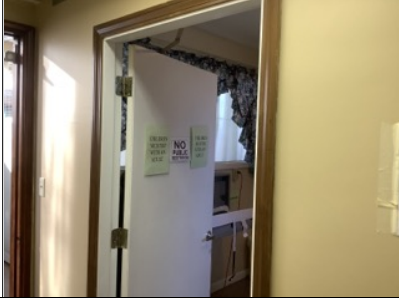
Door requires > 5 lbs. of force to open	10 lbs	Adjust closers so doors do not require more than 5 pounds of force to open.	1	Labor	\$0
Signage												
8	Single-User Toilet Room	1		Signage	Designation

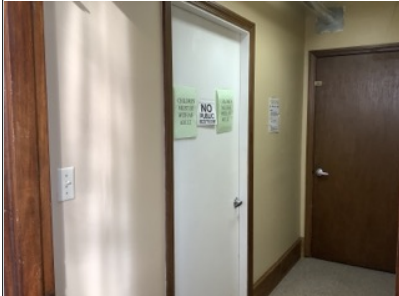
Signage is not provided	-	Locate compliant signage alongside the door on the latch side.	1	232	\$232
Toilet & Bathing Rooms

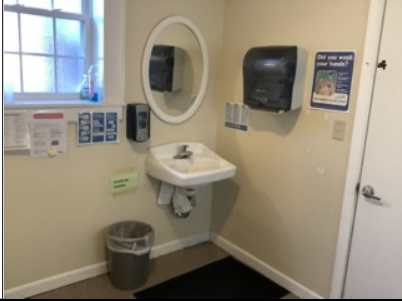
Plumbing underneath is exposed Mat not securely attached	-	Insulate or otherwise configure pipes to prevent contact for at least one lavatory. Secure the mat located underneath the lavatory.	1	92 Labor	\$92
Single-User Toilet												
10	Single-User Toilet Room	1		Single-User Toilet	N/A

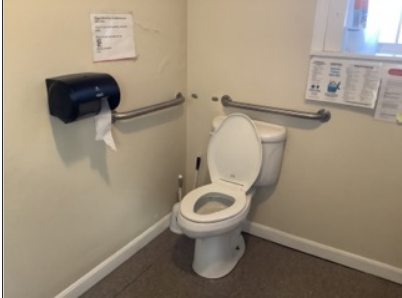
Flush control not on open side Toilet paper dispenser is not compliant	- -	Relocate the flush control to the open side. Relocate toilet paper so that it is 24" min. high, located under the grab bar, and between 7" and 9" from the front of the toilet.	1	630	\$630
Dispensers												
11	Single-User Toilet Room	1		Dispensers	Paper Towel Dispenser

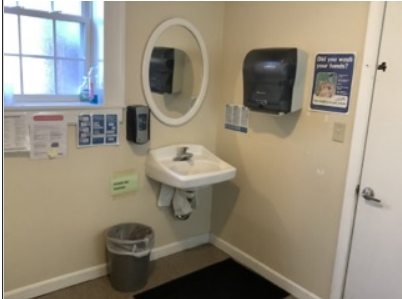
Controls > 48" high Dispenser acts as a protruding object	50.6" 8"	Relocate the paper towel dispenser so the operable part is 48" max. above the finished floor. Relocate the paper towel dispenser to the rear wall, so it is located out of the circulation pathway.	1	256 Labor	\$256

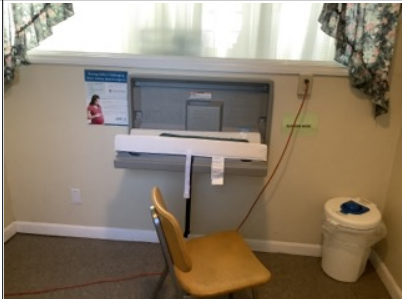
30" x 48" clear floor space not provided	-	Relocate the chair to ensure a 30" by 48" clear floor space positioned for a forward approach is provided at the baby changing table.	1	Labor	\$0
